## Annual Inspection

Corfe Castle Parish Council

West Street Play Area

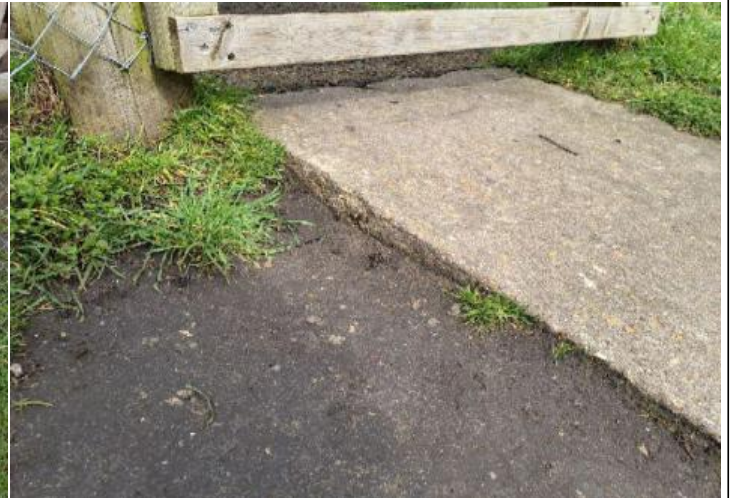
**Finding:** There are trip hazards present

There are trip hazards present - Reinstate surrounding surfaces to level to remove the trip points

**Action:** Reinstate surrounding surfaces to level to remove the trip points

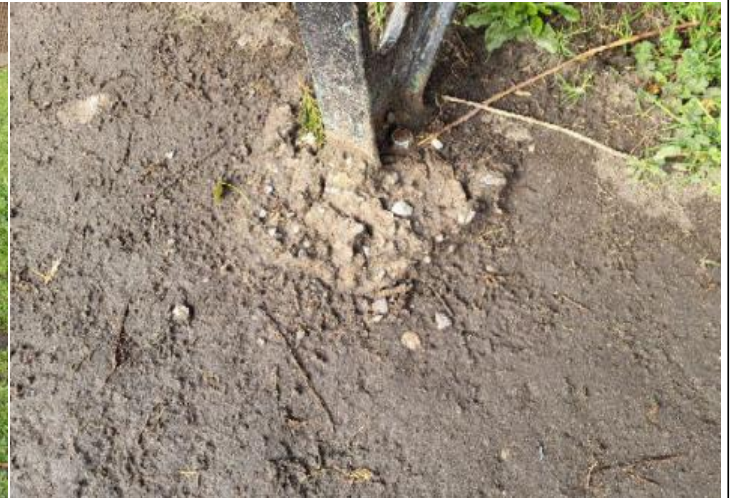
**Finding:** The surface has eroded and the foundations are exposed

**Action:** Reinstate surrounding surfaces to cover the foundations

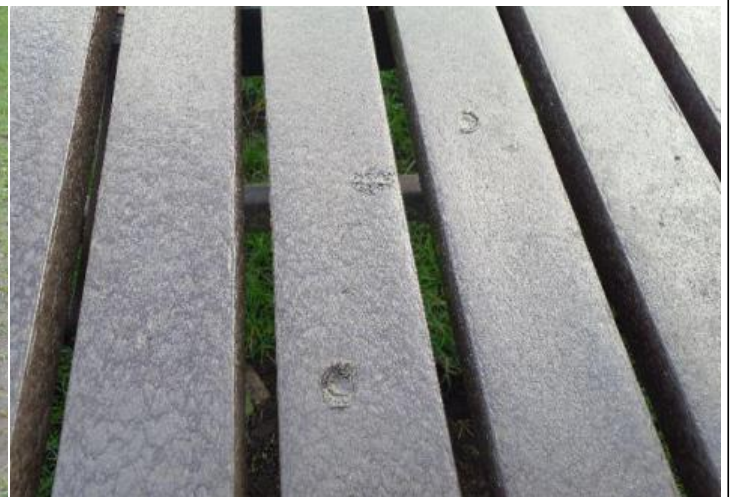
**Finding:** There is some evidence of fire damage to the item

**Action:** Monitor for any further deterioration and repair as required

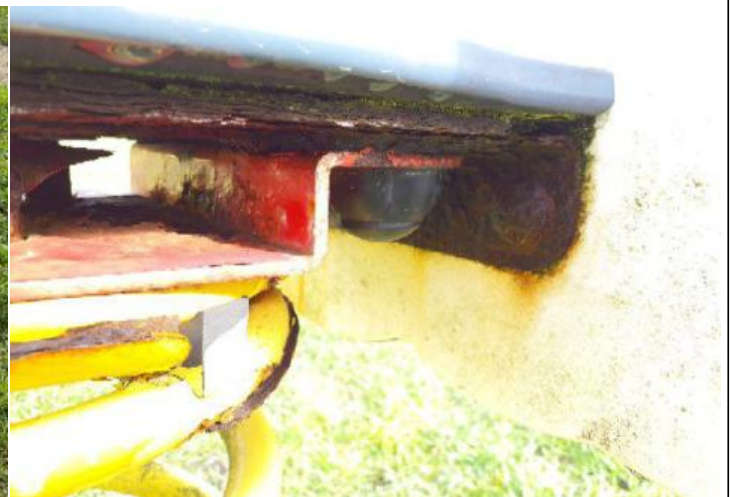
**Finding:** The paintwork on this item has been damaged or worn exposing the metal underneath which is rusting

**Action:** Treat any rusting components and repaint

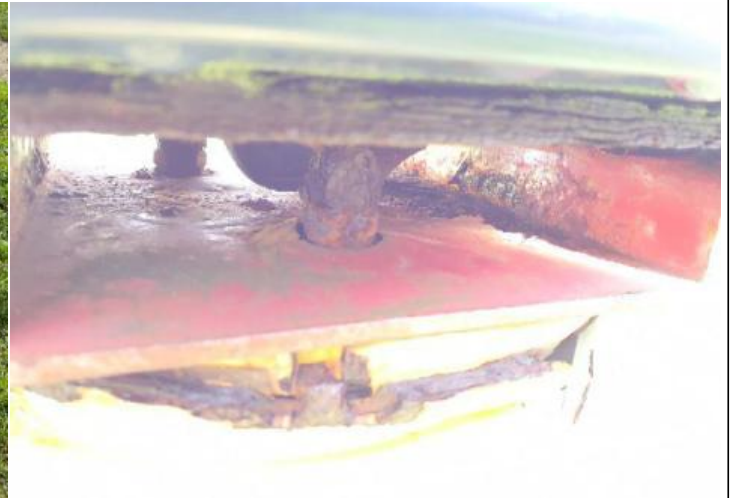
**Finding:** The fixings have corroded excessively

**Action:** Replace all corroded fixings

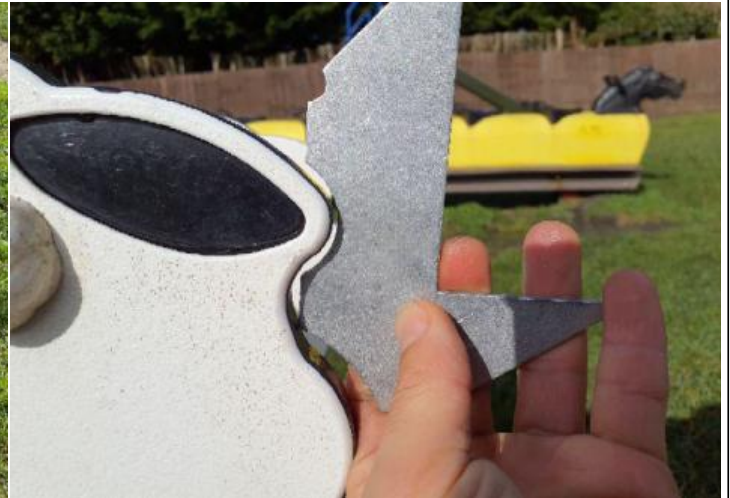
**Finding:** The main body profile has a radius of less than 20mm in places, in contravention of BS EN 1176 Part 6

**Action:** Monitor - No remedial work recommended

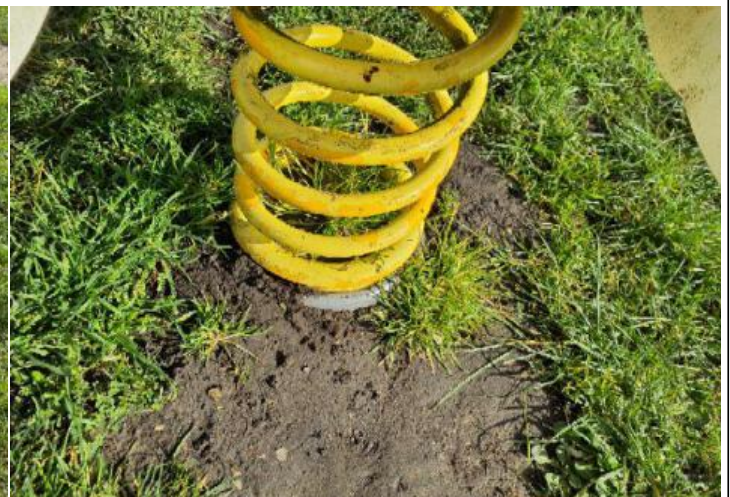
**Finding:** A number of fixing(s) have worked loose on the baseplate

**Action:** Secure all loose fixings

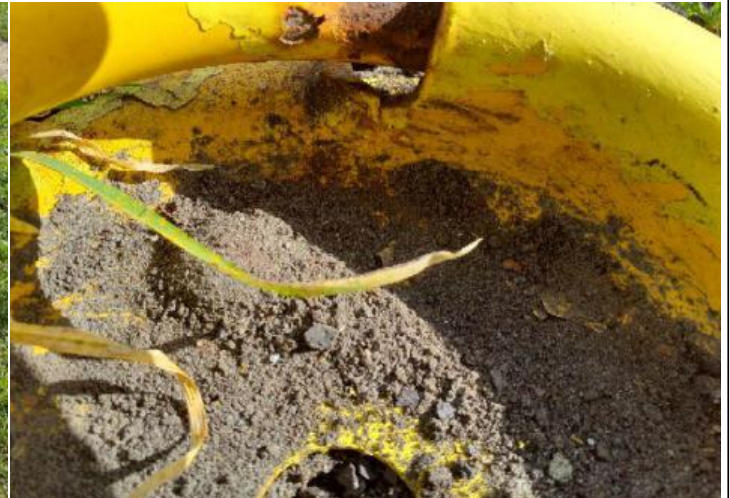
**Finding:** There is a small crack appearing in the baseplate **Action:** Monitor use and repair as required

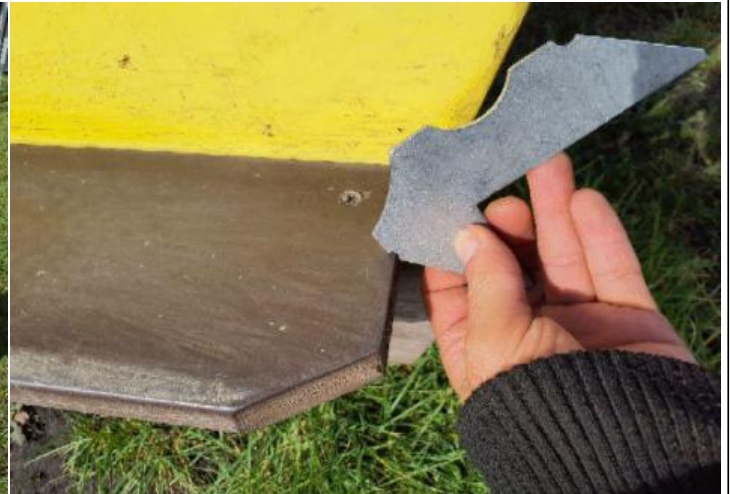
**Finding:** The item has exposed edges and corners with a radius of less than 3mm and fails the requirements of BS EN 1176 **Action:** Provide a 3mm radius to all exposed edges and corners

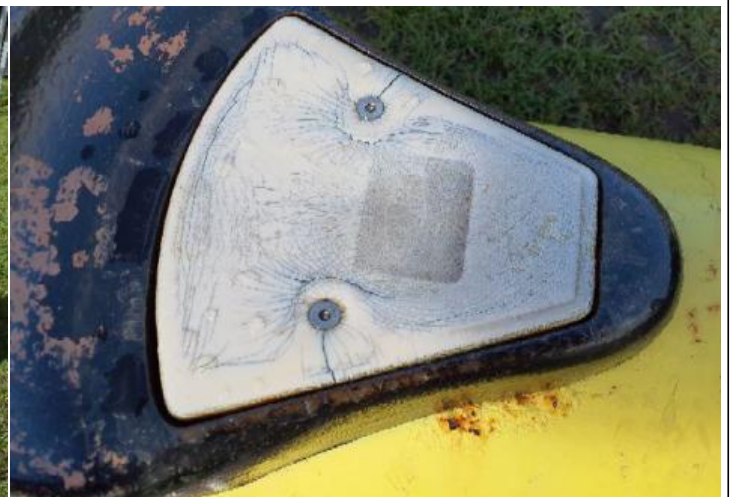
**Finding:** The seat has minor damage or wear

**Action:** Monitor for any further deterioration and replace as required

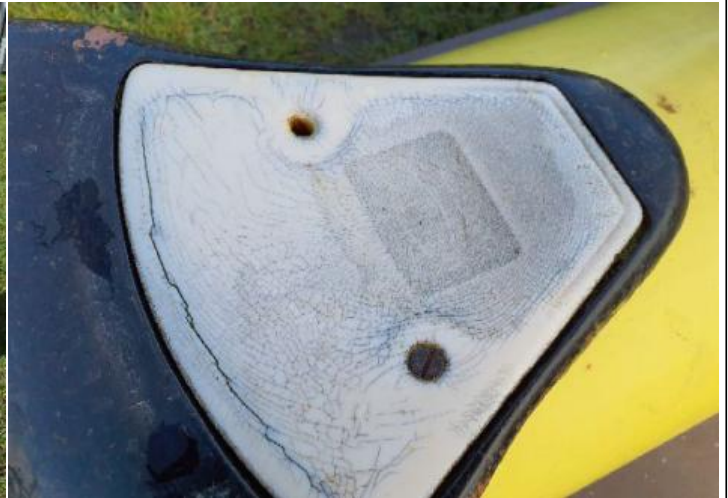
**Finding:** There is or are fixings missing on the item

**Action:** Replace all missing fixings

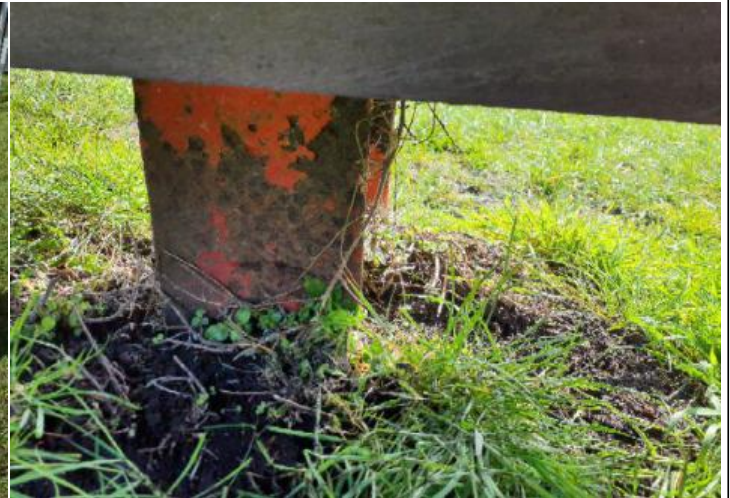
**Finding:** The paintwork on this item has been damaged or worn exposing the metal underneath which is rusting

**Action:** Treat any rusting components and repaint

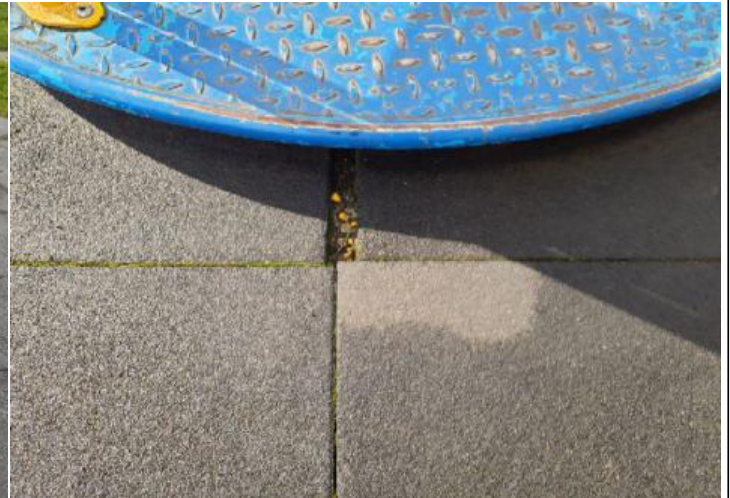
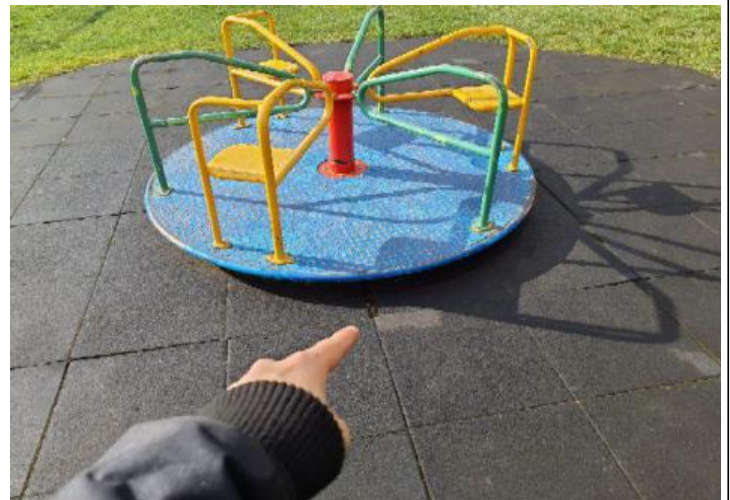
**Finding:** There are gaps opening in between the tiles

**Action:** Repair

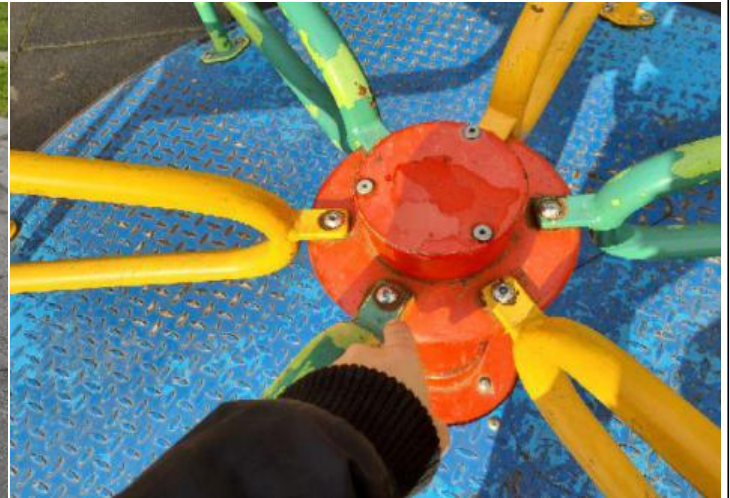
**Finding:** A number of fixing(s) have worked loose

**Action:** Secure all loose fixings

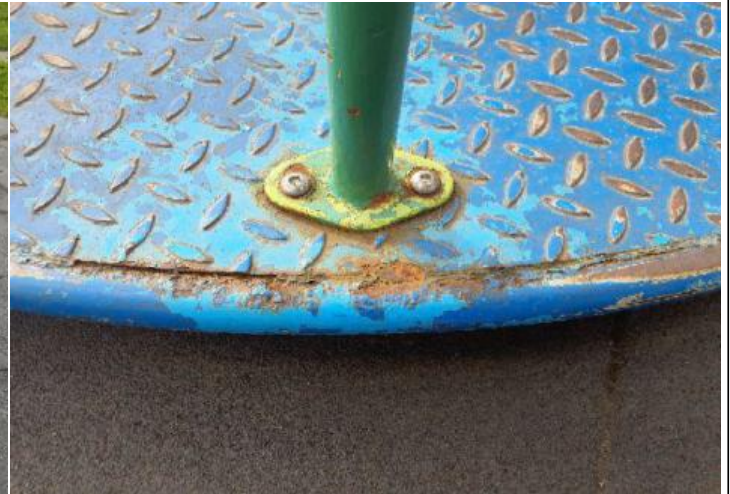
**Finding:** The paintwork on this item has been damaged or worn exposing the metal underneath which is rusting

**Action:** Treat any rusting components and repaint

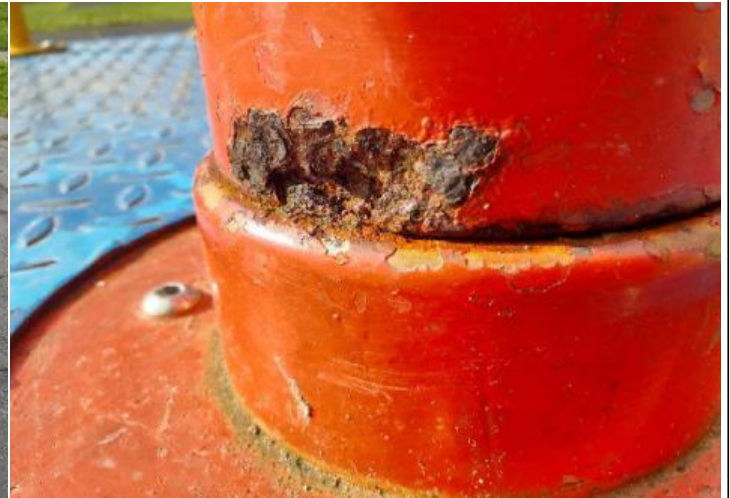
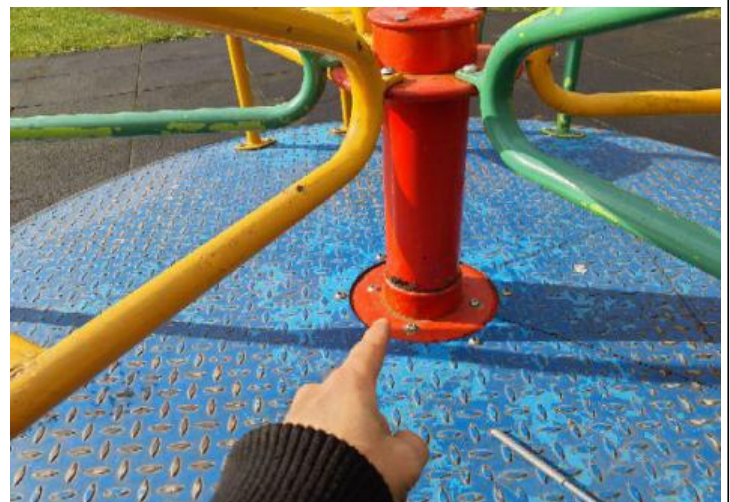
**Finding:** Parts of the steel on this item have corroded excessively and the metal has perforated in places

**Action:** Ensure all affected areas are treated and repaired

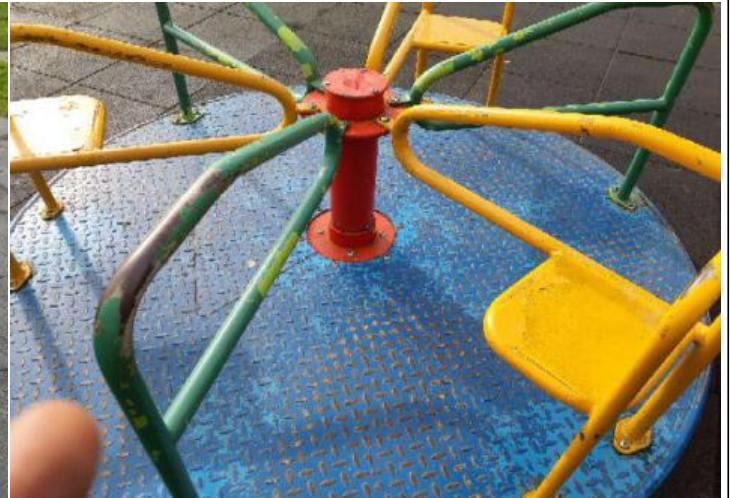
**Finding:** The bearing is showing signs of wear

**Action:** Monitor for any further deterioration and replace as required

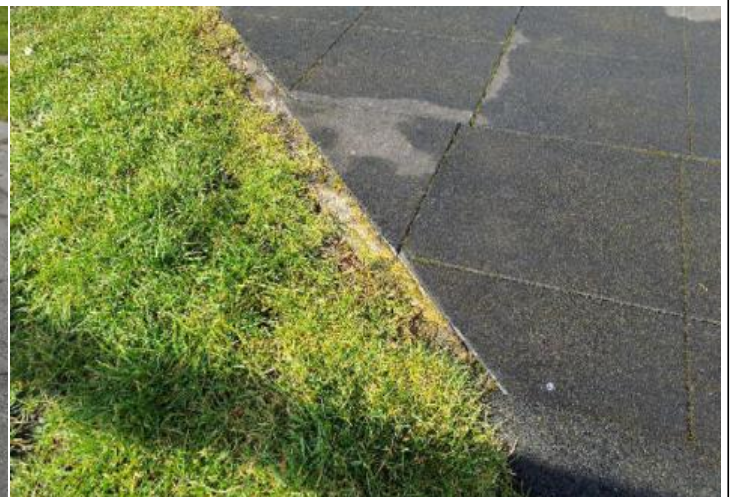
**Finding:** There is moderate damage to the surface

**Action:** Repair the damaged areas of surfacing

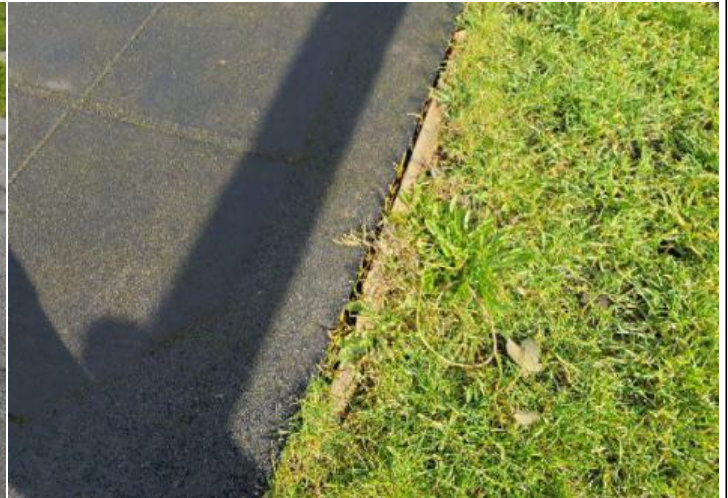
**Finding:** There are gaps opening between the surfacing and the edging surround or between the joints in the surfacing **Action:** Monitor for any further deterioration and repair as required

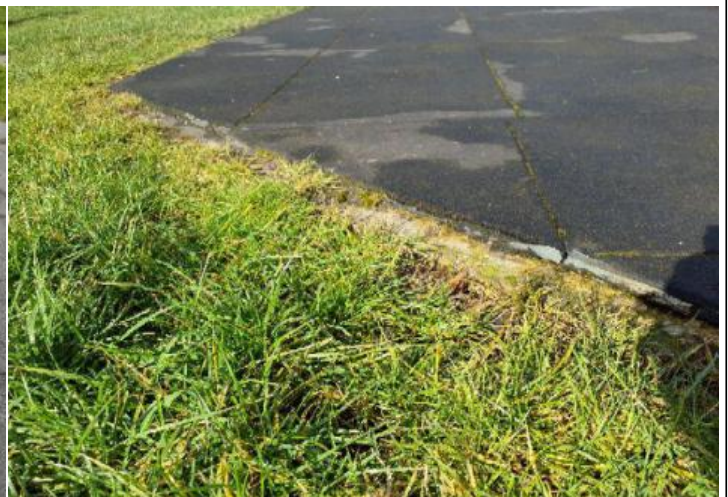
**Finding:** There are trip hazards at the edges of the surface **Action:** Reinstate surrounding surface levels to remove the trip points

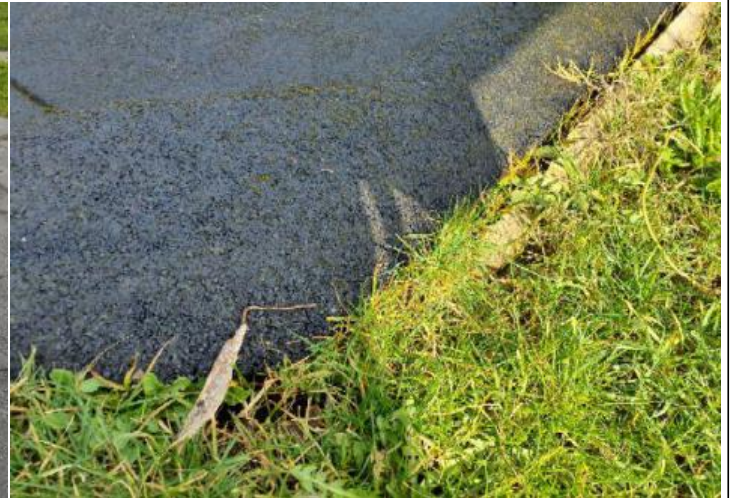
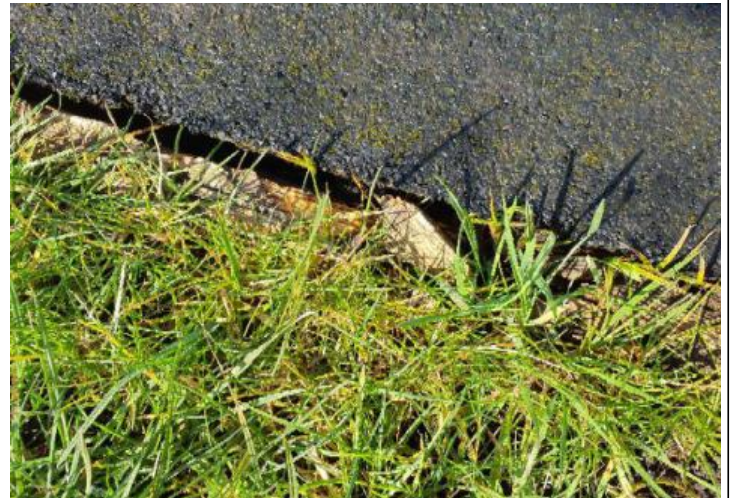
**Finding:** There are areas or parts of the timber on the edging that have rotted or are missing

**Action:** Replace all affected timbers

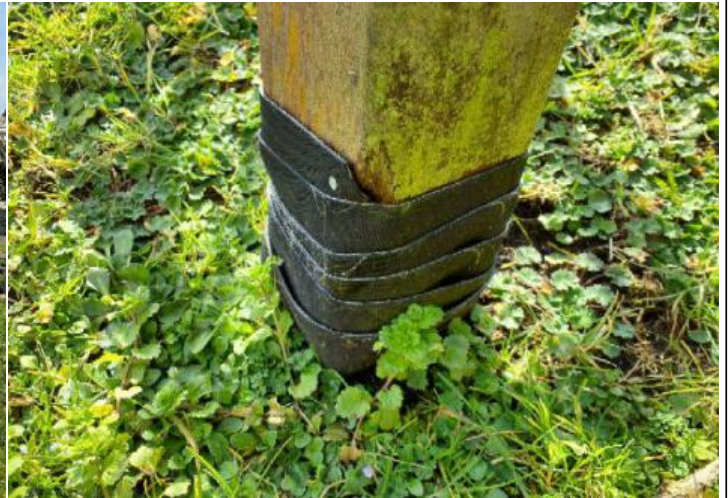
**Finding:** There is some strimmer / machinery damage apparent on the posts, this can penetrate the preservative applied to the timber and accelerate the rotting process. The timber has been covered making it difficult to now test for rot without removing the plastic covering

**Action:** Remove the plastic covering to check for any deterioration (rot) and replace as required

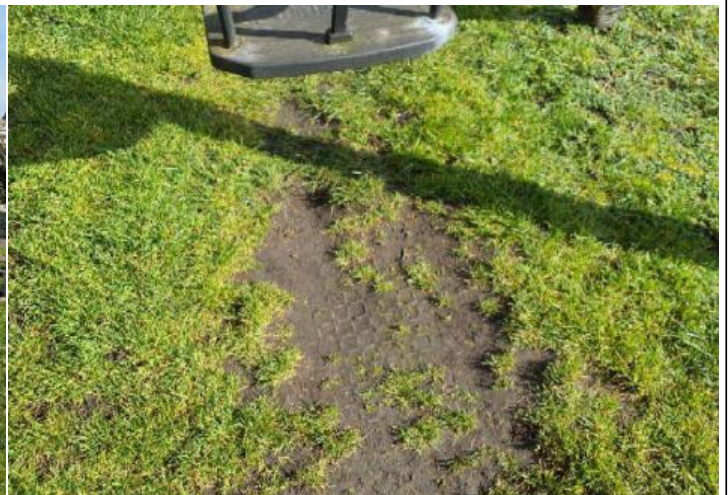
**Finding:** The grass mats are silted up and the soil is compacted; this may have an effect on the impact absorbing properties of the surface

**Action:** Consider HIC testing impact absorbing properties to ensure the correct surface qualities are maintained for the equipment and replace as required

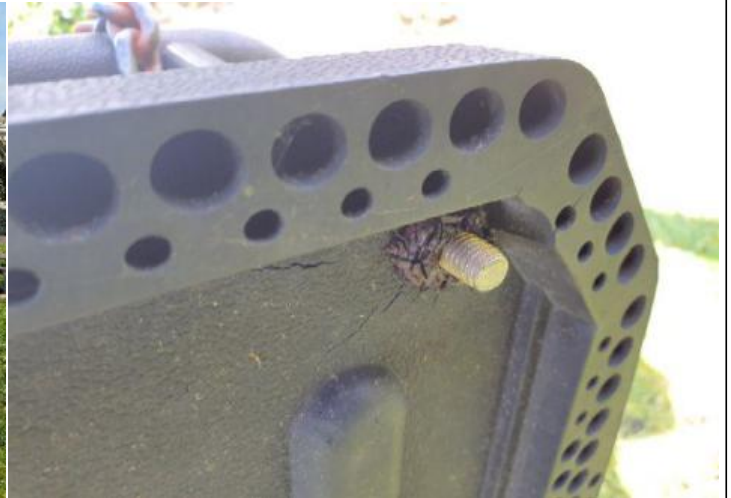
**Finding:** The fixings have corroded excessively

**Action:** Replace all corroded fixings

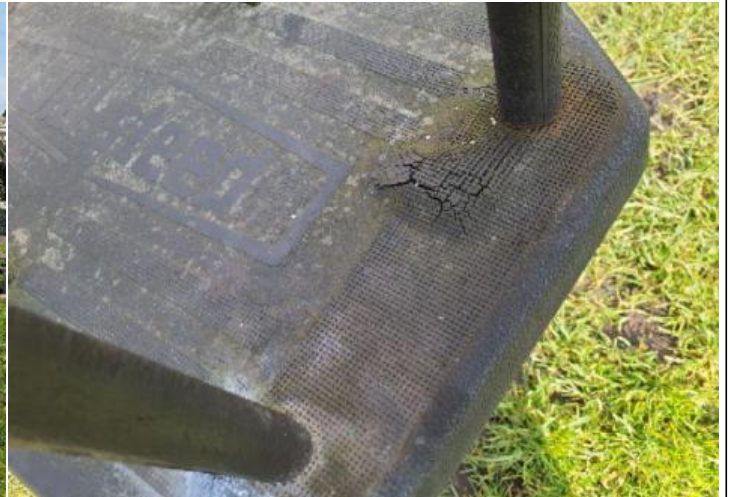
**Finding:** The seat has damage or wear, possibly from internal corrosion

**Action:** Dismantle the seat for inspection and replace as required

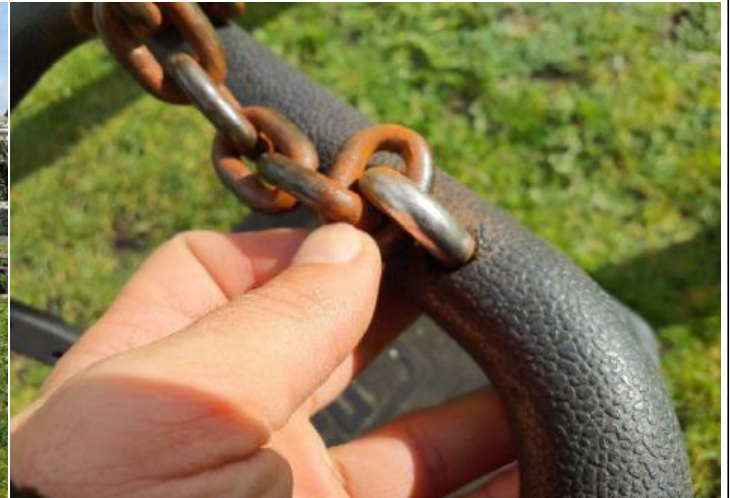
**Finding:** There is some notable evidence of chain wear

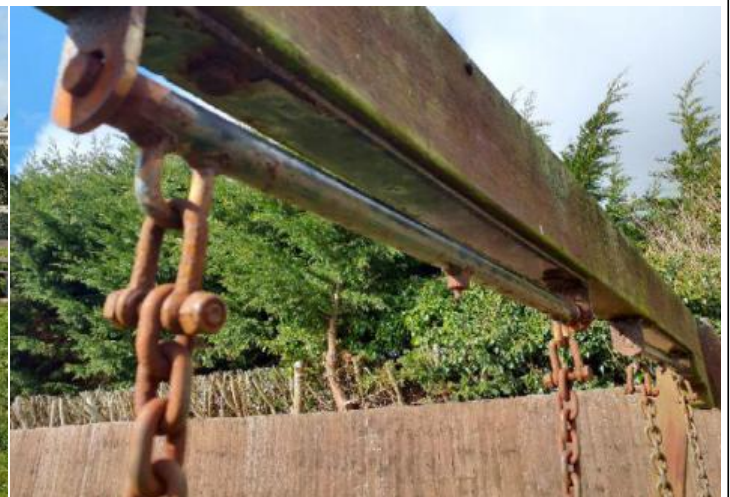
**Finding:** The paintwork on this item has been damaged or worn exposing the metal underneath which is rusting

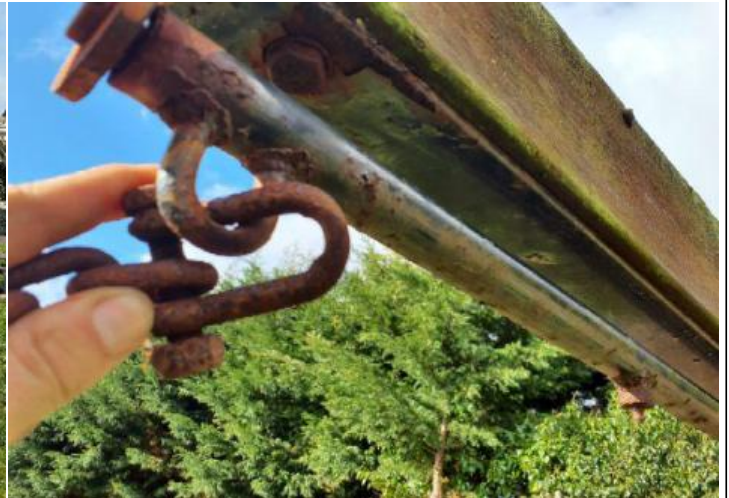
**Finding:** There is some wear to the shackles.

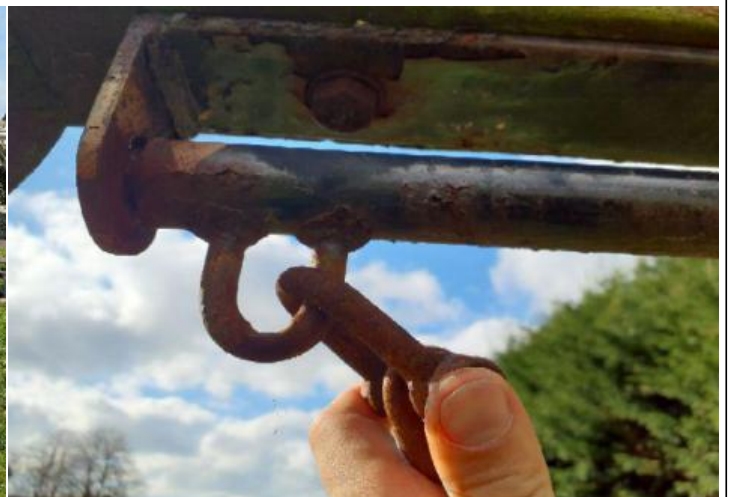
**Finding:** The connecting lugs are showing signs of wear

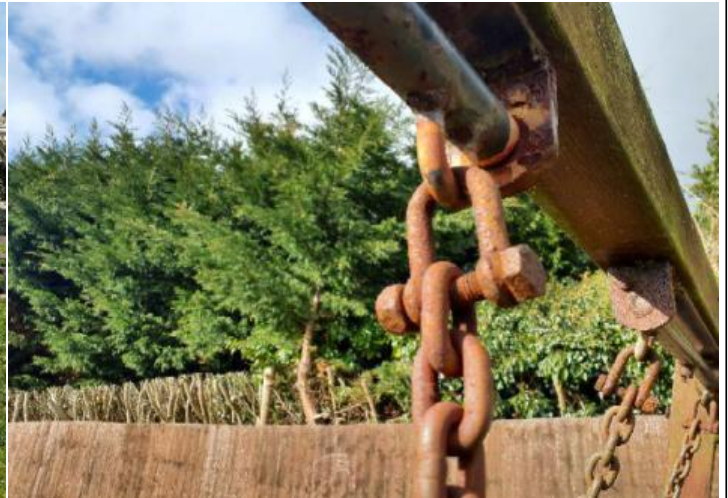
**Finding:** The fixings have corroded excessively

**Action:** Replace all corroded fixings

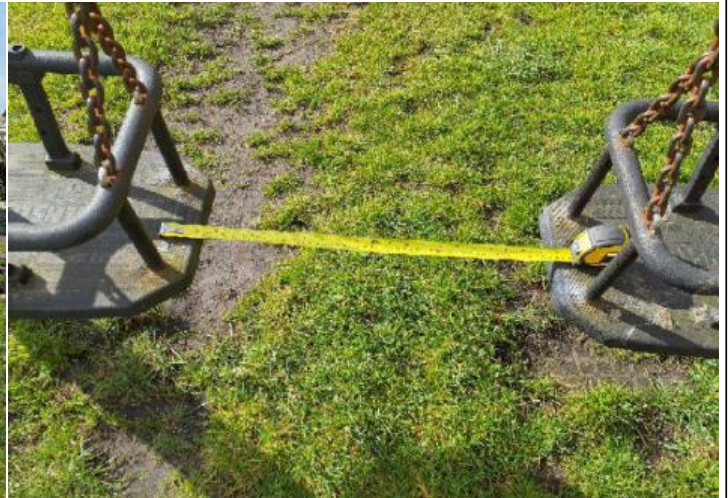
**Finding:** The seats are too close to each other as defined in BS EN 1176 Part 2; this is a low risk failure and no remedial action is required  
**Action:** Monitor - No remedial work recommended

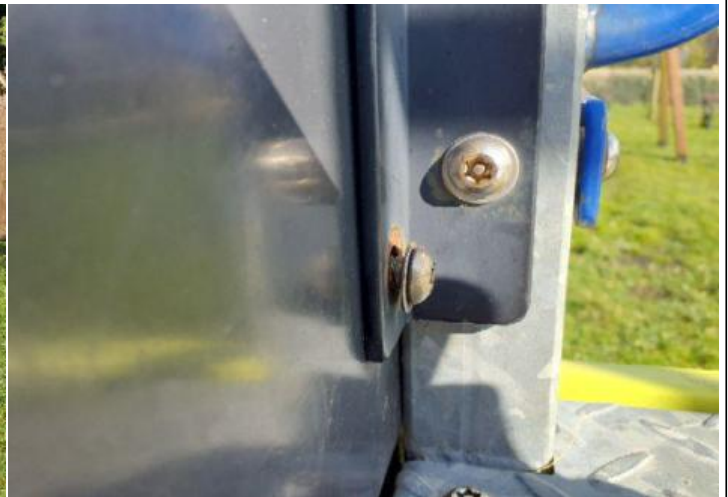
**Finding:** A number of fixing(s) have worked loose  
**Action:** Secure all loose fixings

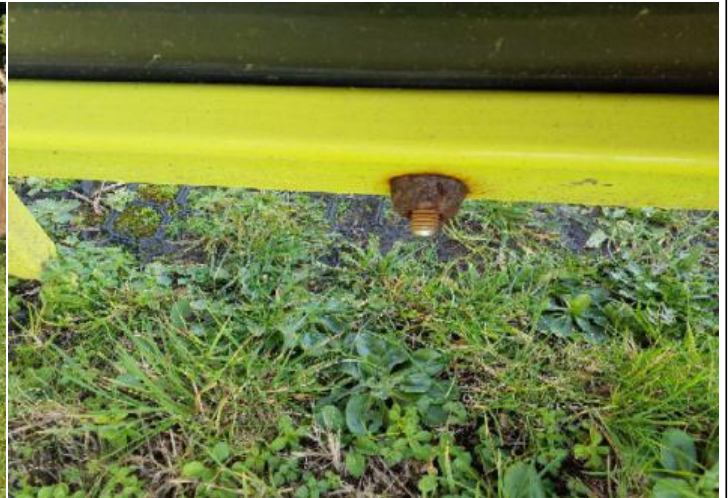
**Finding:** The fixings have corroded excessively

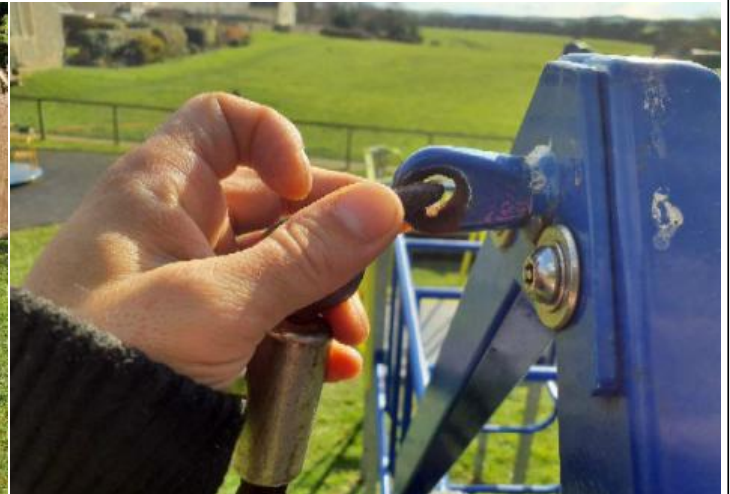
**Finding:** The connecting lugs are showing signs of wear

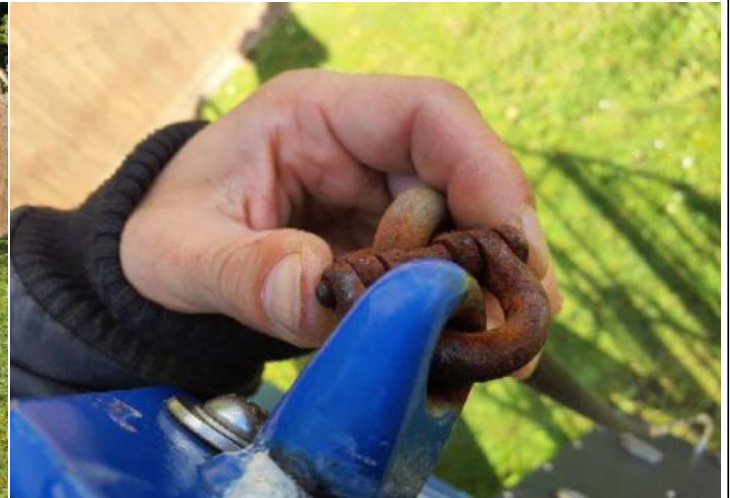
**Finding:** There is some wear to the shackles

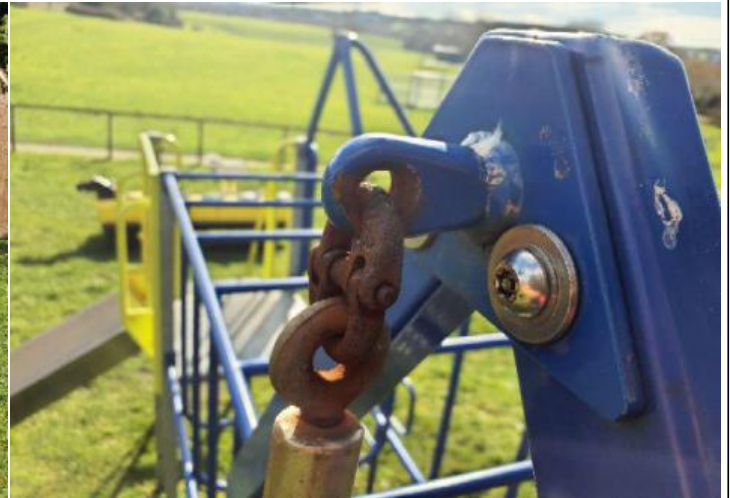
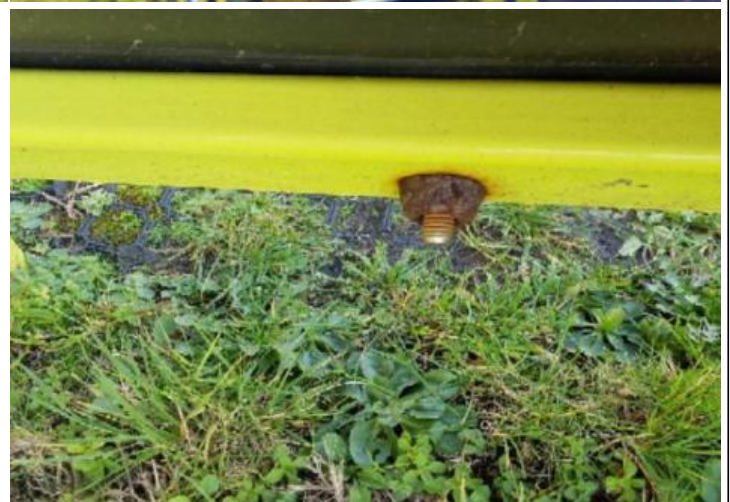
**Finding:** The fixings have corroded excessively

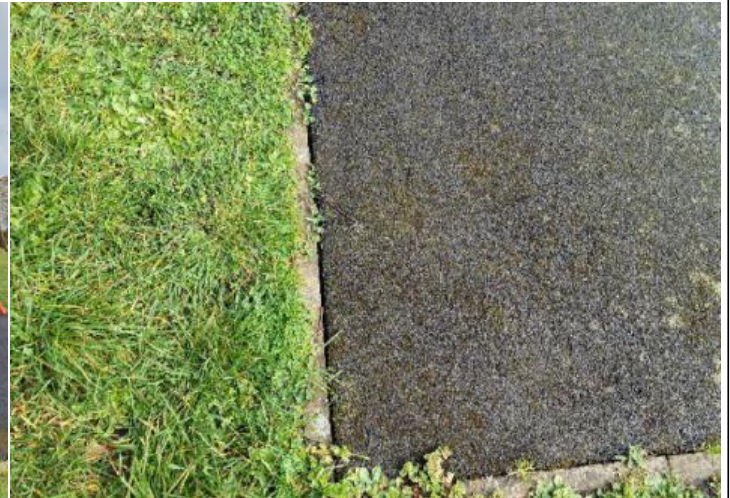
**Finding:** There are gaps opening between the surfacing and the edging surround or between the joints in the surfacing  
**Action:** Monitor for any further deterioration and repair as required

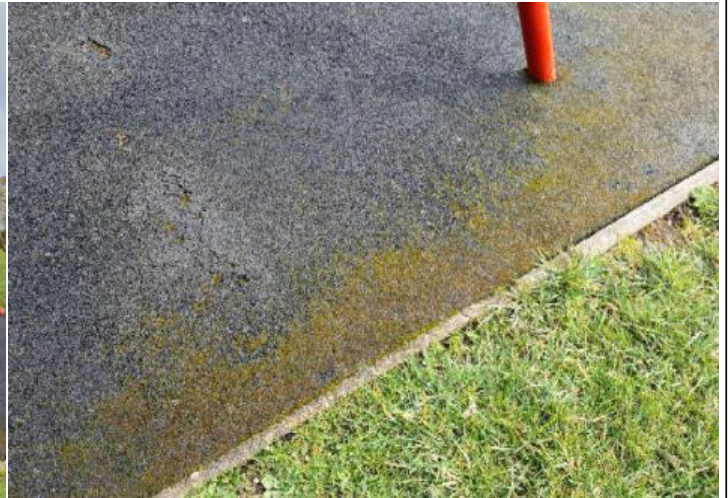
**Finding:** There is algae, silt or moss growth on the surface resulting in slippery conditions

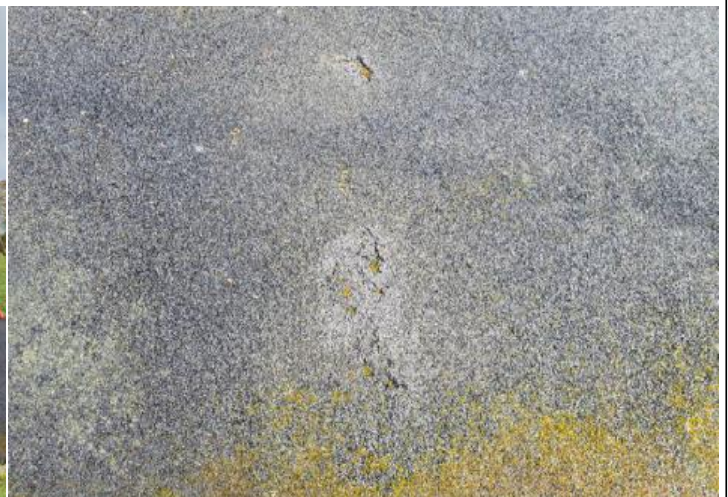
**Finding:** There is some minor damage to the surface

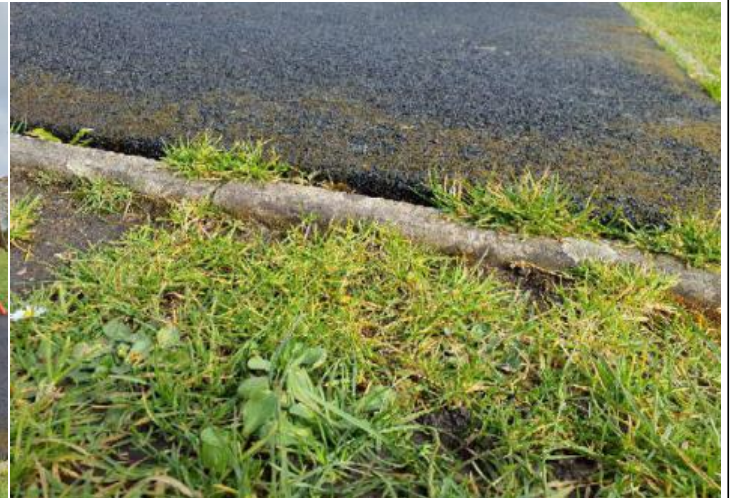
**Finding:** The surface is lifting at the edges and creating trip points  
**Action:** Repair perimeter of surfacing to remove trip points

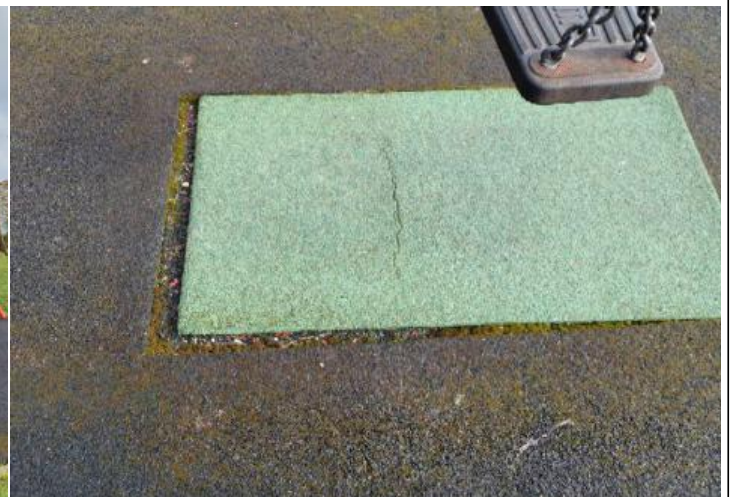
**Finding:** There are significant gaps (over 30mm) between the repairs in the surface; these are large enough for a small foot to enter  
**Action:** Repair surfacing

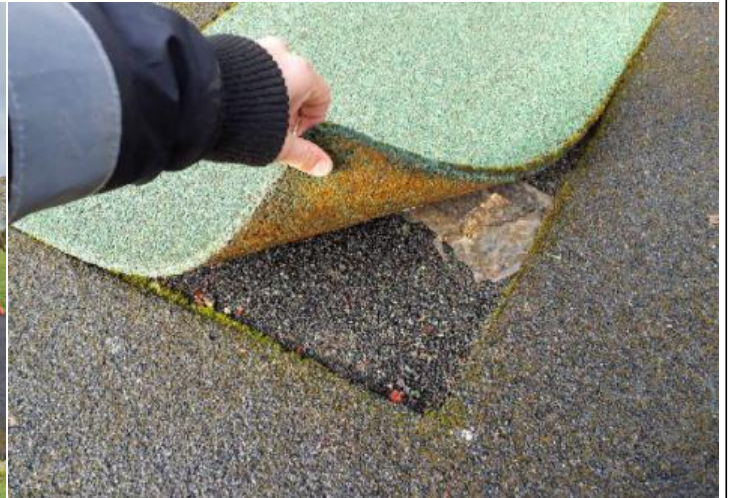
**Finding:** The repaired surfacing is lifting at the edges and creating trip points

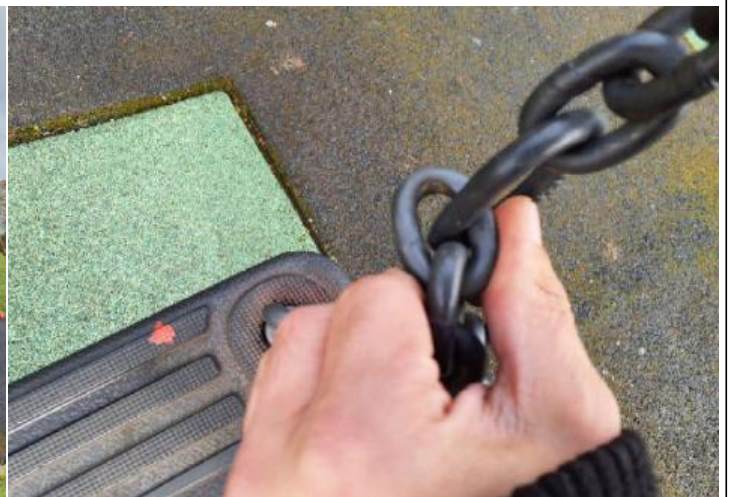
**Finding:** There is some notable evidence of chain wear

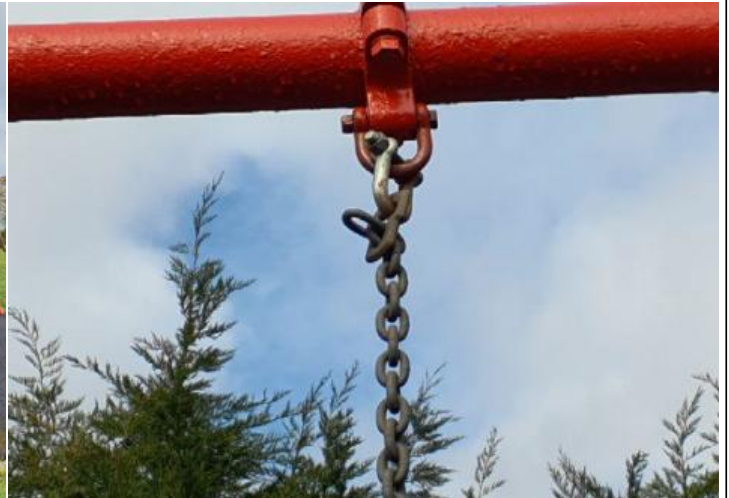
**Finding:** Crucifix or T connectors should have at least two complete chain links through the connector to meet with the manufacturers recommendations

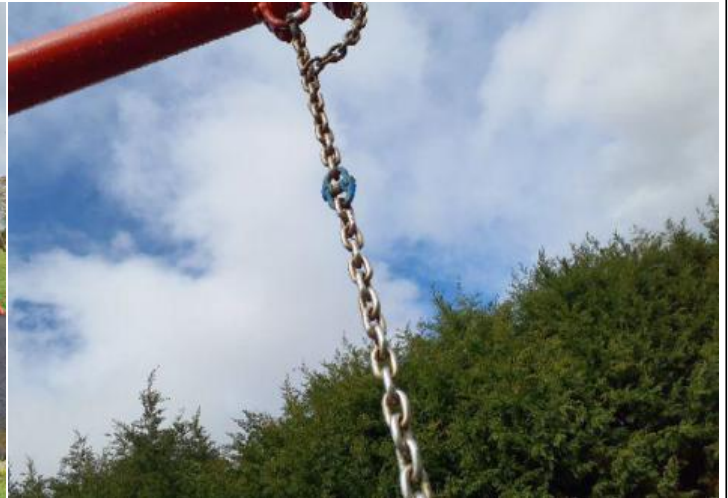
**Finding:** There is some wear to the shackles.

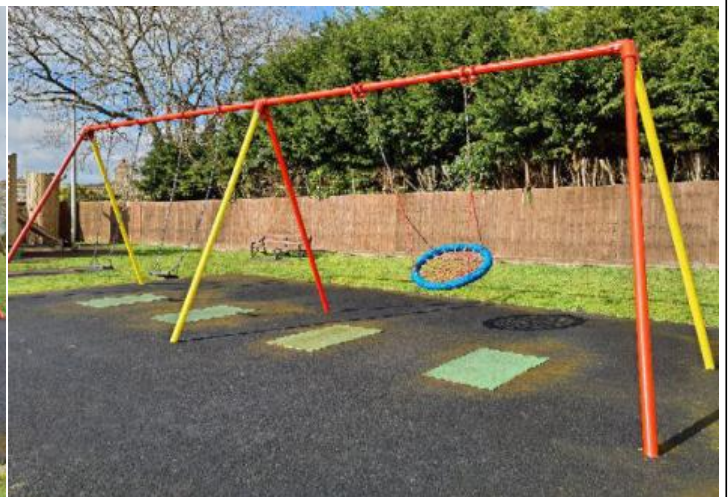
**Finding:** There is some flex in the frame when in use JD - NO

There is some flex in the frame when in use JD - NO - Monitor use and repair as required

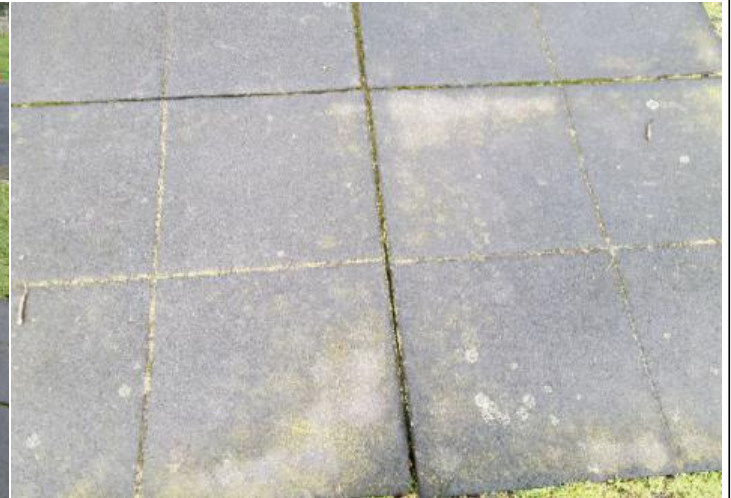
**Finding:** There are gaps opening in between the tiles

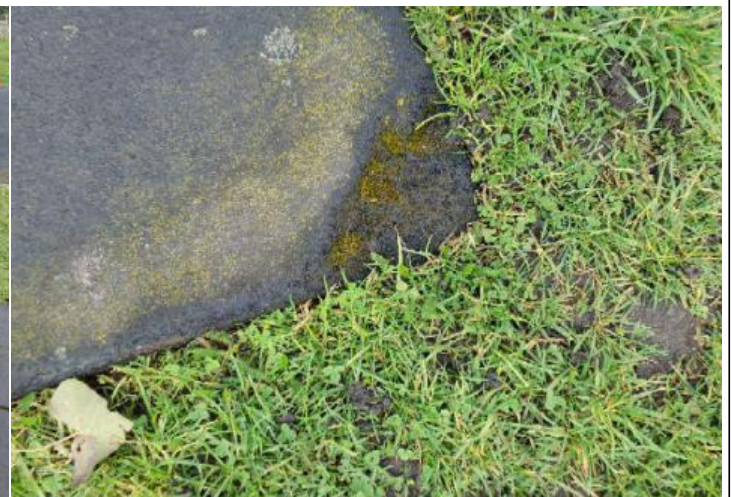
**Finding:** There is some minor damage to the surface

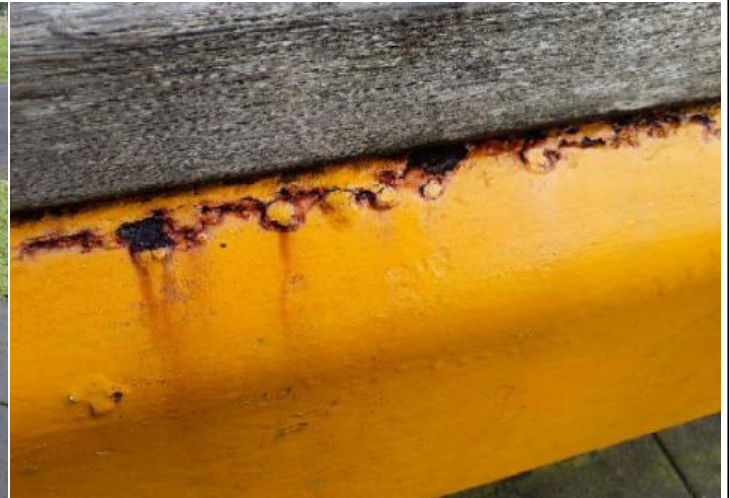
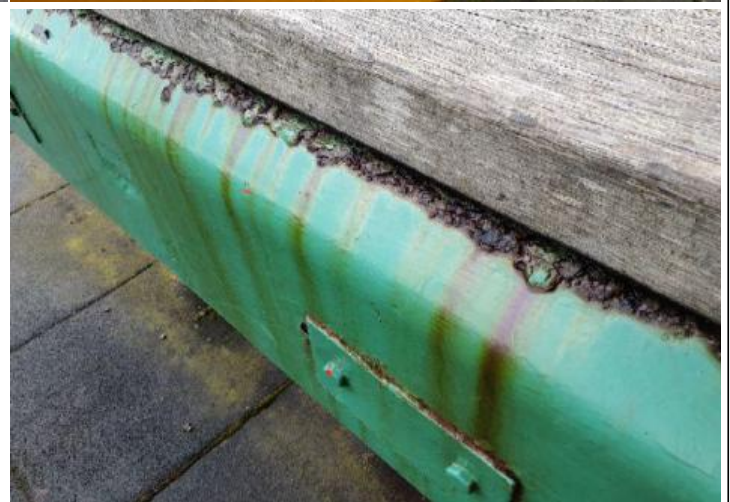
**Finding:** The paintwork on this item has been damaged or worn exposing the metal underneath which is rusting

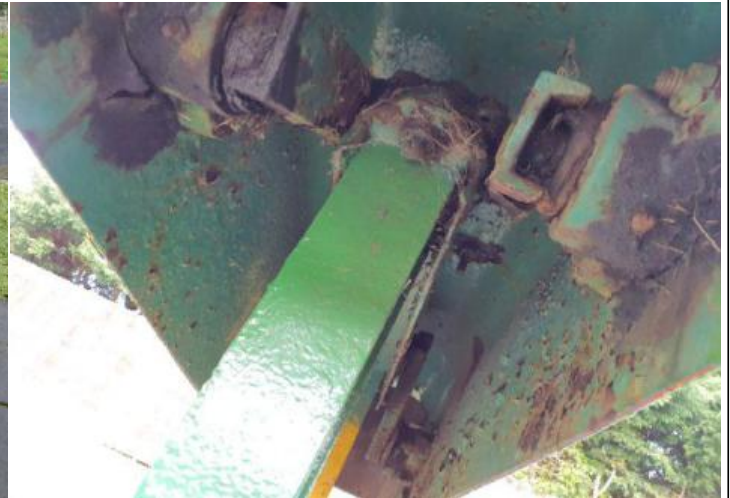
**Finding:** There is no gaiter protection for accessible moving parts (possible shear trap) as recommended in BS EN 1176 Part 1; 4.2.6 Moving Parts

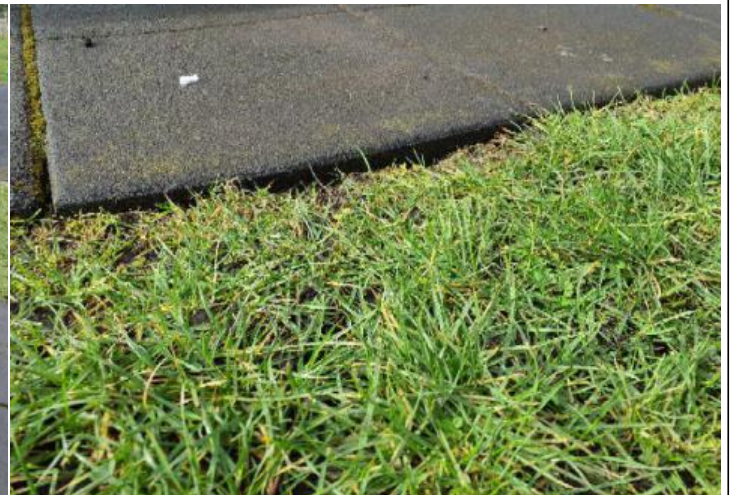
**Finding:** There are trip hazards present

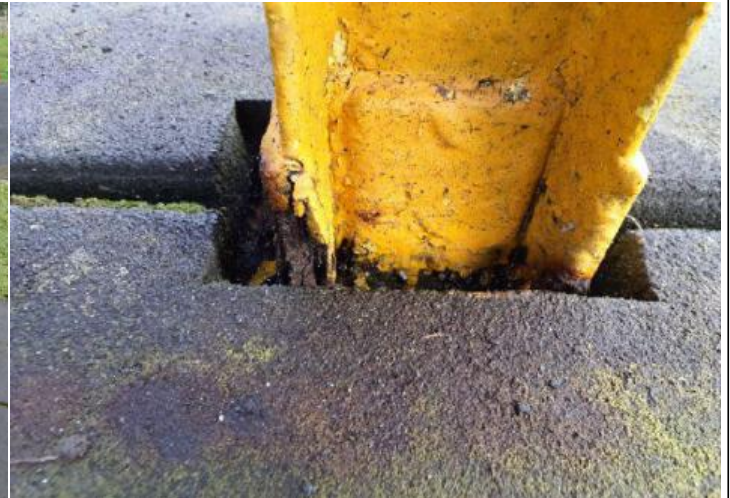
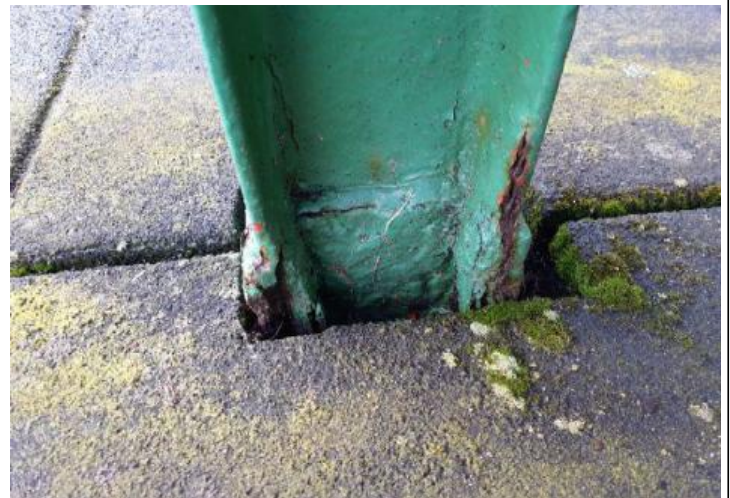
**Finding:** Parts of the steel on this item have corroded excessively

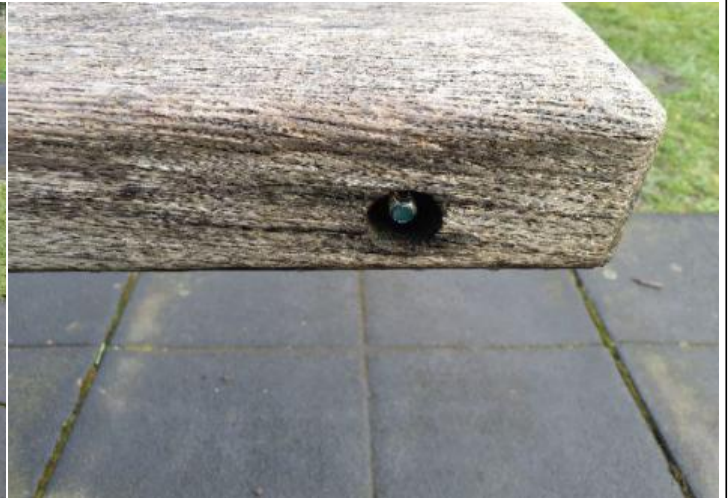
**Finding:** There is/are bolt cap covers missing or damaged on the item
