## Annual Inspection

Corfe Castle Parish Council

West Street Play Area

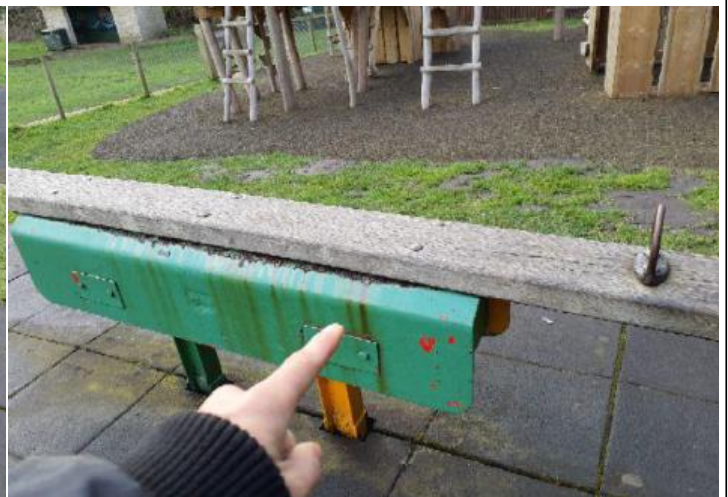
**Finding:** The mechanism is worn / damaged

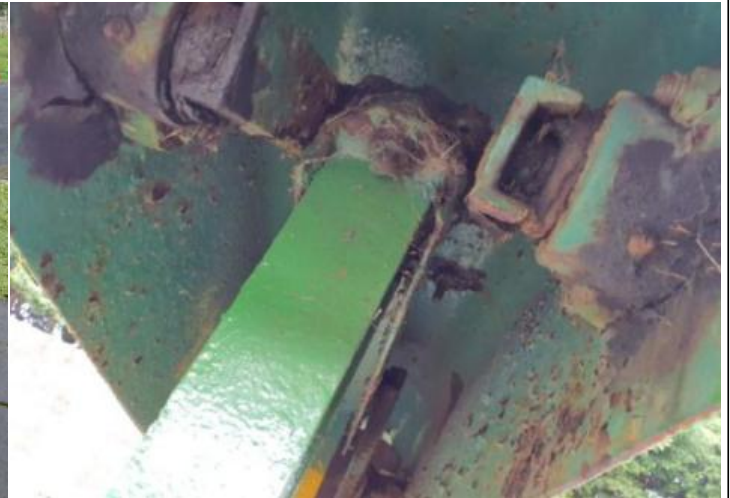
**Finding:** The weld(s) on this item have failed

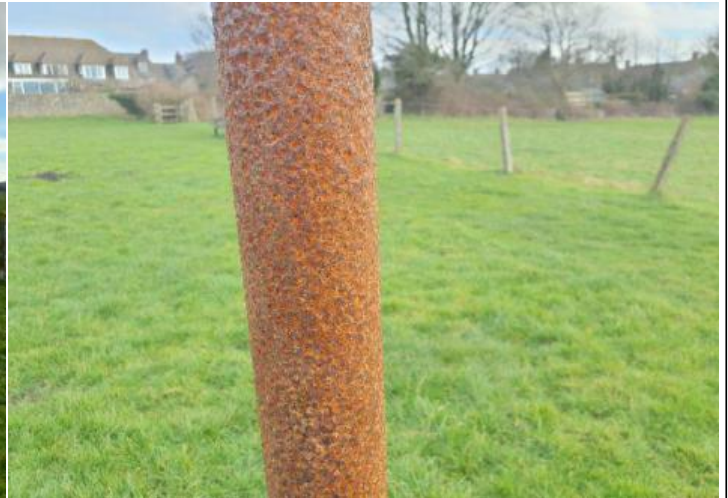
**Finding:** There is surface corrosion present on the item

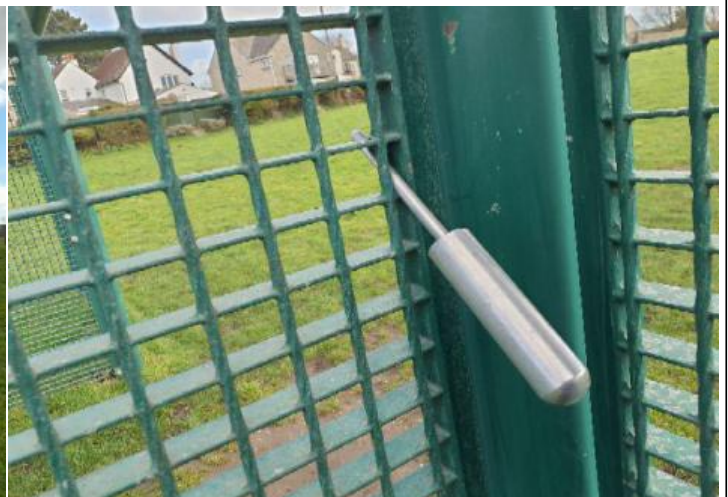
**Finding:** There is/are finger entrapments in the frame and the item fails to meet the requirements of BS EN 15312 Clause 4.4.2.2 Entrapment of fingers

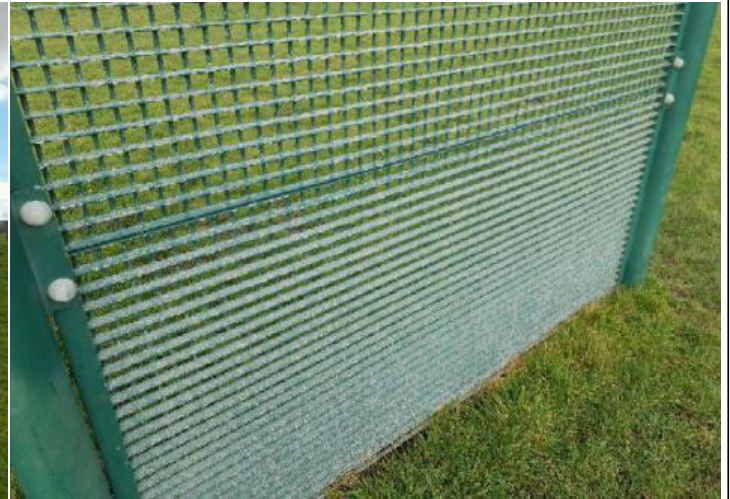
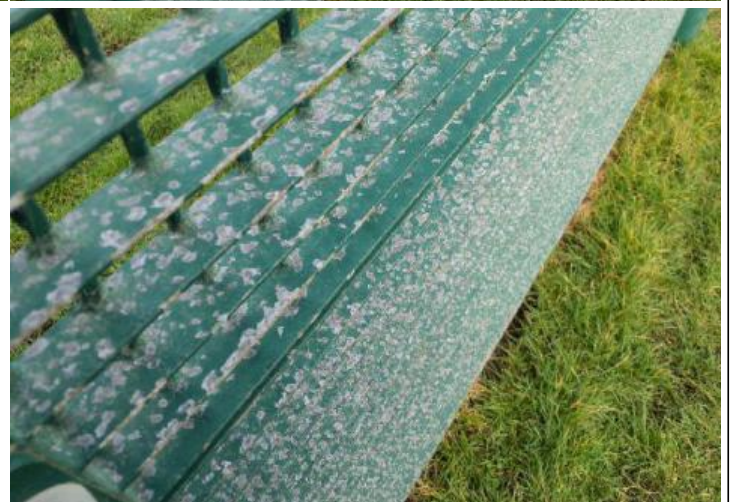
**Finding:** There is surface corrosion present on the item

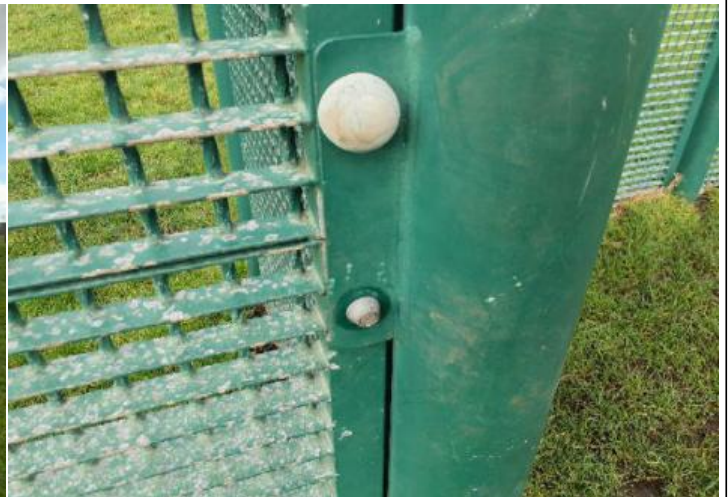
**Finding:** There is/are bolt cap covers missing or damaged on the item

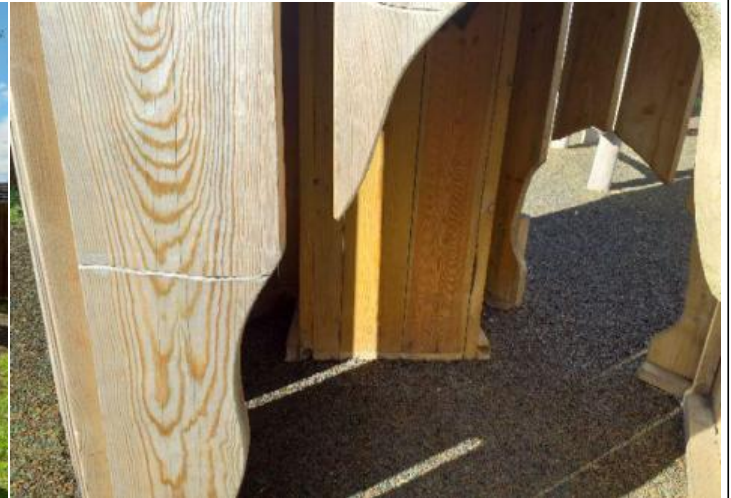
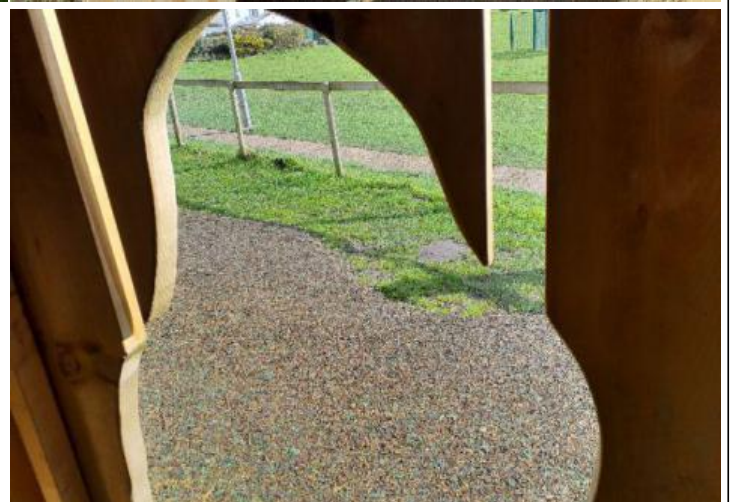
**Finding:** There are sharp edges where the barrier slats have been cut to create an entrance to below the multi-play

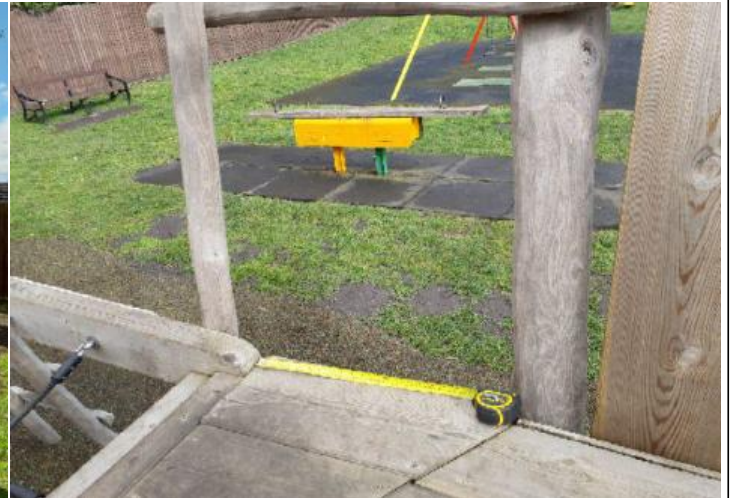
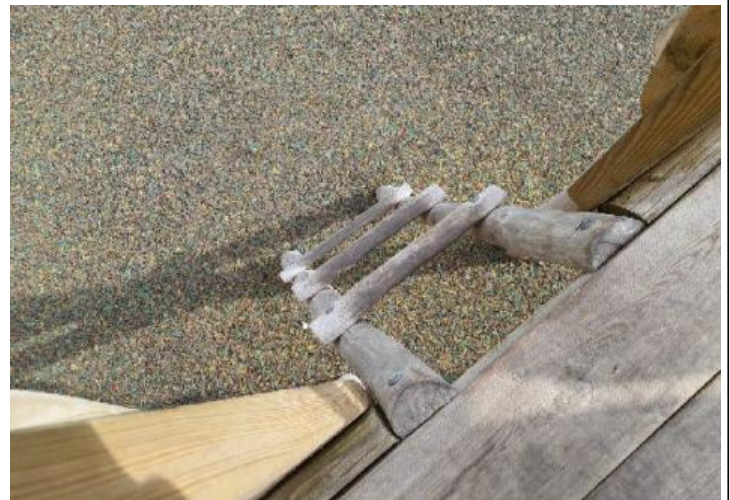
**Finding:** There is an opening in the barriers exceeding the width allowed (500mm) in BS EN 1176, this is a low risk failure and no remedial action is required
