# *PLAY AREA SAFETY INSPECTION REPORT*

## CORFE CASTLE PARISH COUNCIL

Park Name: West st. Play Area.  
Location: West st. Corfe Castle BH20 5HQ  
*///bride.conducted.pounding*

Inspection undertaken June 2023  
This report issued July 4<sup>th</sup> 2023

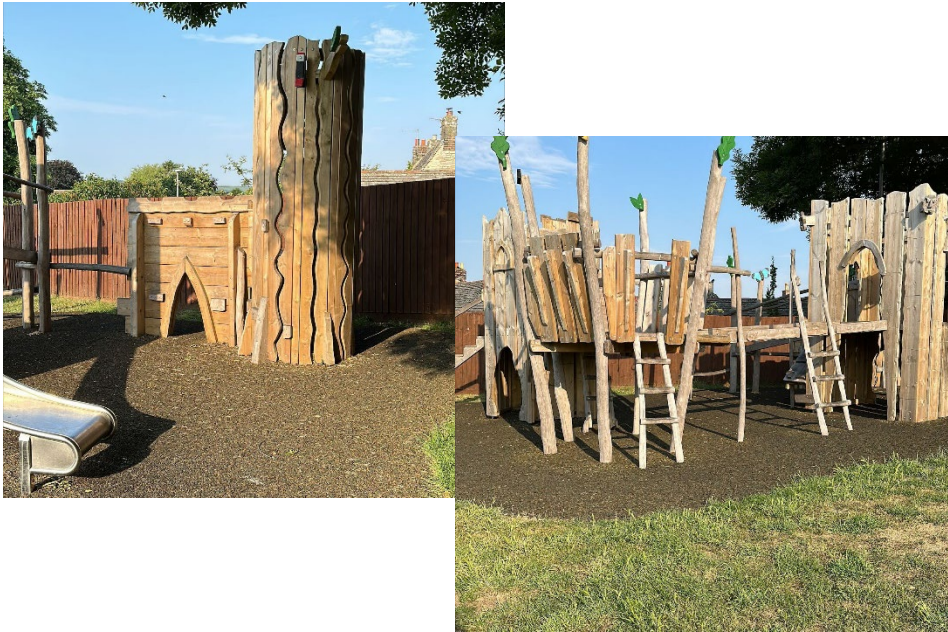
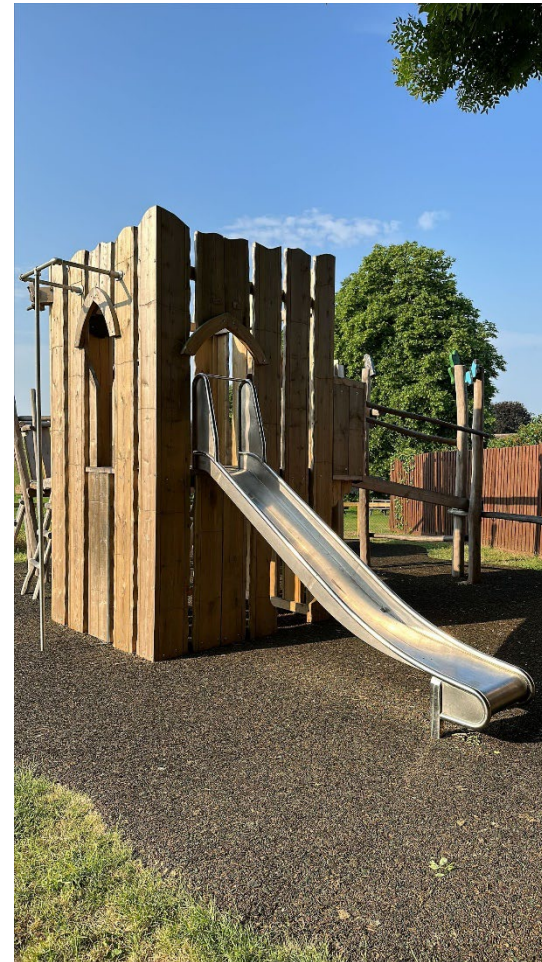
## 4.1 Twin Tower with Slide

There are some potential issues around the height of various components on the Andy Frost unit and he has been approached for a manufacturers comment.

There are no significant issues with this unit. There are areas such as the climbing pole and the traversing bridge where adherence to the guidance in BS standard EN1176 is not strictly followed - but the unit is designed to be challenging and encourage a degree of risk taking and the impact absorbent surfacing is sufficient to limit the severity of any falls.

| Item | Issue | Recommendation |
|---|---|---|
| 4.1 | Fall from height | Monitor use for any reported falls |

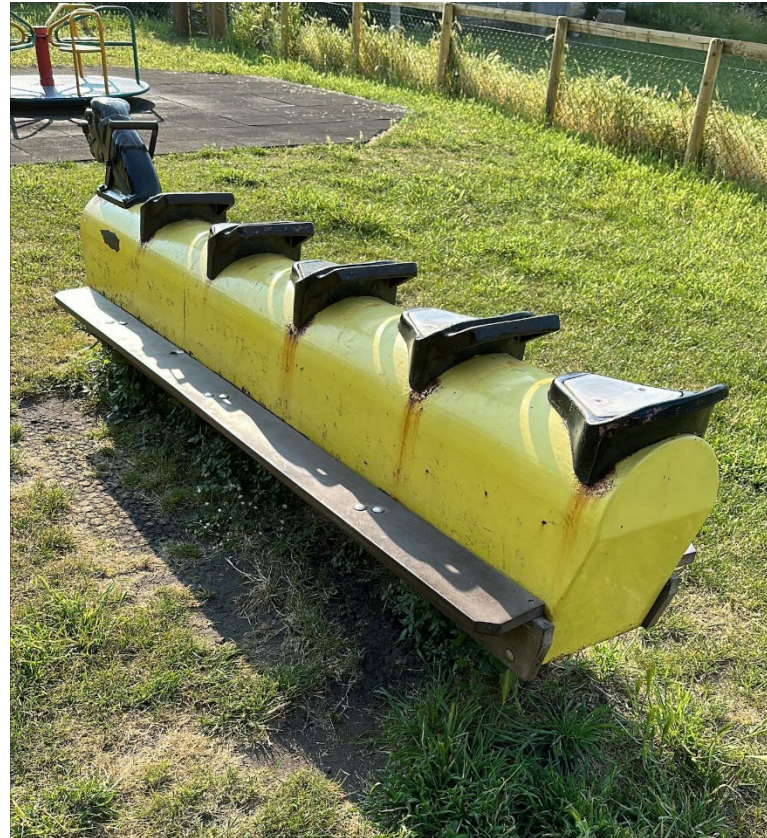
## 4.2 Wicksteed Rocking Horse See-Saw

There are no significant issues with this unit. It does not comply with BSEN1176 in various ways but is still being sold as seen by Wicksteed despite this. It has a demonstrable long and excellent safety history of over 40 years.

There is significant wear in the dampers and corrosion in the posts and so plans should be made to replace this unit over the next 2-3 years.

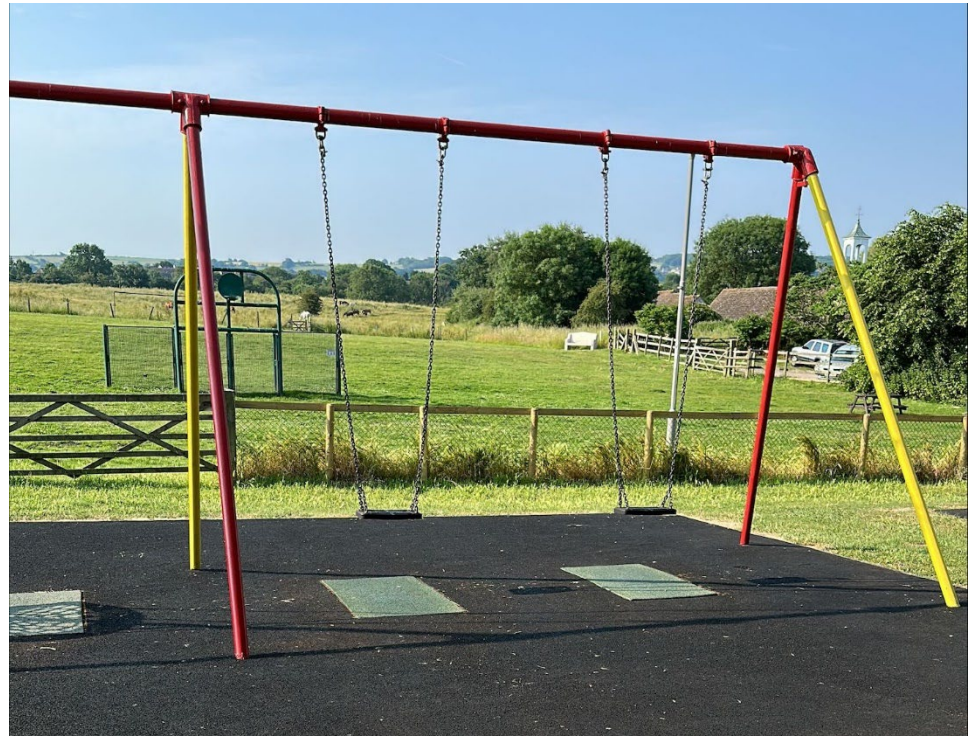
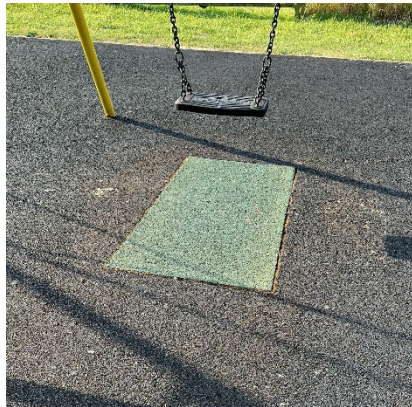
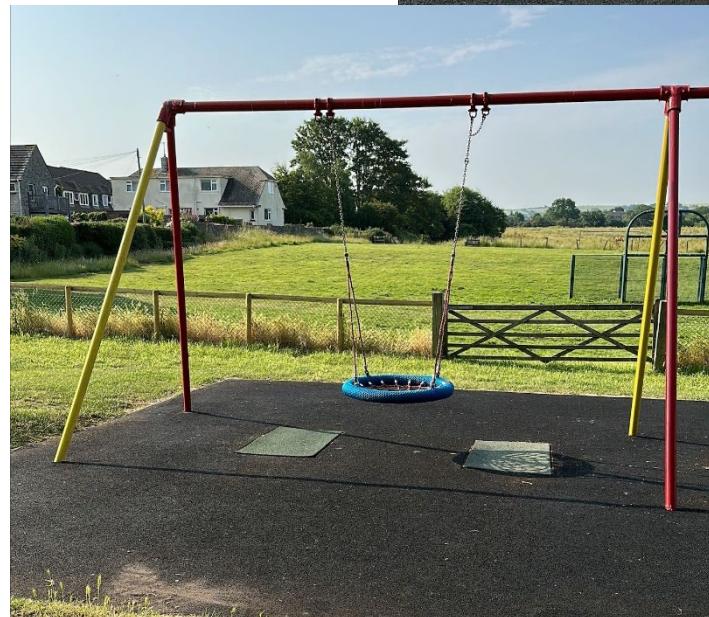
### 4.3 Wicksteed 2 Bay Swing Set

The surfacing on the two bay swing is in a poor state of repair. This could be removed entirely and laid to grass and rubber grass mat.

Although this unit is in reasonable condition the surfacing is in poor condition. Wear patches have been cut in at some point but are now loose and easily lifted. Gateway shackles have been fitted to the flat seats and these could easily be removed to minimise risk of failure.

The twist on the basket ropes was addressed during the inspection. This unit is entirely serviceable and has many years left but plans should be made to renew the surfacing – grass with grassmats is quite suitable here.

| Item | Issue | Recommendation |
|---|---|---|
| 4.3 | Gateway shackles can fail | Remove them |

| Item | Issues | Recommendation (s) | Supply Only | Supply & fit |
|---|---|---|---|---|
| 4.3 | Gateway shackles can fail | Remove, Fit standard shackles and adjust chains | | £25 |

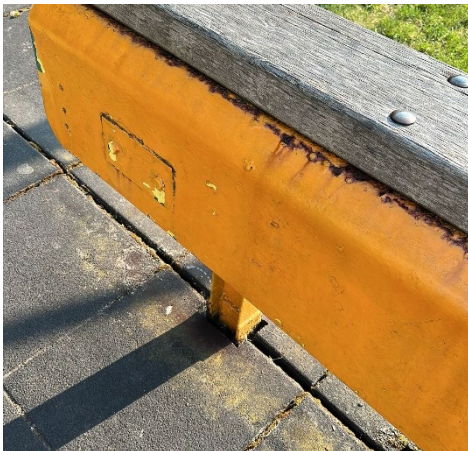
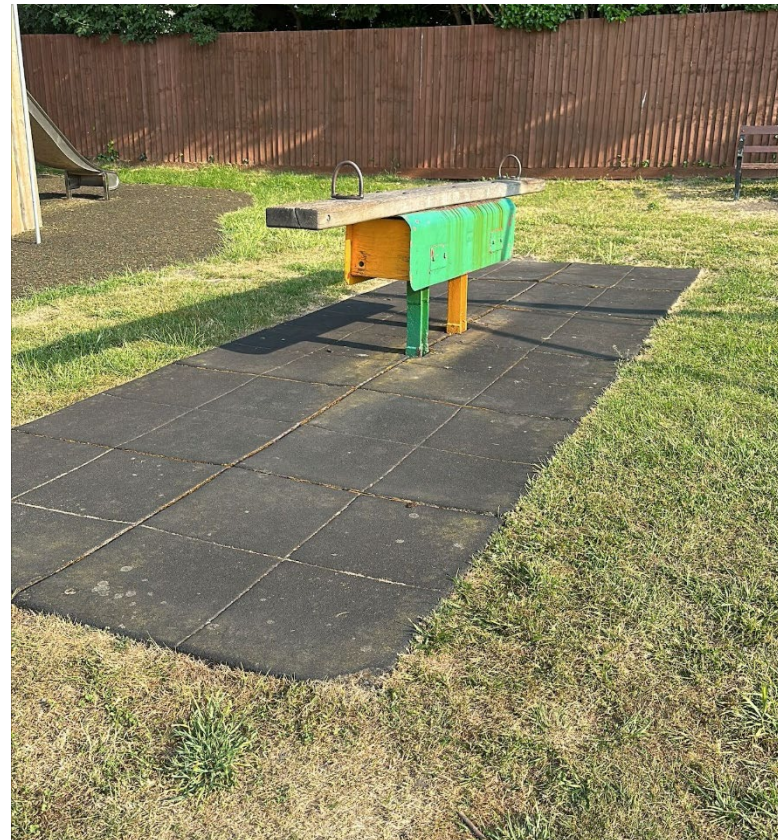
#### 4.4 Wicksteed Non-Bump See-Saw

There are no significant issues with this item.

This is an older model of the version still sold, with the wooden deck and exposed posts. The unit contains an internal damping mechanism to prevent sudden jarring and this is wearing. The unit is rusting along its casing.

Plans should be made to replace this unit over the next 2-4 years.

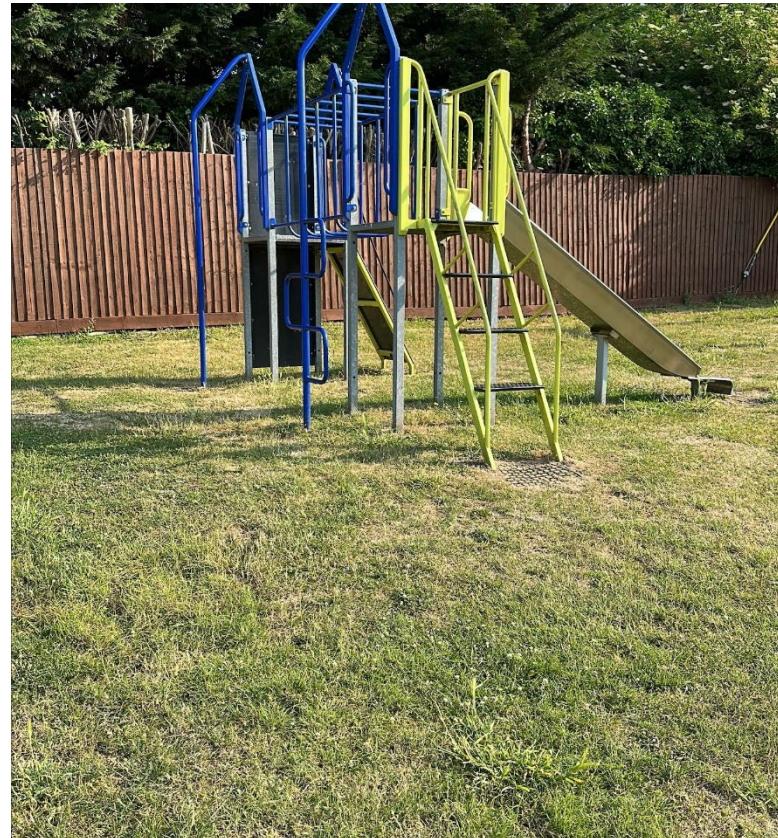
## 4.5 SMP Multi-play unit

There are no significant issues with this unit.

There is surface corrosion on some fittings and more extensive corrosion on some nuts. These should be monitored and replaced as necessary.

Previous reports have commented on unused fixing holes. These units were manufactured in component form with a number of possible configurations. The manufacturer ceased to exist many years ago and the holes are not an issue.

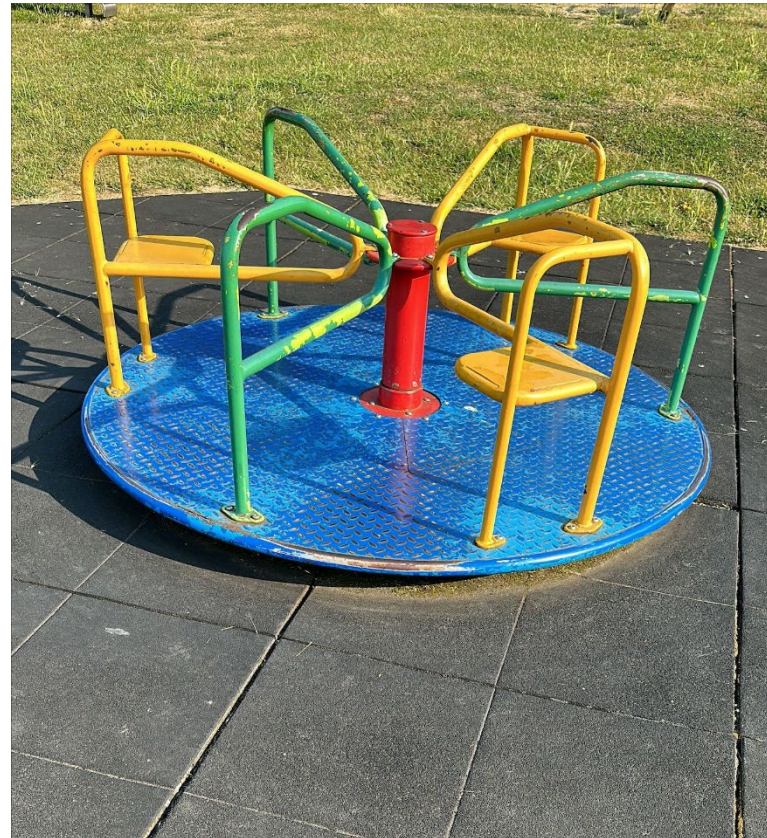
## 4.6 Wicksteed Rotaplay

There are several minor issues with this unit.

The fittings cannot be tightened on the handrails as they are seized.

The surfacing is worn but does not impact on safety.

There is some lateral movement suggestive of bearing wear. However, this unit and its parts are no longer manufactured. Units with limited bearing wear may persist for many years. If the wear becomes excessive then plans will need to be made to replace it.

There is quite significant corrosion on the spindle which is a load bearing element and there is a probability that this will be present in areas that are not visible.

Plans should be made to replace this unit in 1-5 years.

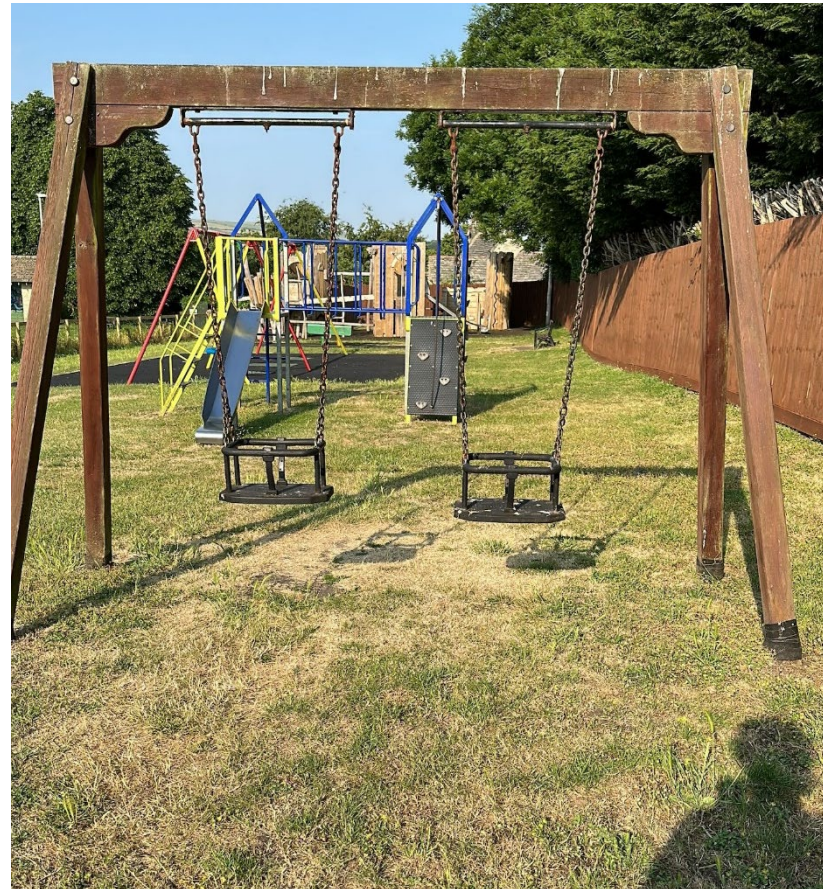
## 4.7 Taylor Made Toddler Duo

The timber toddler swing is at the point where it could fail and should be removed.

There are various issues with this unit.

The wooden posts installed into the ground will have significant decay.

The seats have internal corrosion and require replacement.

There is corrosion on the bearing bar.

The timber is decaying and splitting around the crossbar supports and these could easily fail.

There are no repairs possible on this unit and it has come to the end of its useful life.

| Item | Issue | Recommendation |
|---|---|---|
| 4.7 | Beyond maintenance | Remove |

Plans should be made to replace it within the next 6 months.  
There is space here for a replacement unit.

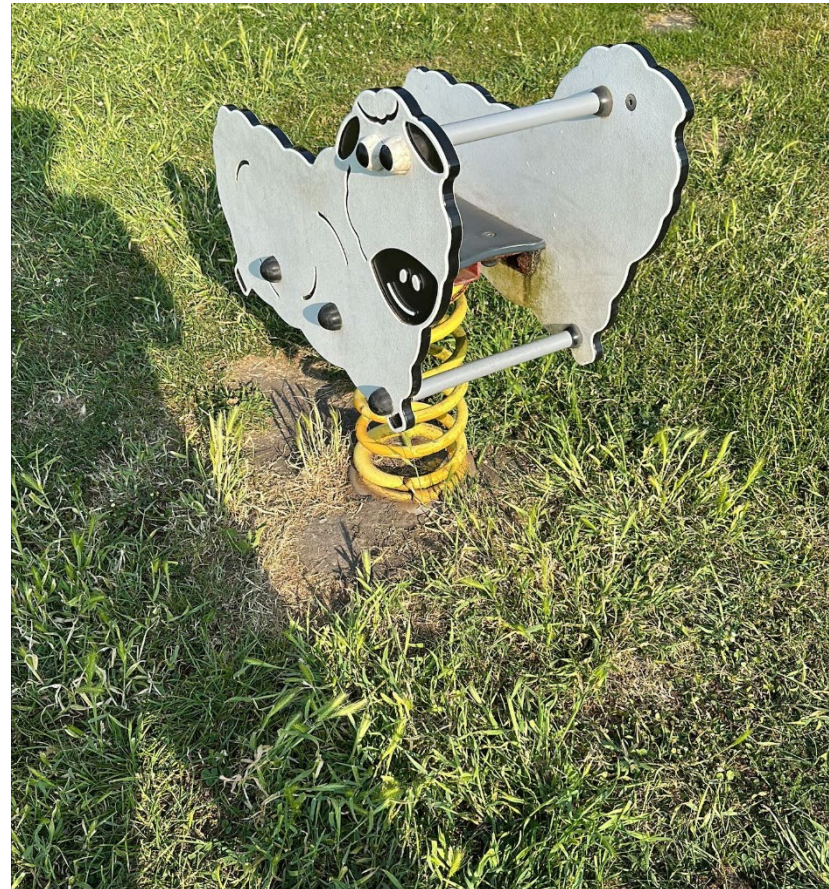
## 4.8 Fahr Baa (Sheep) Springer

The item was slightly loose in its mountings but was tightened during the inspection.

There is corrosion on the mounting plate, but the body is sound. The mounting plate, spring, and buried ground frame are all replaceable when required. Currently it should be monitored and may need repairs within the next 18 months to two years.

There are no other significant issues.

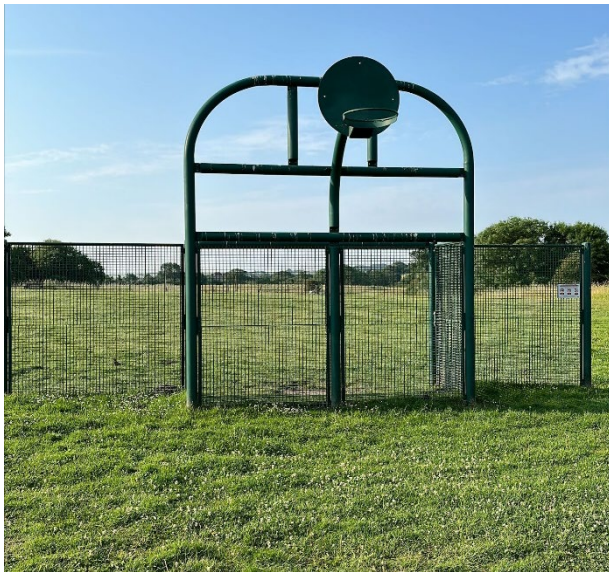
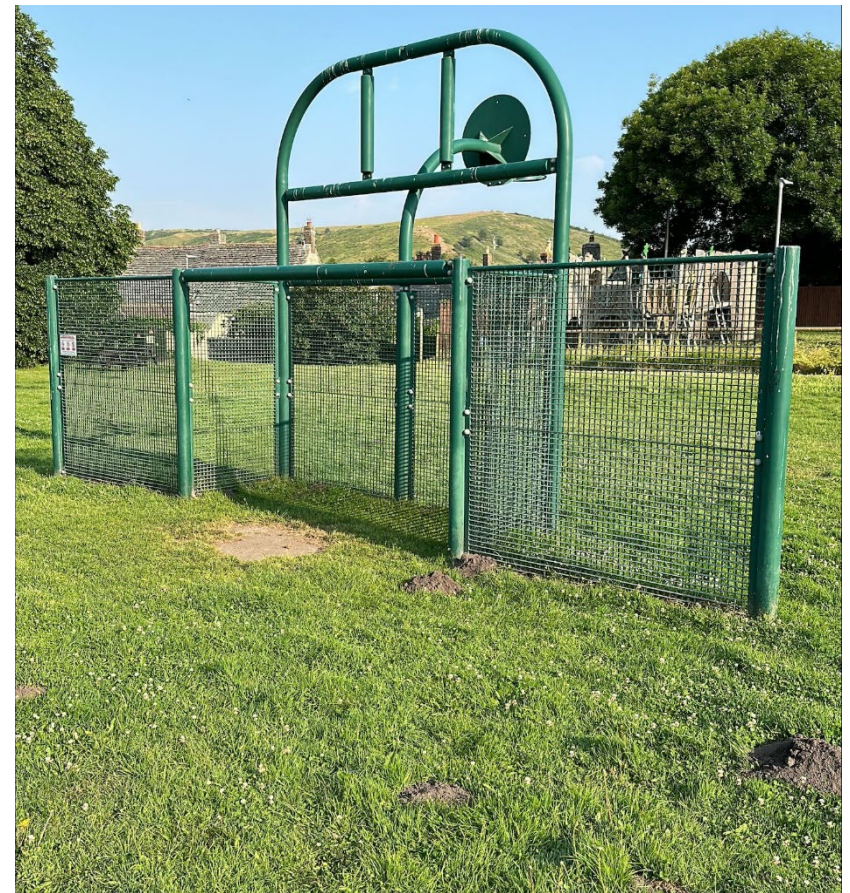
## 4.9 MUGA Goal End

Powder coating on the MUGA end is failing and given the location this means that it will corrode quickly. The panels are of a size where re-coating is a relatively inexpensive process, and this should be considered to protect the capital asset.

There are no significant issues with this item other than the failure of the powder coating. This is fairly inexpensive to remedy and it is worth contacting a local provider to quote for this. As an asset the unit comprises a significant investment and with the correct protection against corrosion will last a further 25 years.

The manufacturer should be identified – normally rebound panels would be expected behind the hoop and backboard but these are not present. It may be that they are missing or were never fitted. If fitted they would improve the play value.

The item has no fall height and cannot be climbed. There is no forced movement and therefore no finger entrapment.

| Item | Issue | Recommendation |
|---|---|---|
| 4.9 | Powder coating failing | Re-powder coat panels |

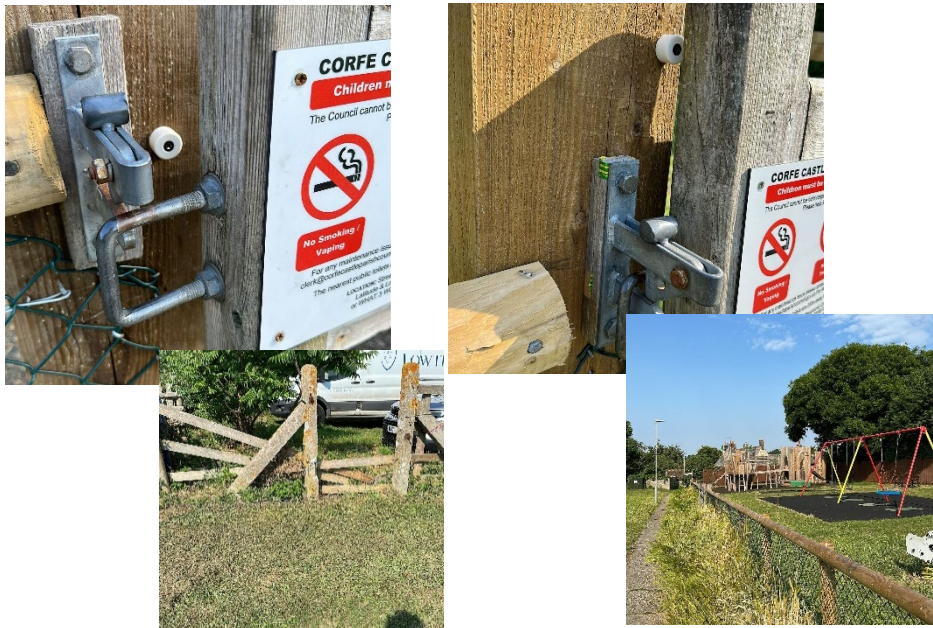
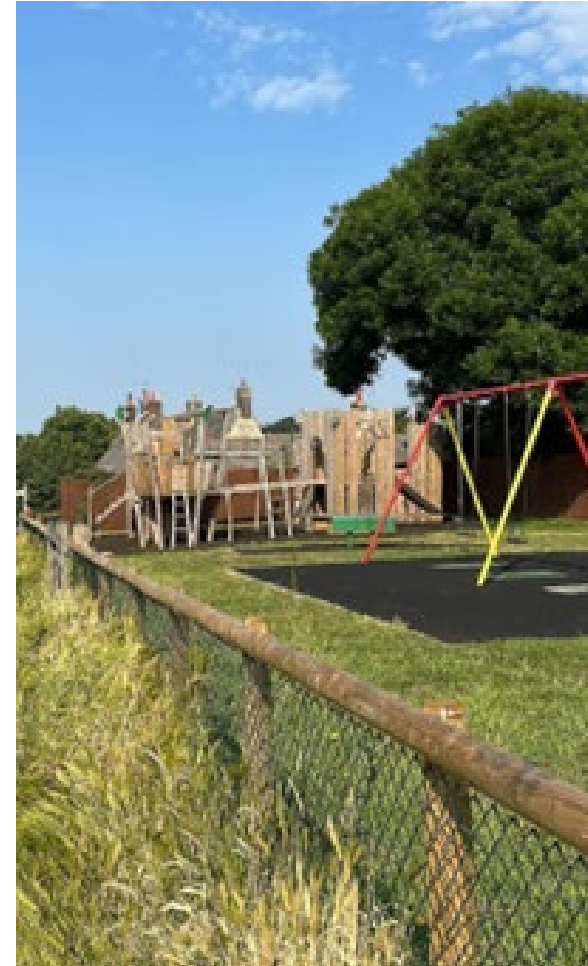
## 4.10 Fencing & Gates

There is an untidy and damaged section of fencing and old gateway near the parking area. This has the potential to cause minor injury and could also encourage anti-social behaviour by signalling an acceptance of neglect. It should be tidied up.

Both gates were fitted with spacers during the inspection and are otherwise in reasonable condition.

The right-hand gate was adjusted to close correctly.

The post and rail fence with mesh infill is in reasonable condition.

There is a timber feather edge fence in good condition to the rear.

There is a section of fencing in a state of disrepair next to the parking area which could pose a minor hazard.

| Item | Issue | Recommendation |
|---|---|---|
| 4.10 | Damaged area by car park | Repair /Tidy up broken sections |

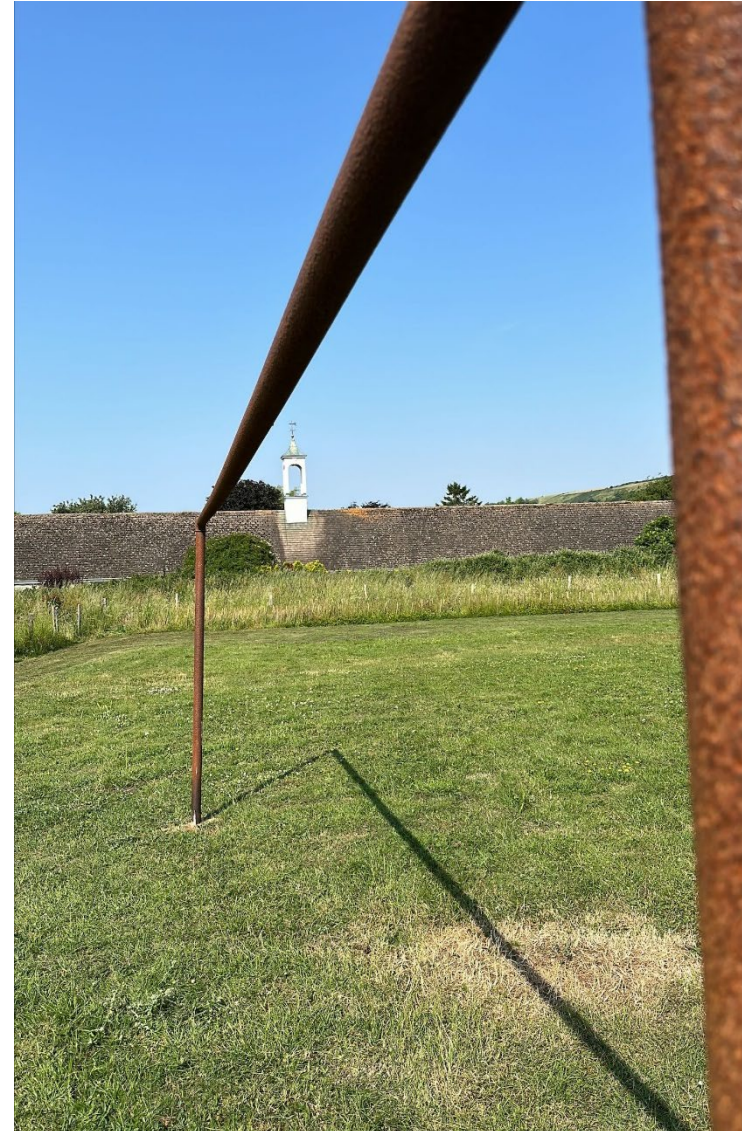
## 4.11 Goal

There is a single 21 x 7 socketed goal in the recreation area.  
This is untreated with significant surface corrosion.  
Deflection is within expected norms but the goal predates the current standards.  
There are no obvious issues.

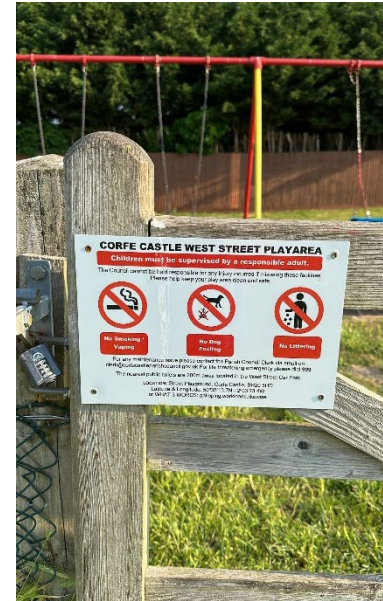
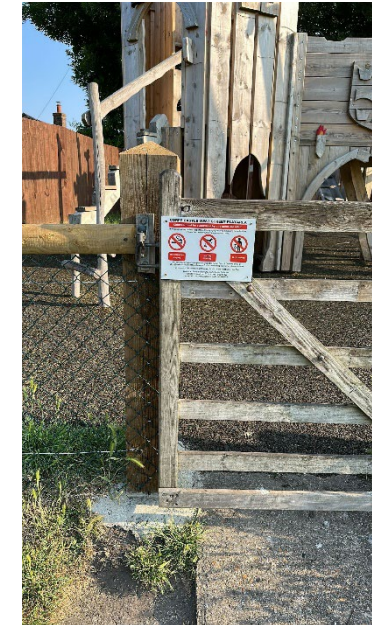
## 4.12 Signage

The Covid sign must be removed as there is no need for it, and it reduces the impact when such a warning is required.

There is clear sign displaying operator & emergency contact details and location information and this is displayed in several locations.

There is a sign for Covid Controls which should be removed.

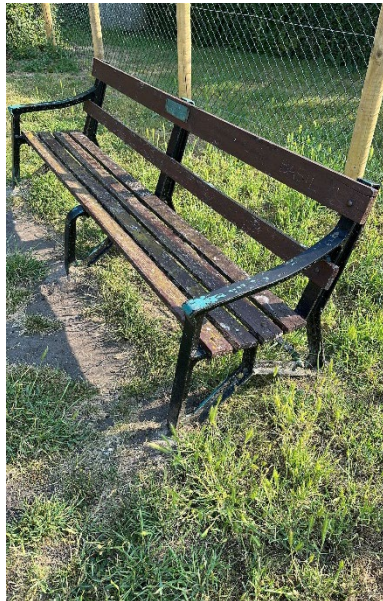
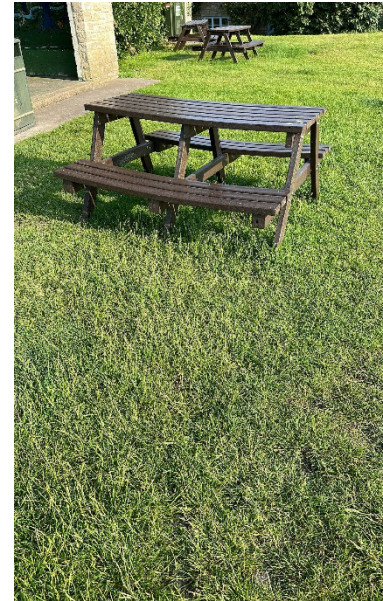
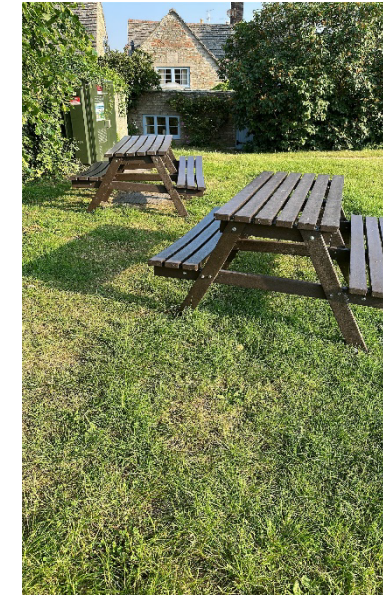
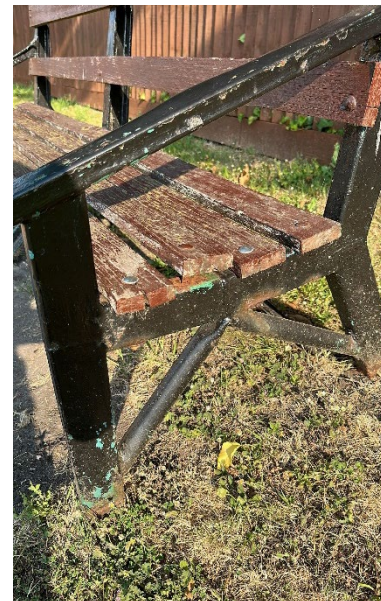
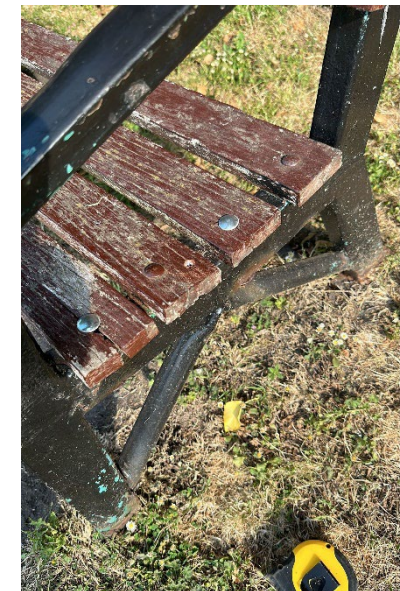
## 4.13 Seating

The picnic tables are twisting and causing additional load on the fixings as well as deforming the plastic. They will last much longer if installed onto solid bases.

Timbers should be regularly treated to prevent decay – the two benches are overdue for this.

There are three picnic tables of reclaimed plastic. These could do with being set on firmer bases as they becoming distorted by being placed on uneven ground which in turn is loosening the fixings.

There are two wooden benches on metal frame. A lath on one bench was loose and reattached during the inspection. Both benches are in need of a preservative treatment.

| Item | Issue | Recommendation |
|---|---|---|
| 4.13 | Untreated timber | Treat timbers |
| 4.13 | Unsupported tables | Provide bases |

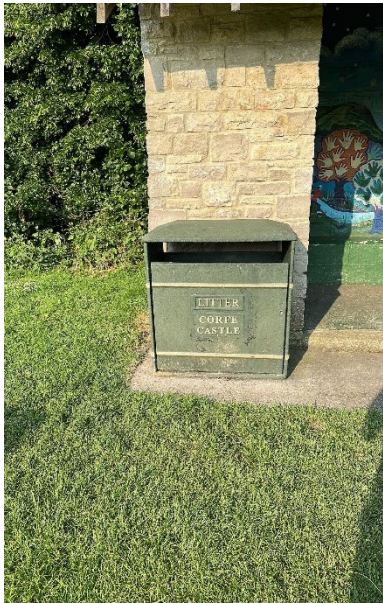
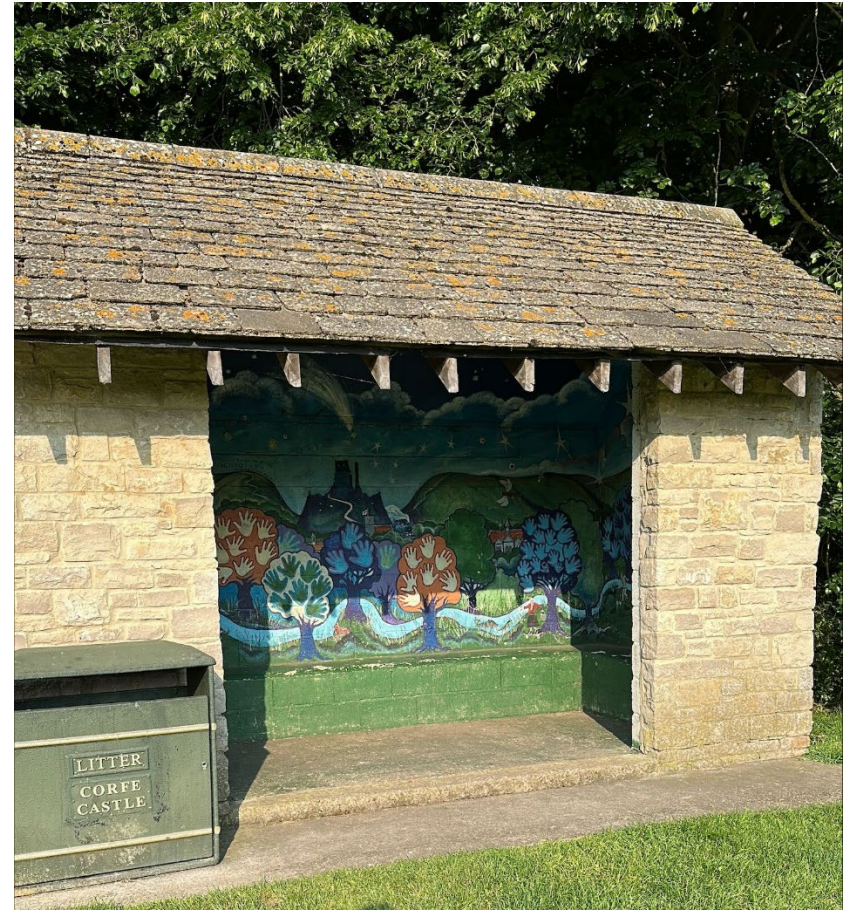
## 4.14 Ancillaries

There is stone built shelter with cast seating. There are no obvious issues with this structure.

There is a refuse bin adjacent to the shelter and there are no obvious issues with the bin.
