# *PLAY AREA SAFETY INSPECTION REPORT*

## CORFE CASTLE PARISH COUNCIL

Park Name: West st. Play Area.  
Location: West st. Corfe Castle BH20 5HQ  
*///bride.conducted.pounding*

Inspection undertaken September 2023  
This report issued September 20<sup>th</sup> 2023

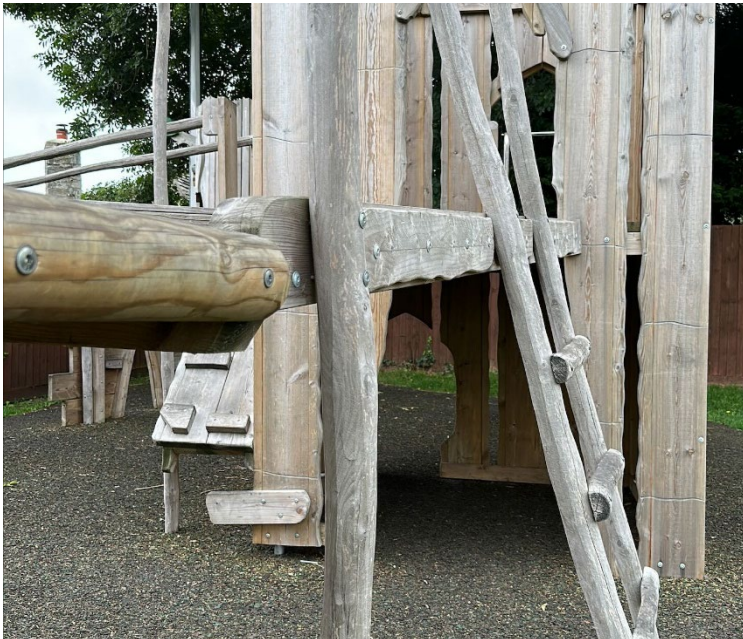
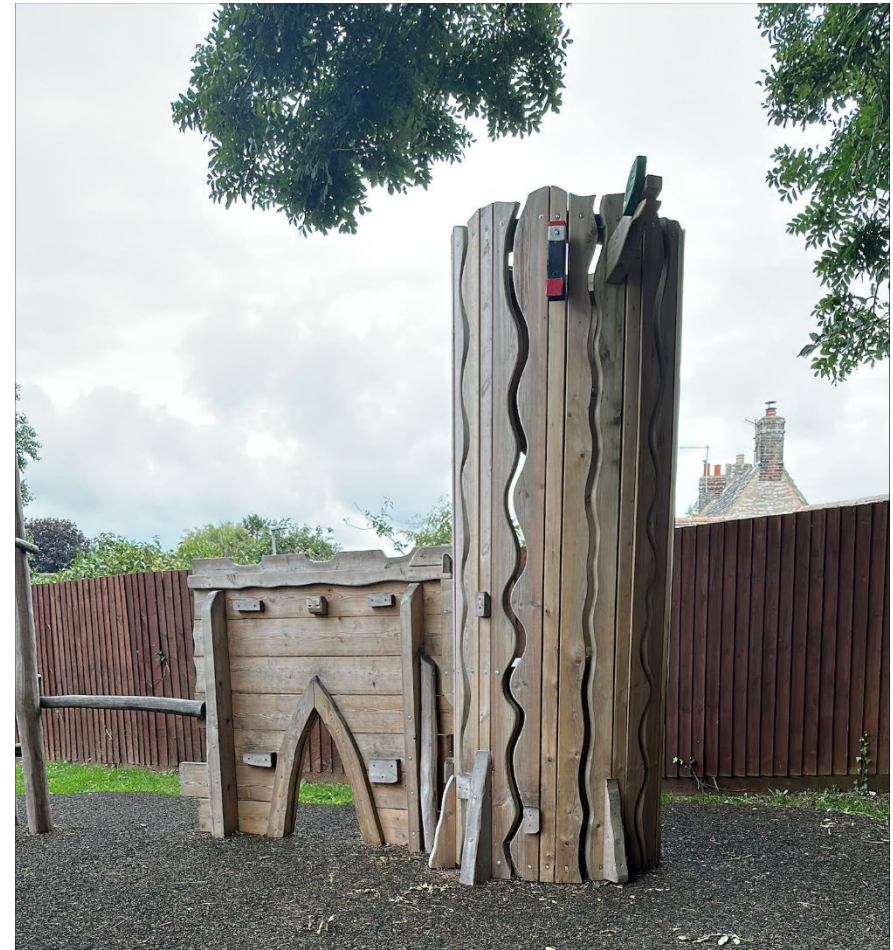
## 4.1 Twin Tower with Slide

| Item | Issue | Recommendation |
|---|---|---|
| 4.1 | Fall from height | Monitor use for any reported falls |

There are no significant issues with this unit.

The unit is designed to have challenging elements and as such the higher-level components are not easily accessible. As with any such unit there is a higher risk level associated with its use, but this is within acceptable limits and suitable controls are present.

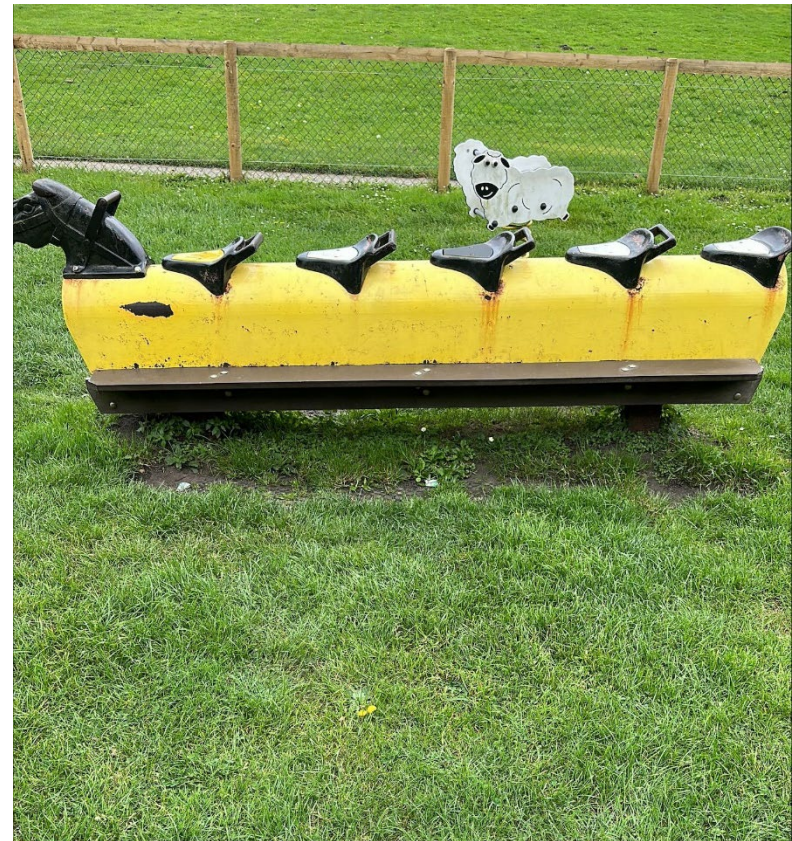
## 4.2 Wicksteed Rocking Horse See-Saw

There is significant wear in the dampers and corrosion in the posts and so plans should be made to replace this unit over the next 2-3 years.

There are no other significant issues.

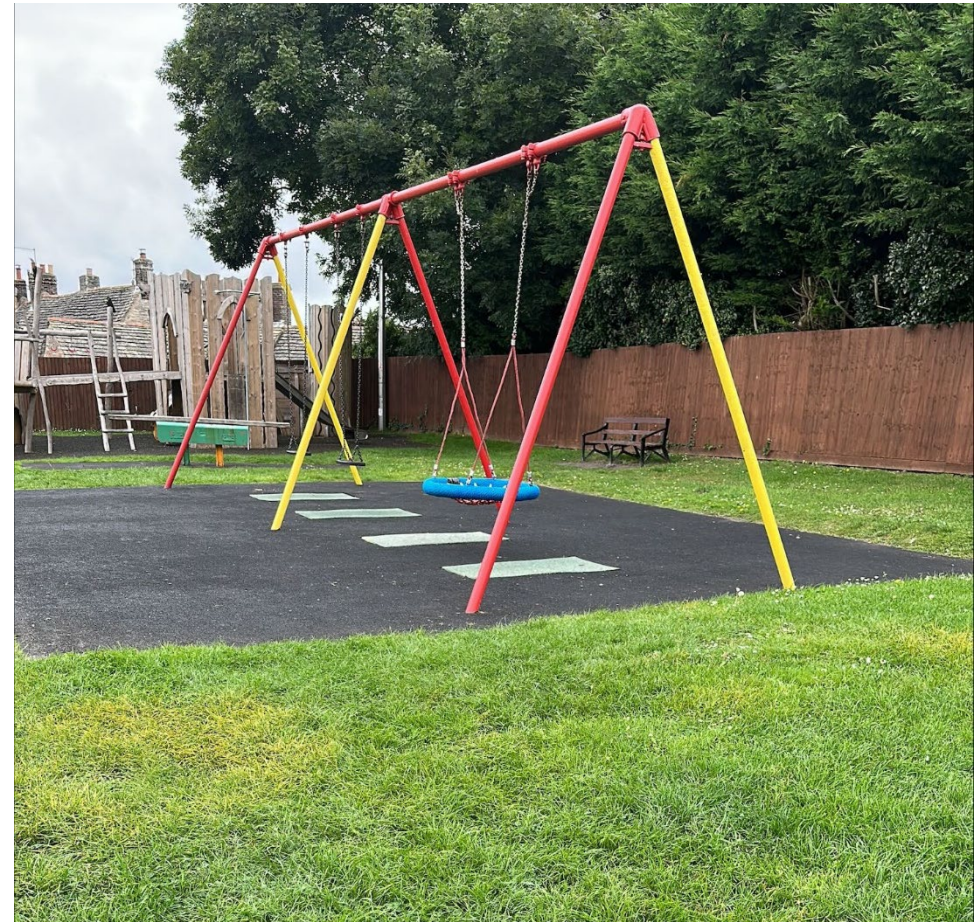
### 4.3 Wicksteed 2 Bay Swing Set

| Item | Issue | Recommendation |
|---|---|---|
| 4.3 | Gateway shackles can fail | Remove them |

The surfacing on the two-bay swing is in a poor state of repair.

There are no significant issues with this unit other than the surfacing (see Q2 report).

The flat seats are secured with gateway shackles. There are no significant issues affecting these, but they do have a lower tolerance than more traditional shackles and could be replaced if required.

| Item | Issues | Recommendation (s) | Supply Only | Supply & fit |
|---|---|---|---|---|
| 4.3 | Gateway shackles can fail | Remove, Fit standard shackles and adjust chains | | £25 |

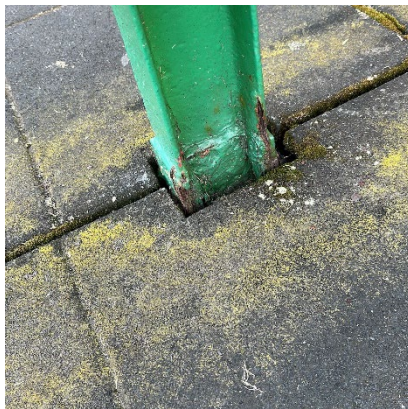
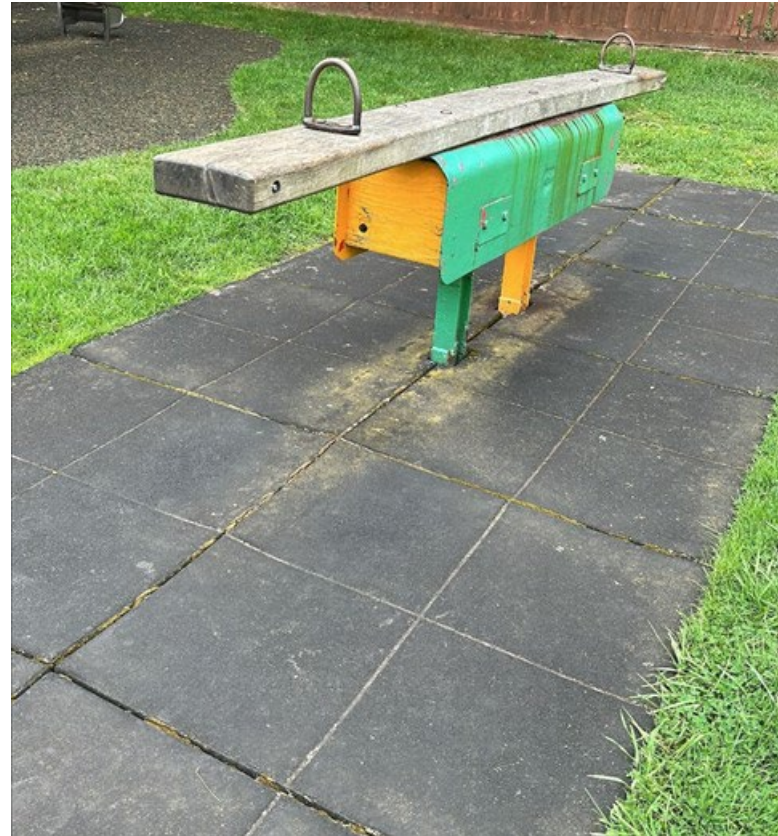
#### 4.4 Wicksteed Non-Bump See-Saw

There are no significant issues with this item other than age and corrosion.

Plans should be made to replace this unit over the next 2-4 years.

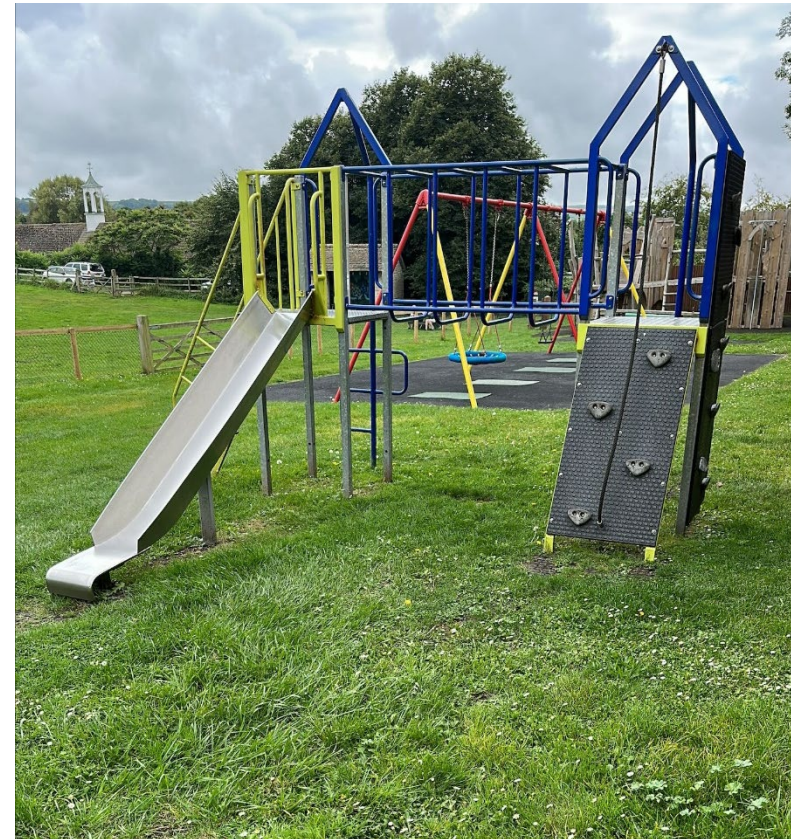
#### 4.5 ***SMP Multi-play unit***

There are no significant issues with this unit.

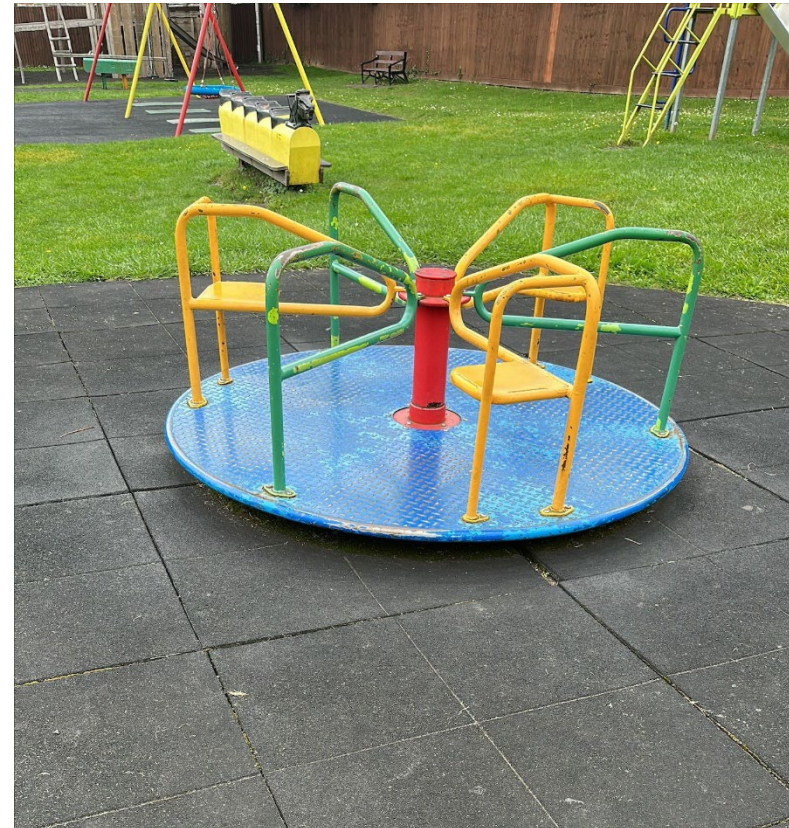
## 4.6 Wicksteed Rotaplay

There are several minor issues with this unit (see Q2 Report) which remain unchanged. .

There are no new or significant issues.

Plans should be made to replace this unit in 1-5 years.

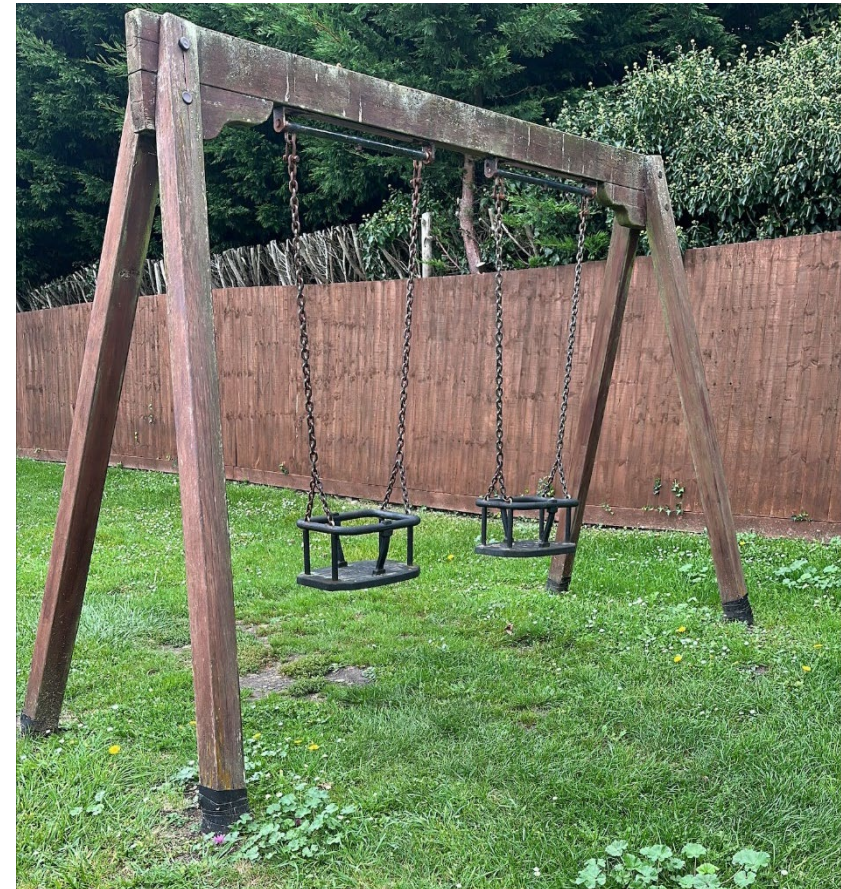
## 4.7 Taylor Made Toddler Duo

| Item | Issue | Recommendation |
|---|---|---|
| 4.7 | Beyond maintenance | Remove |

The timber toddler swing is at the point where it could fail and should be removed / replaced.

There are various issues with this unit (see Q2 report).

There are no new issues.

Plans should be made to replace it when reasonably practicable.

There is sufficient space here for a replacement unit.

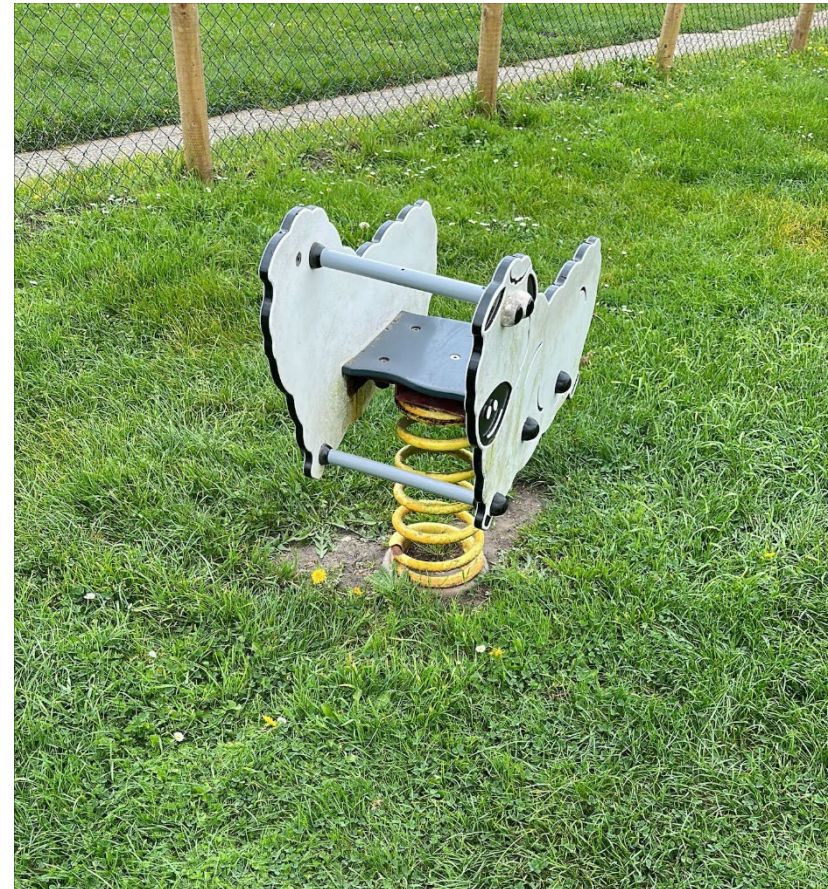
## 4.8 *Fahr Baa (Sheep) Springer*

There are no significant issues.

There is no notable change to the level of corrosion previously reported.

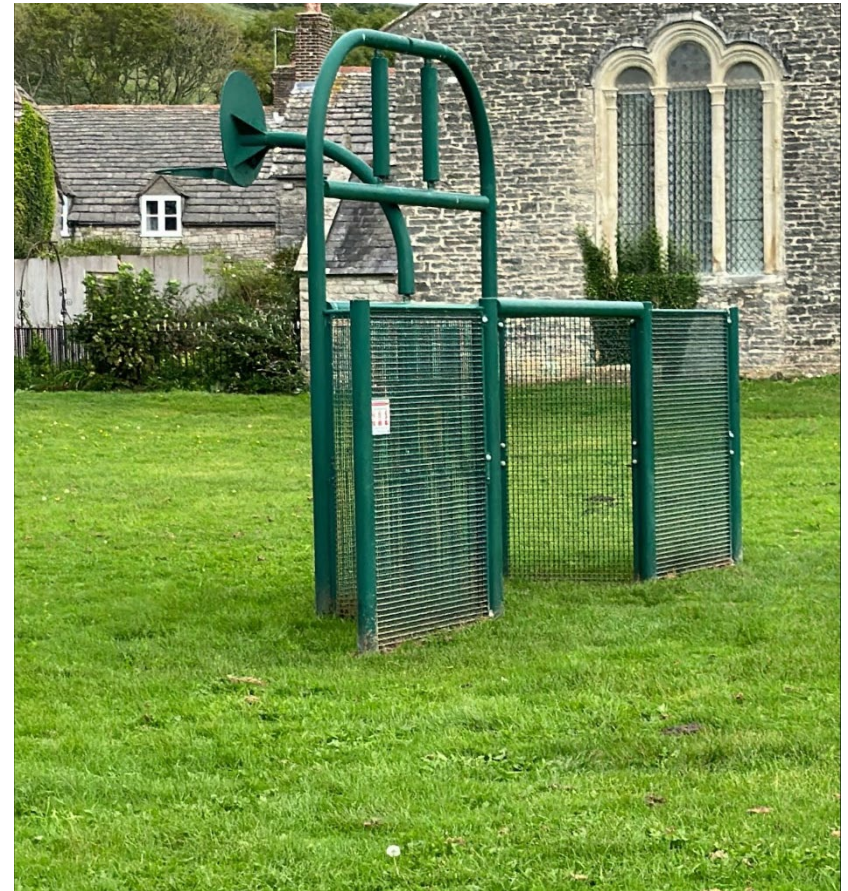
## 4.9 MUGA Goal End

| Item | Issue | Recommendation |
|---|---|---|
| 4.9 | Powder coating failing | Re-powder coat panels |

Powder coating on the MUGA end is failing.

There are no issues with this unit other than the condition of the powder coating previously reported.

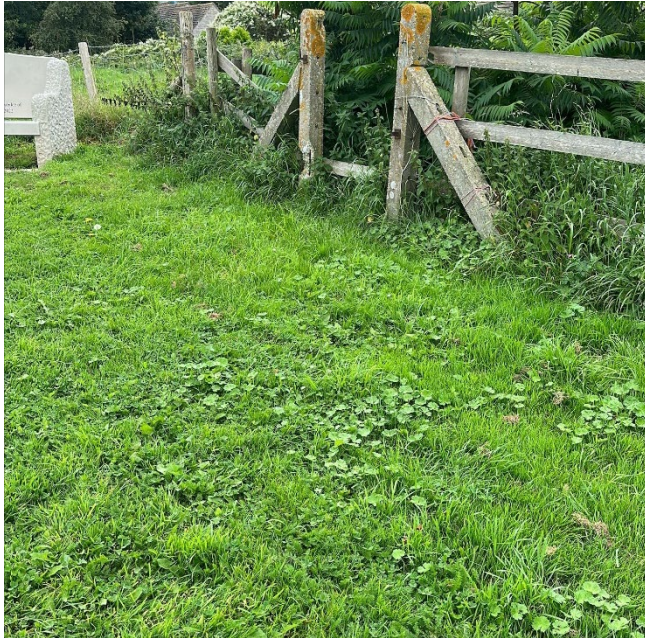
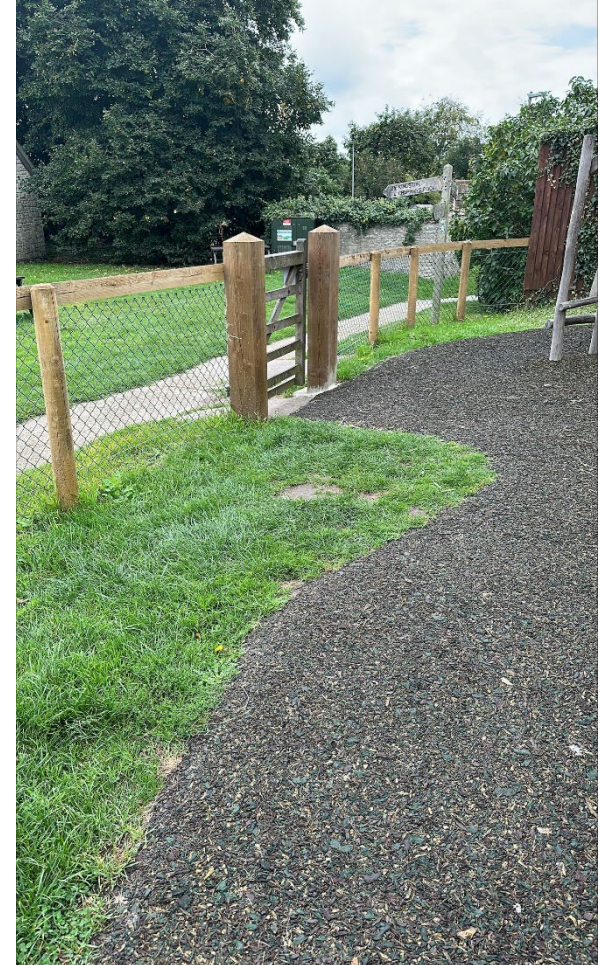
## 4.10 Fencing & Gates

| Item | Issue | Recommendation |
|---|---|---|
| 4.10 | Damaged area by car park | Repair /Tidy up broken sections |

There are no significant issues with the gates or most of the fencing.

There is a section of fencing in a state of disrepair next to the parking area which could pose a minor hazard.

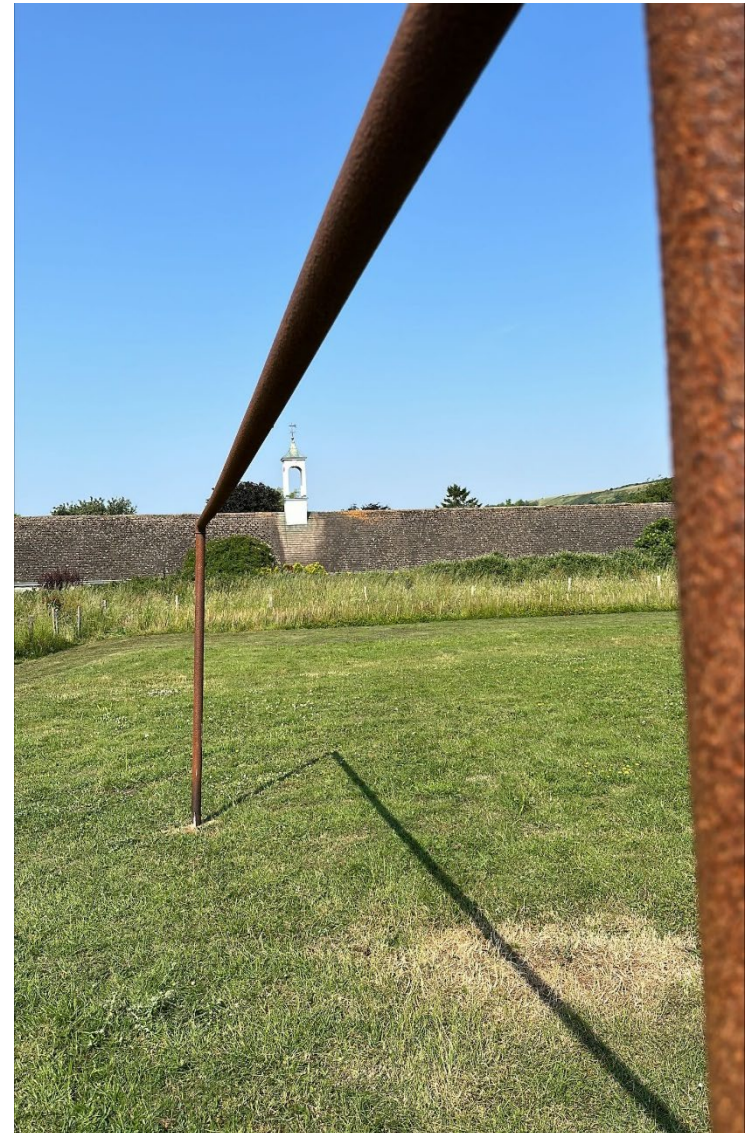
## 4.11 Goal

There are no obvious issues other than the poor surface condition of this item and its visual impact.

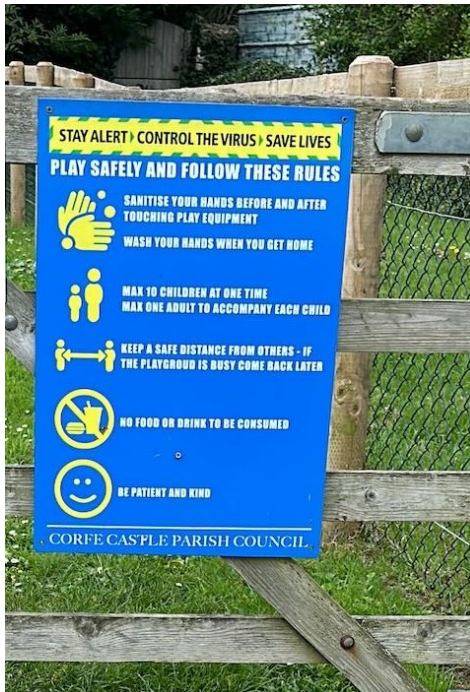
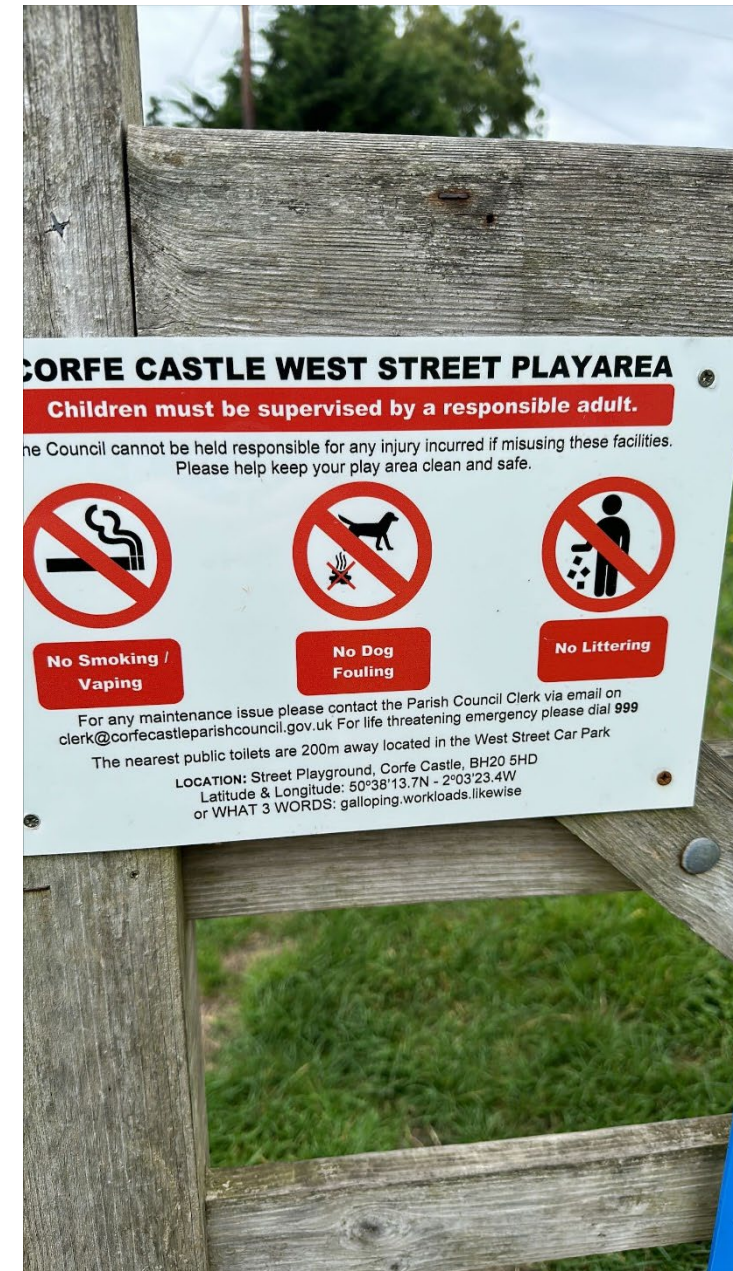
## 4.12 Signage

The Covid sign must be removed as there is no need for it, and it reduces the impact when such a warning is required.

There is a sign for Covid Controls which should be removed as it carries guidance which neither relevant or correct.

There is clear sign displaying operator & emergency contact details and location information and this is displayed in several locations.

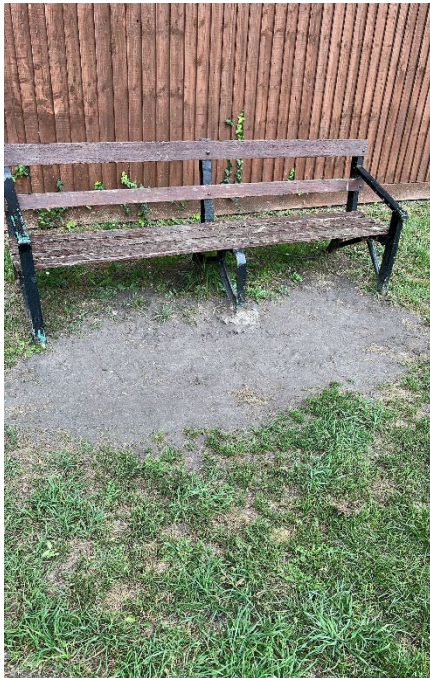
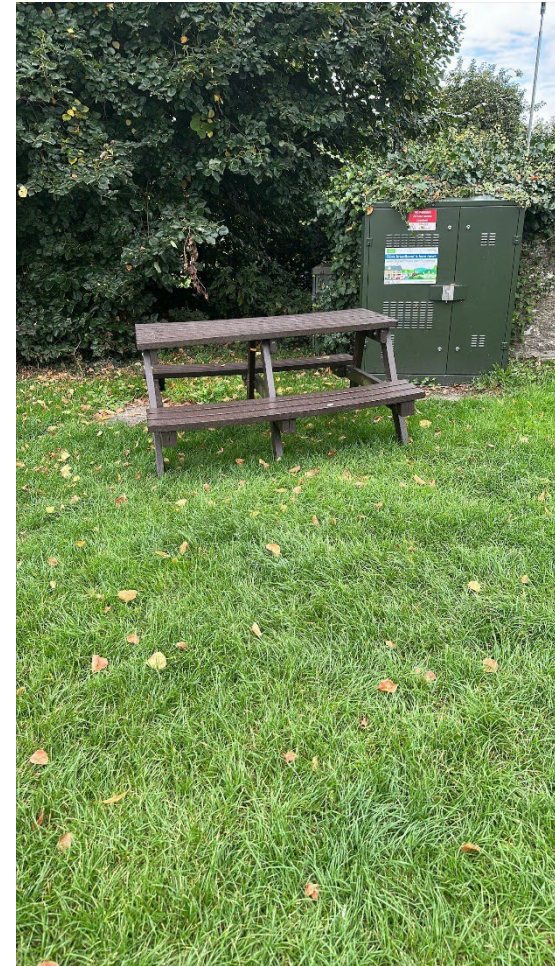
## 4.13 Seating

| Item | Issue | Recommendation |
|---|---|---|
| 4.13 | Untreated timber | Treat timbers |
| 4.13 | Unsupported tables | Provide bases |

The picnic tables are twisting and causing additional load on the fixings as well as deforming the plastic.

Timbers should be regularly treated to prevent decay – the two benches are overdue for this.

The recycled benches should be reset on a base to prevent strain on the frame.

The wooden benches should be treated against decay.

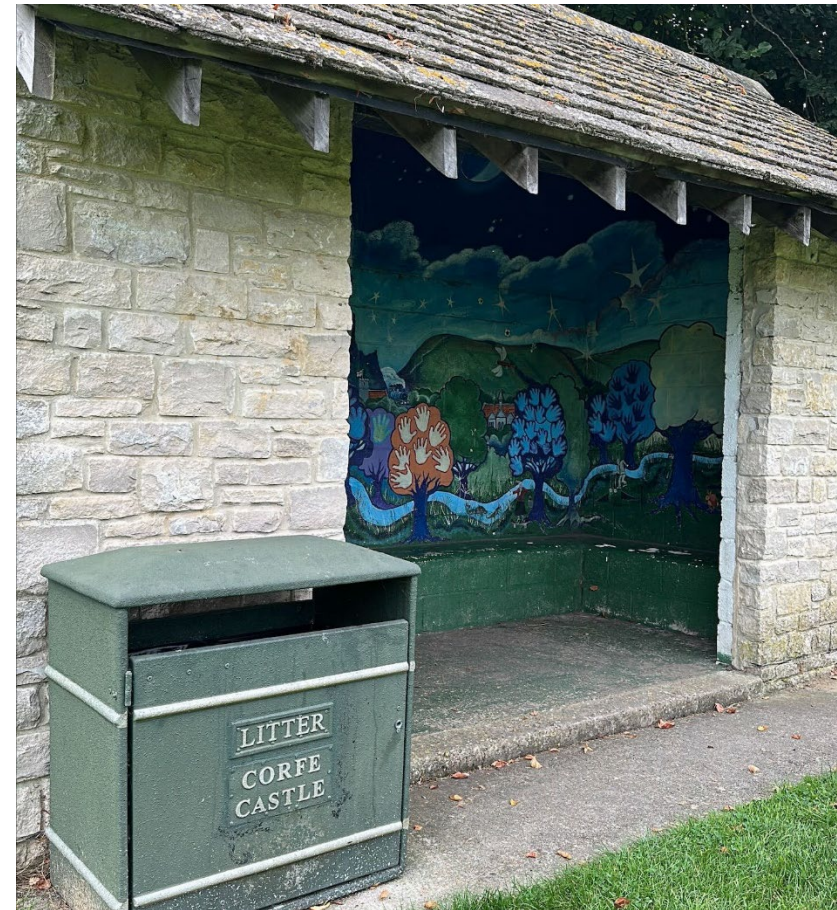
#### 4.14 Ancilliaries

There is stone built shelter with cast seating. There are no obvious issues with this structure.

There is a refuse bin adjacent to the shelter and there are no obvious issues with the bin.
