# the play inspection company

## Post Installation Report

Corfe Castle Parish Council

West Street Play Area

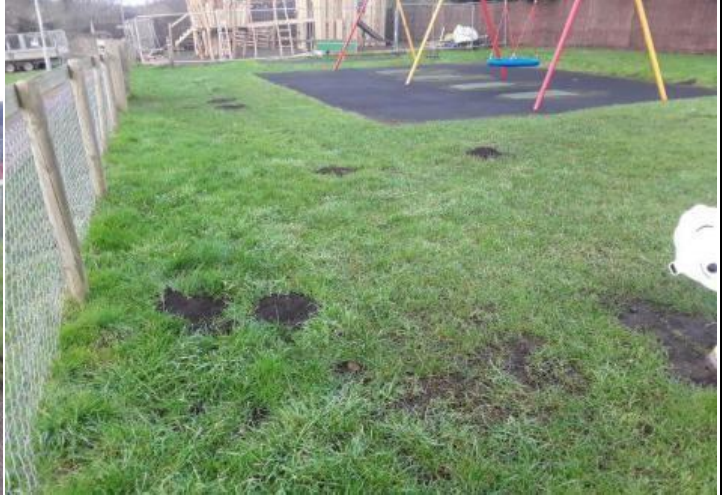
**Finding:** There are a number of molehills within the area **Action:** Remove moles by appropriate means, reinstate and these may present unforeseen hazards for users surfaces to level and maintain the area

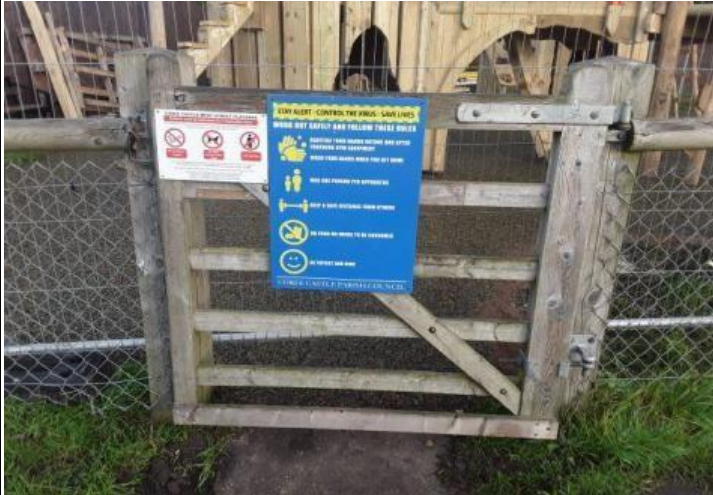
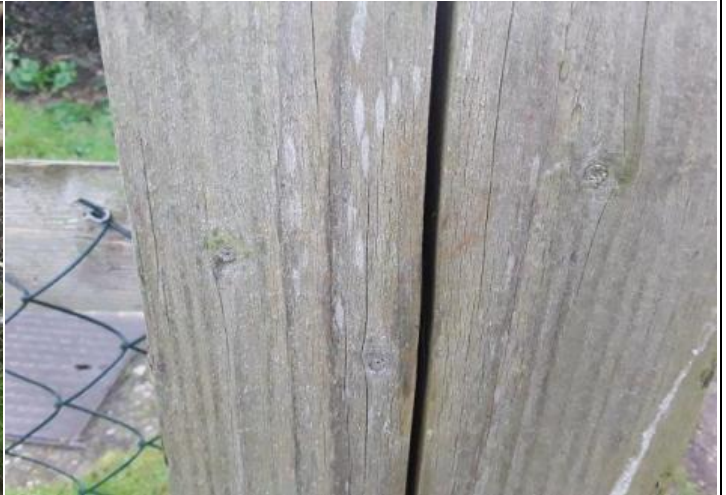
**Finding:** The timber has a number of splits/shakes or air cracks and this may affect the stability or allow water ingress fixing points of the structure and/or cause any instability which will accelerate the rotting process

**i** 6 - Low Risk (Finding 4)

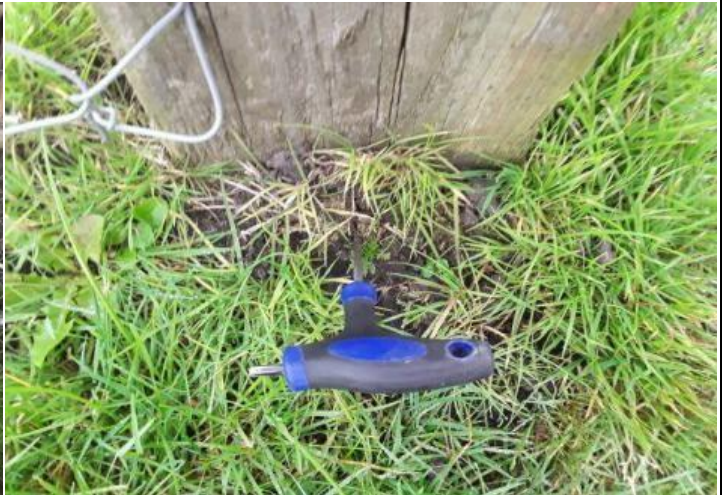
**Finding:** There is some evidence of rot in the timber

**Action:** Monitor for any further deterioration and replace as required

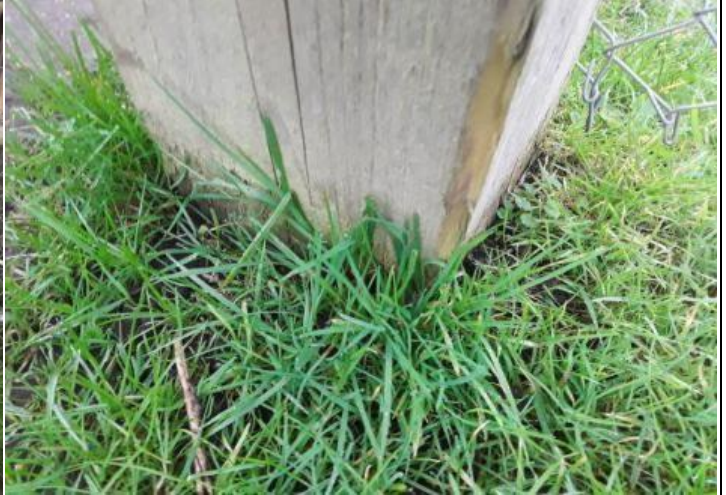
**Finding:** There is some strimmer / machinery damage apparent on the posts, this can penetrate the preservative applied to the timber and accelerate the rotting process

**Action:** Monitor for any deterioration (rot) and replace as required

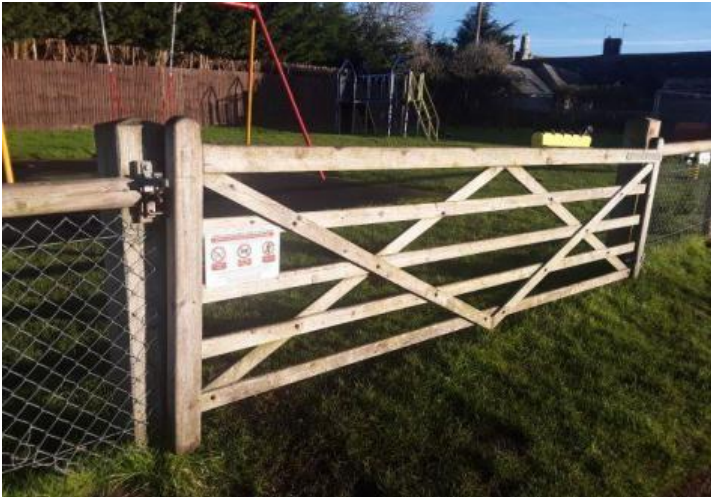
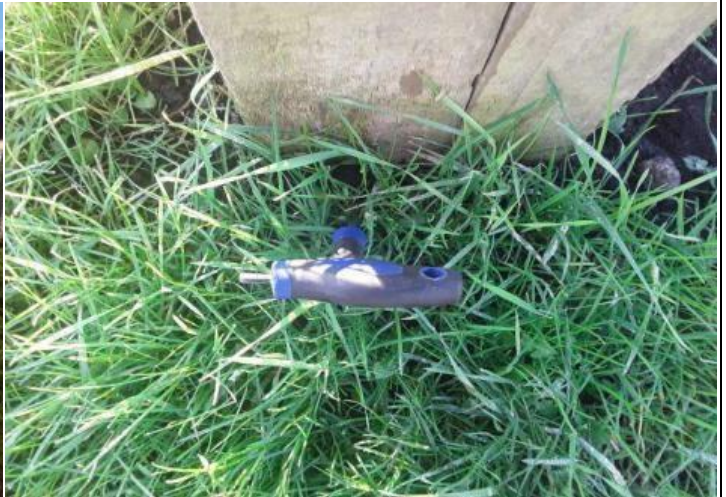
**Finding:** There is some evidence of rot in the timber

**Action:** Monitor for any further deterioration and replace as required

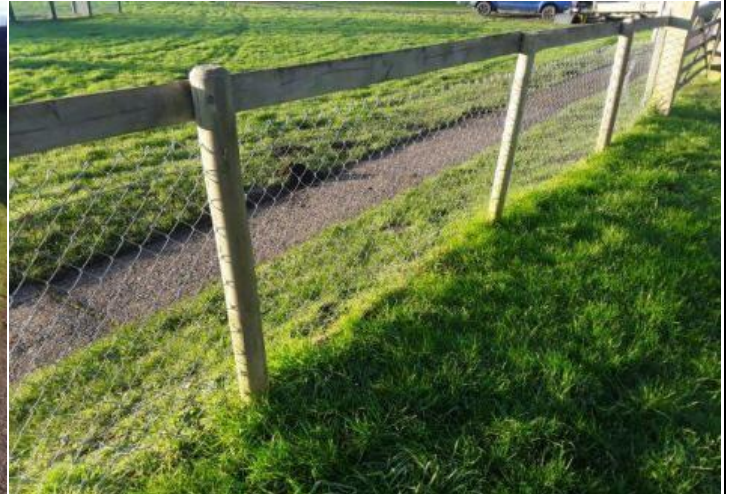
**Finding:** There are a number of loose posts around the required

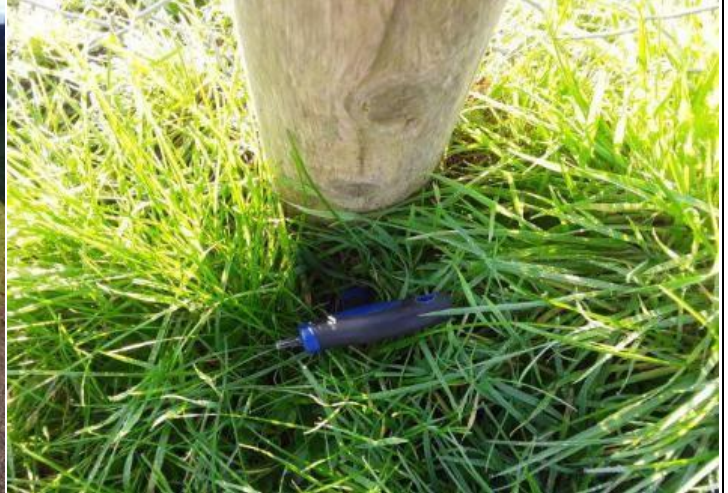
**Finding:** There are areas or parts of the timber on the that have rotted  
**Action:** Replace all affected timbers structure

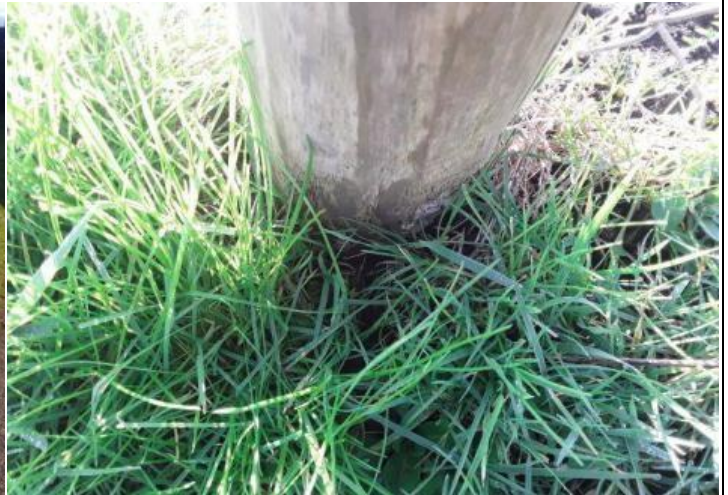
**Finding:** There is some strimmer / machinery damage apparent on the posts, this can penetrate the preservative applied to the timber and accelerate the rotting process  
**Action:** Monitor for any deterioration (rot) and replace as required

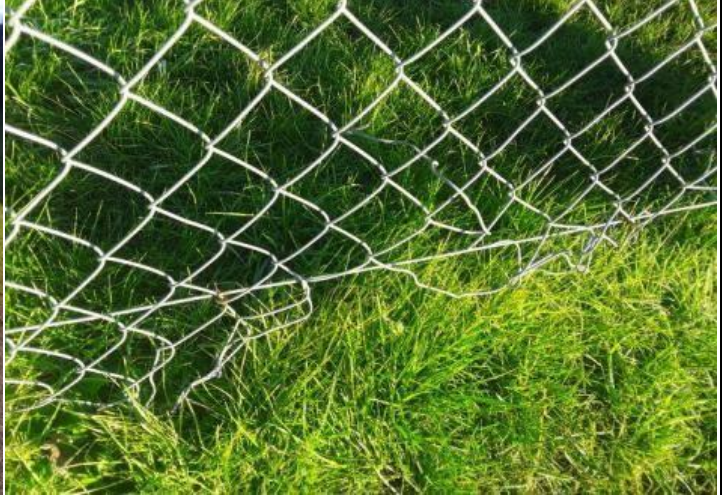
**Finding:** There is some damage to the fence sections

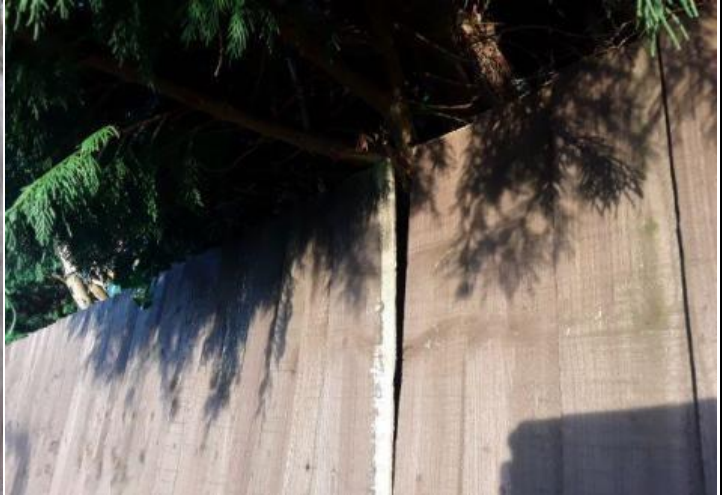
**Finding:** There is some damage to the fence sections

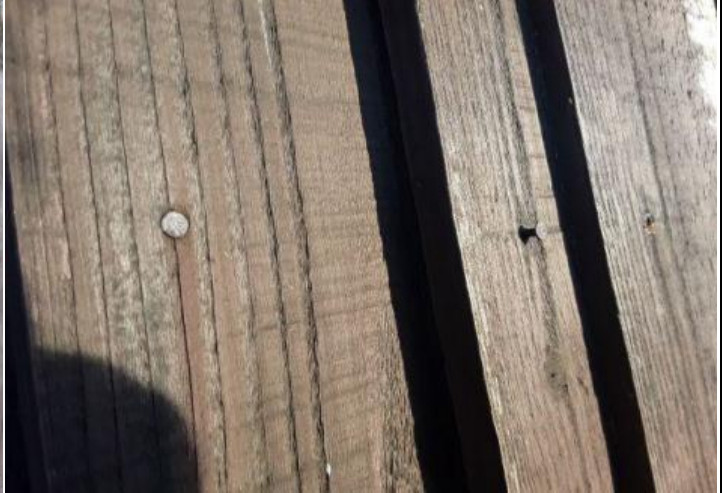
**Finding:** A number of fixings have worked loose around the fencing  
**Action:** Secure all loose fixings

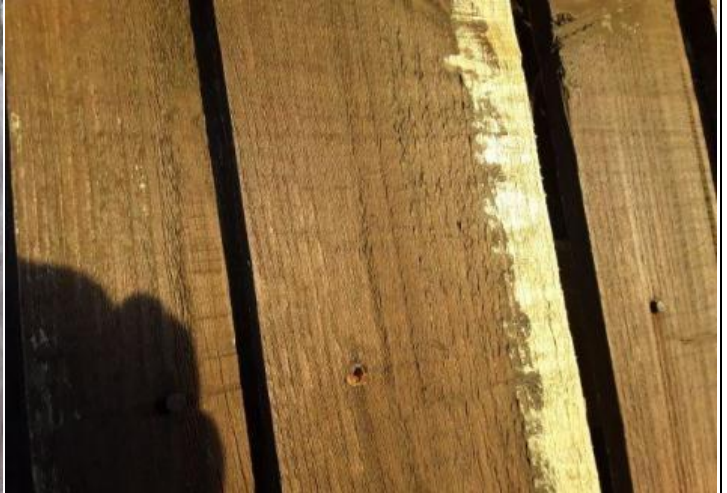
**Finding:** There are a number of fixings missing from the fence  
**Action:** Replace missing fixings fence

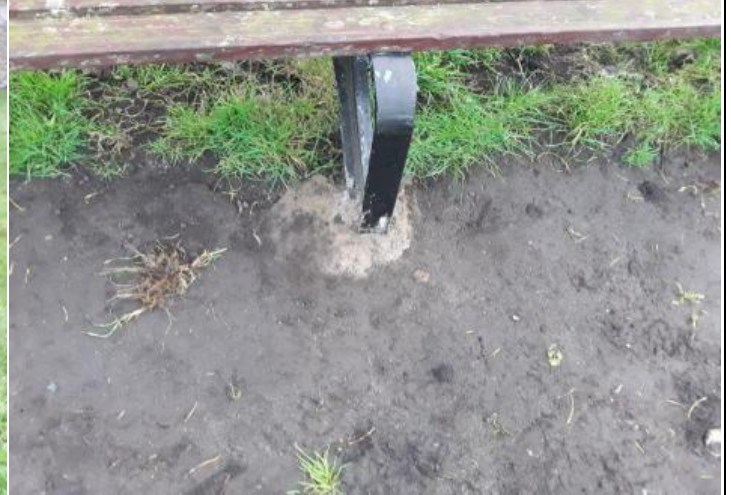
**Finding:** The surface has eroded and the foundations are exposed

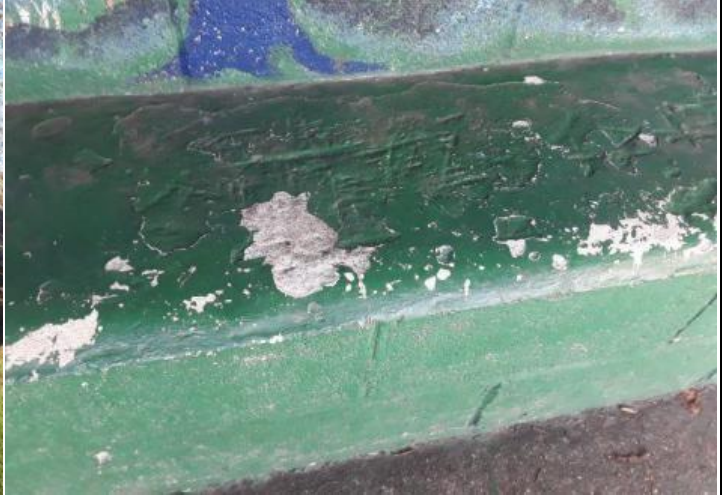
**Finding:** There is some damage to the seating area

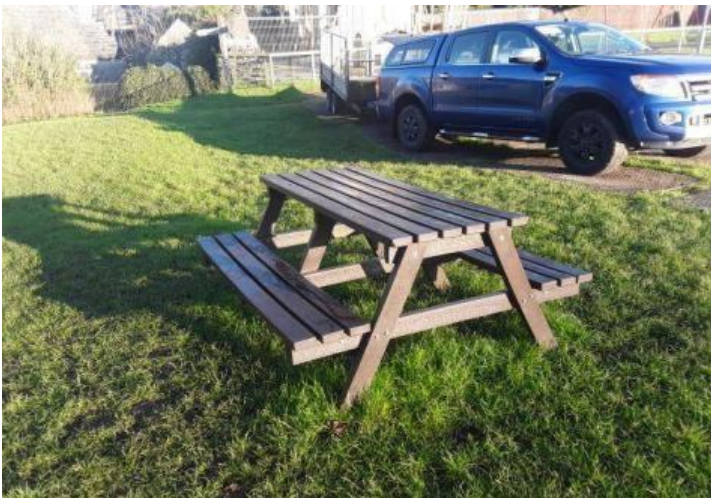
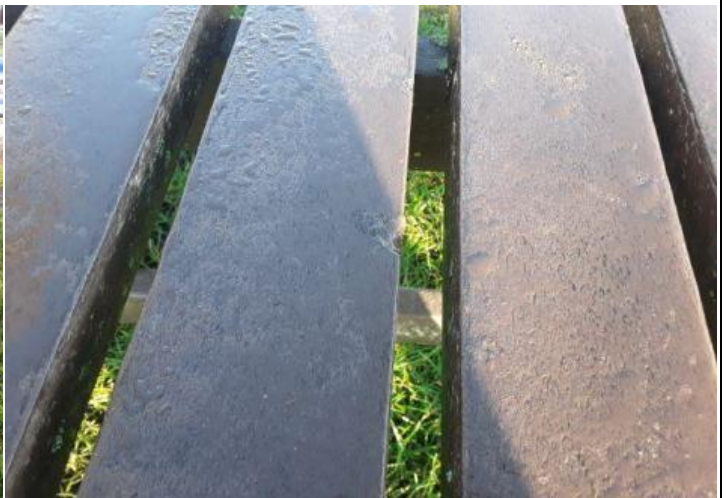
**Finding:** There is some evidence of fire damage to the item

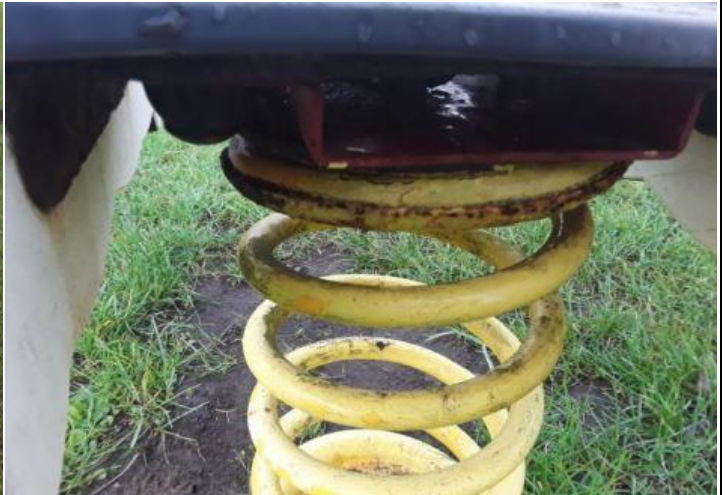
**Finding:** The paintwork on the spring has been damaged or worn exposing the metal underneath which is rusting

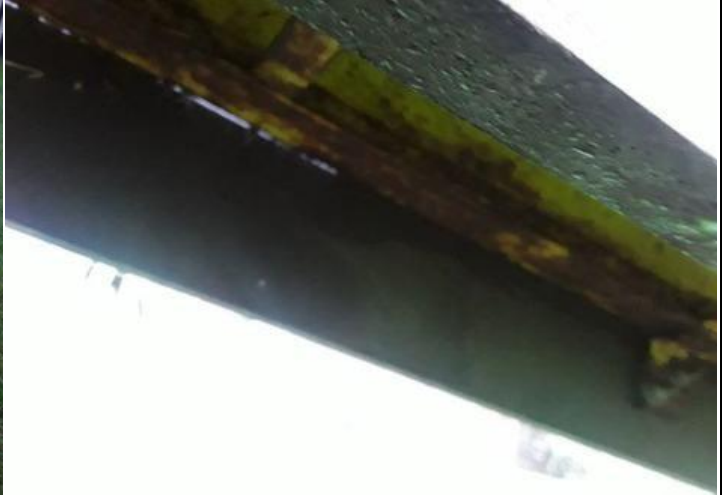
**Finding:** There is no gaiter protection for accessible moving **Action:** Monitor - No remedial work recommended parts (possible shear trap) as recommended in BS EN 1176 Part 1; 4.2.6 Moving Parts

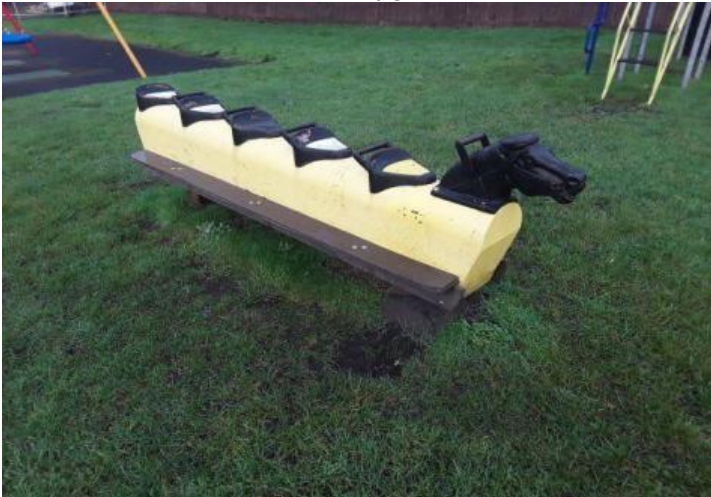
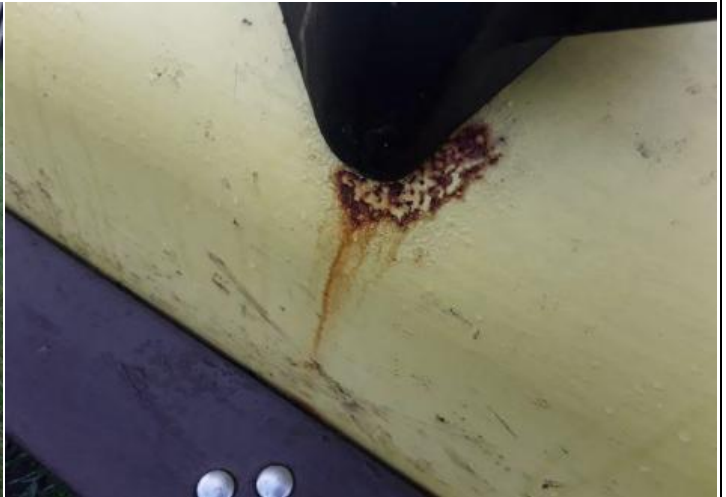
**Finding:** There is surface corrosion present on the item **Action:** Consider treating the item

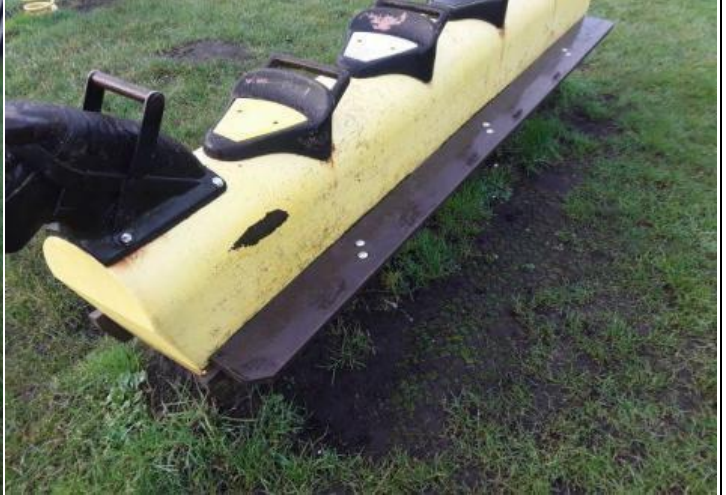
**Finding:** There is some lateral movement during operation **Action:** Monitor for any instability and repair as required

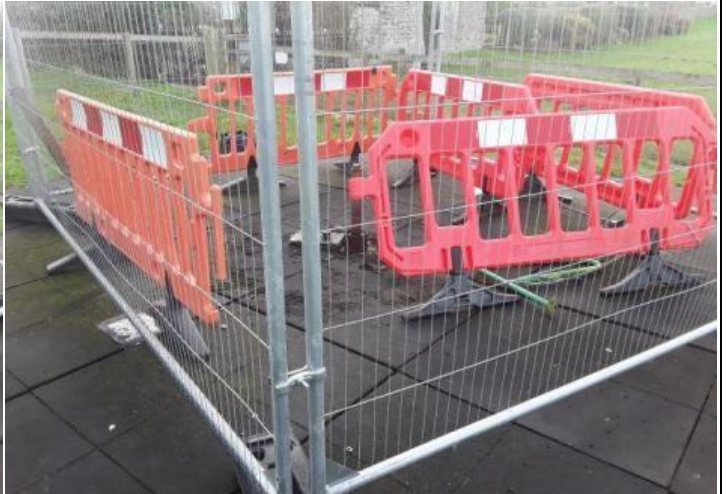
**Finding:** The item has been removed and access has been restricted by the owner / operator **Action:** Complete repairs or removal of item

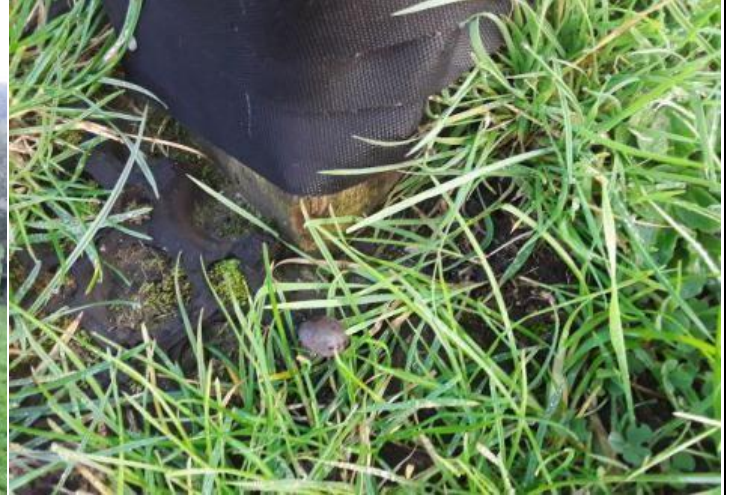
**Finding:** There is some strimmer / machinery damage apparent on the posts, this can penetrate the preservative applied to the timber and accelerate the rotting process  
**Action:** Monitor for any deterioration (rot) and replace as required

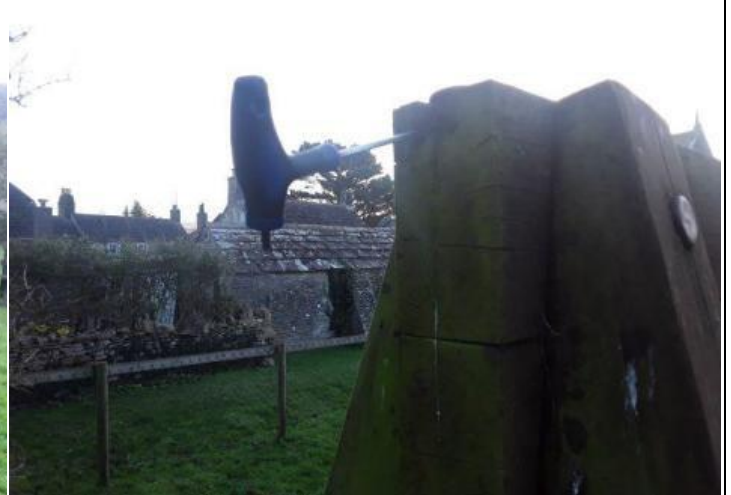
**Finding:** There is some evidence of rot in the crossbeam  
**Action:** Monitor for any further deterioration and replace as required

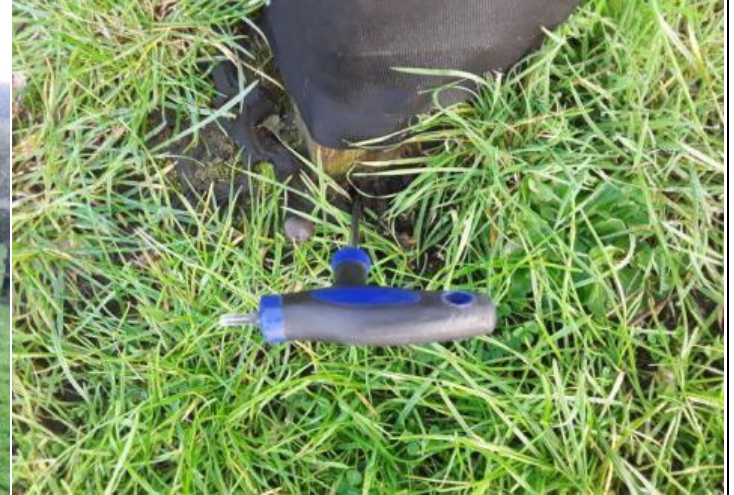
**Finding:** There is some evidence of rot in the posts

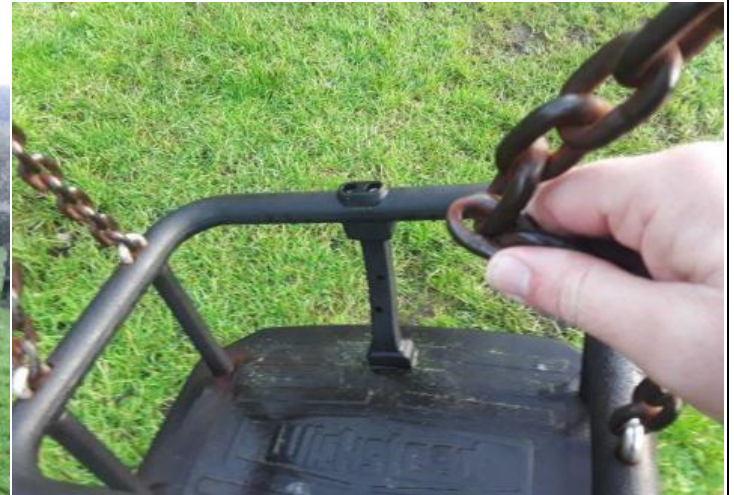
**Finding:** There is some notable evidence of chain wear

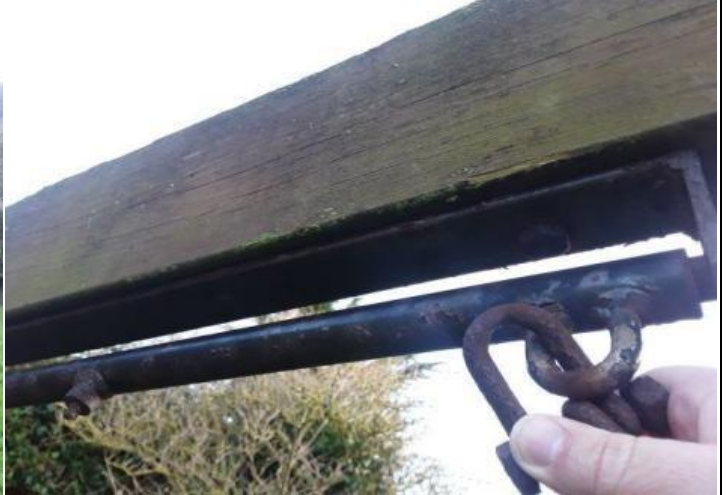
**Finding:** There is some wear to the shackles.

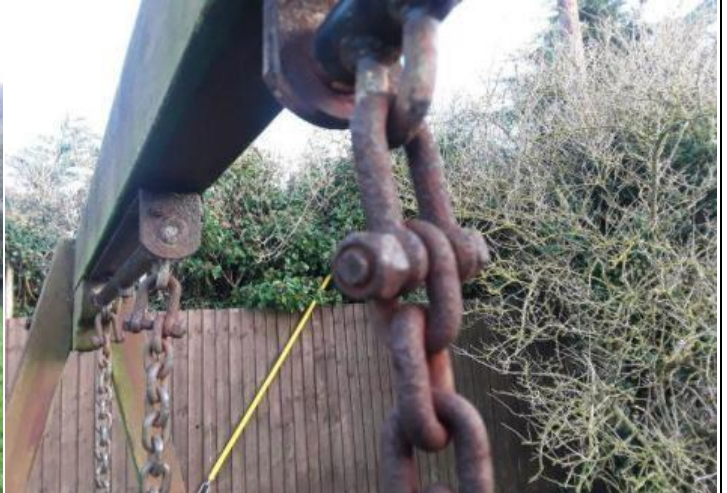
**Finding:** The shackles have corroded excessively

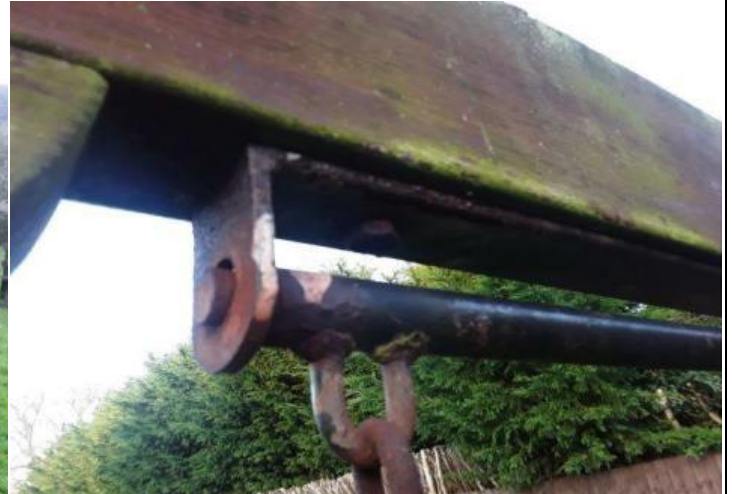
**Finding:** The paintwork on the swing hangers has been damaged or worn exposing the metal underneath which is rusting

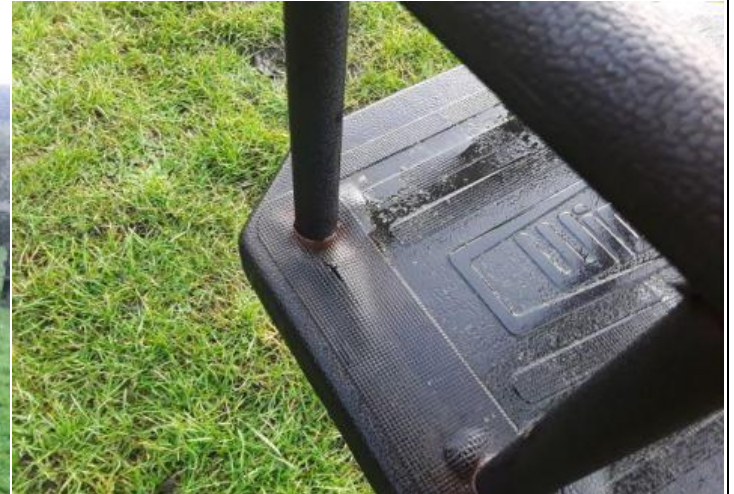
**Finding:** The seat has minor damage or wear

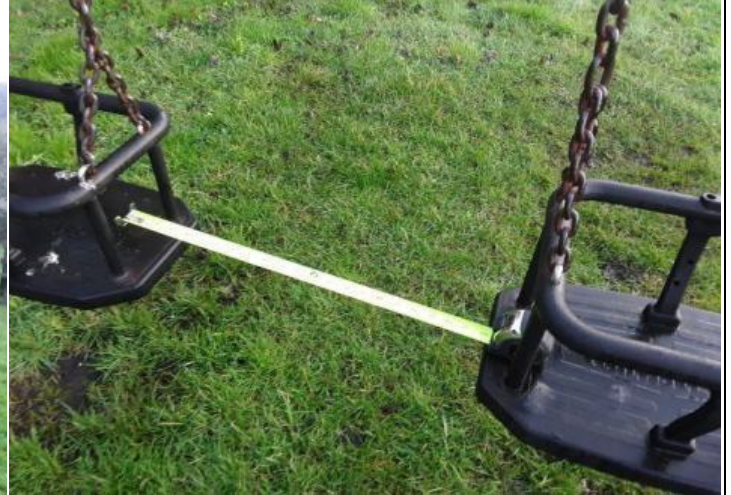
**Finding:** The seats are too close to each other as defined in BS EN 1176 Part 2; this is a low risk failure and no remedial action is required  
**Action:** Monitor - No remedial work recommended

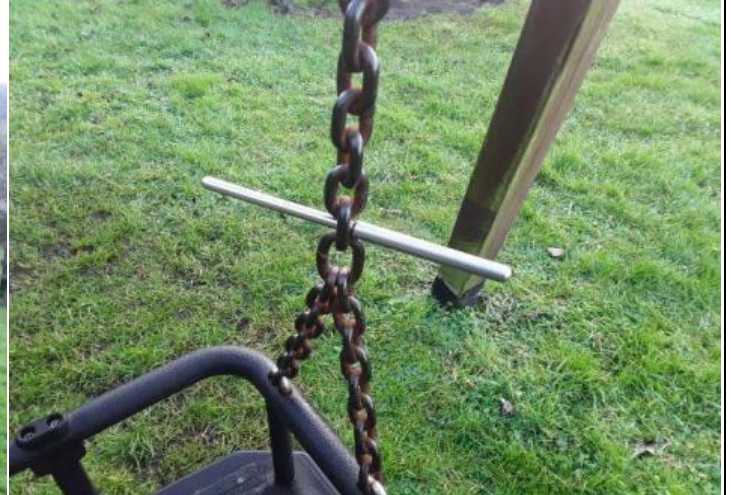
**Finding:** The chain openings are in excess of the 8.6mm as recommended by BS EN 1176  
**Action:** Monitor - No remedial work recommended

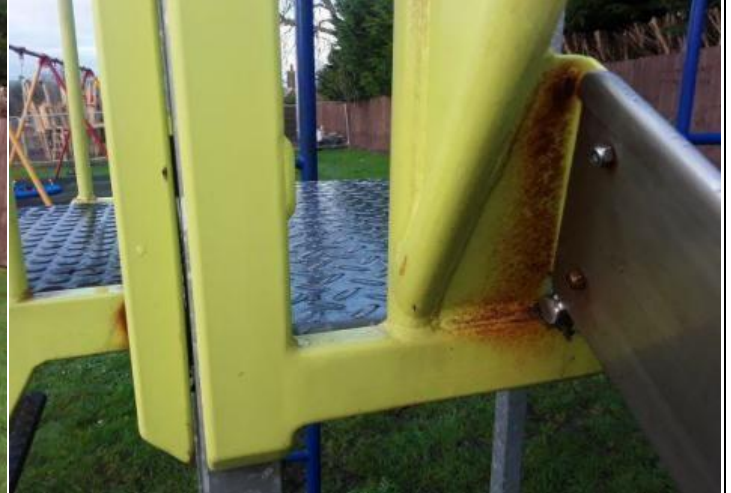
**Finding:** There is surface corrosion present on the item

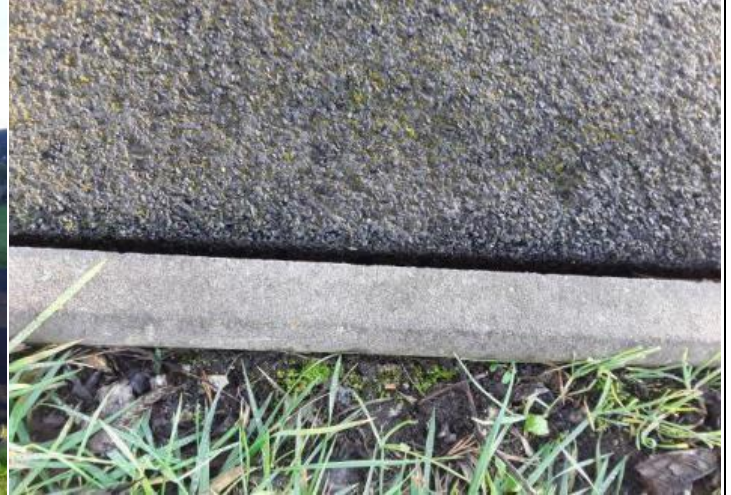
**Finding:** There are gaps opening between the surfacing and the edging surround or between the joints in the surfacing  
**Action:** Monitor for any further deterioration and repair as required

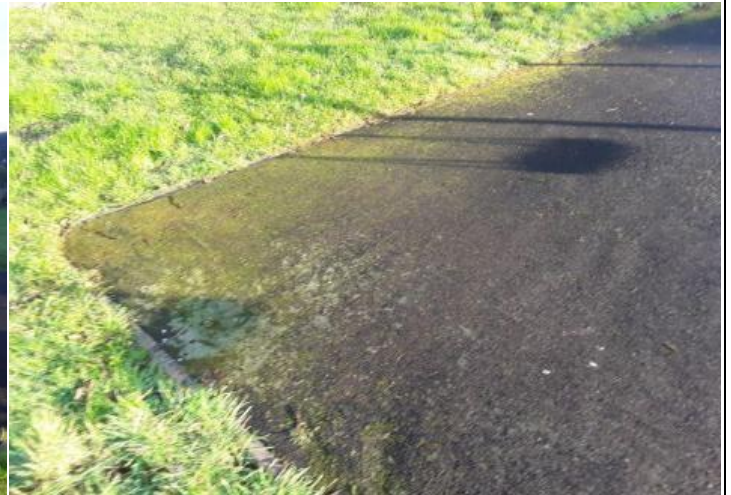
**Finding:** There is algae or moss growth on the surface  
**Action:** Clean and treat appropriately resulting in slippery conditions

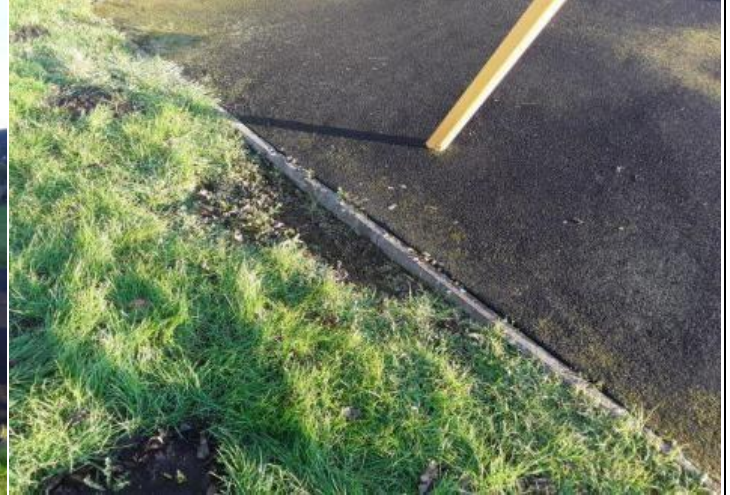
**Finding:** There are trip hazards at the edges of the surface **Action:** Reinstate surrounding surface levels to remove the trip points

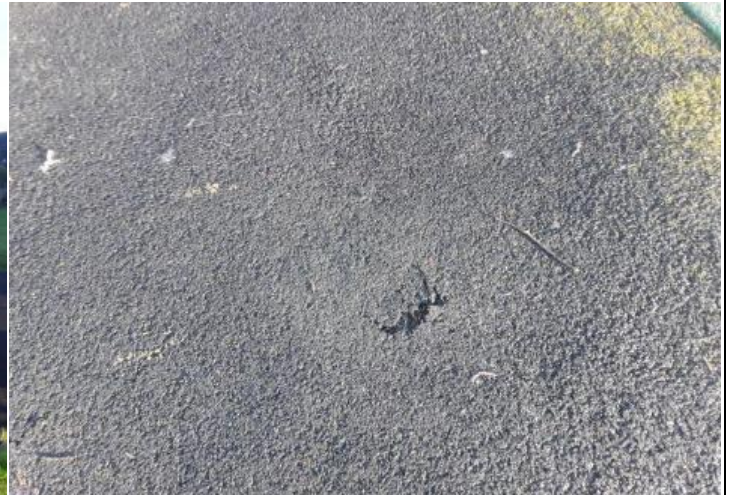
**Finding:** The safety surface under or around this unit has as been damaged required

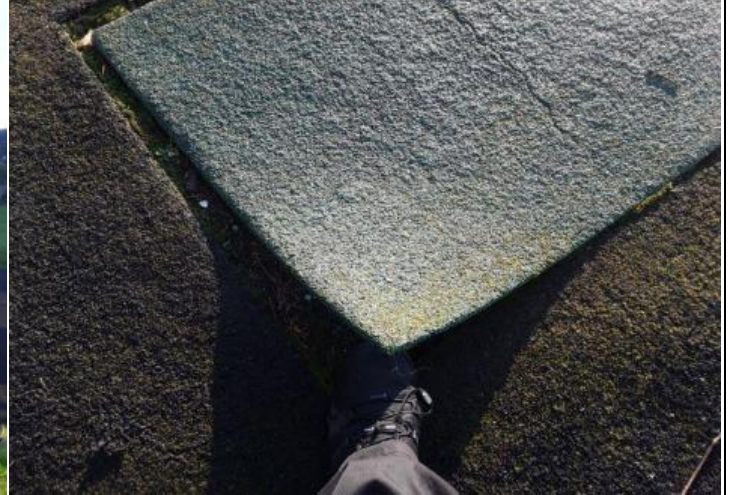
**Finding:** The surface is lifting at the edges and creating trip points  
**Action:** Repair perimeter of surfacing to remove trip points

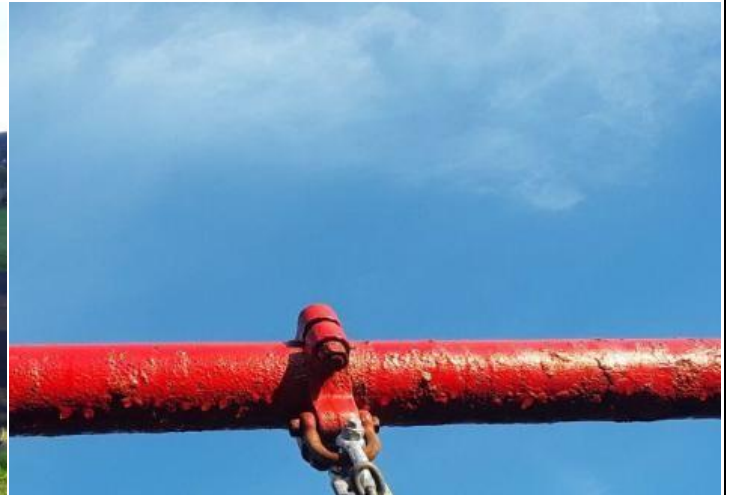
**Finding:** The bushes are showing signs of wear

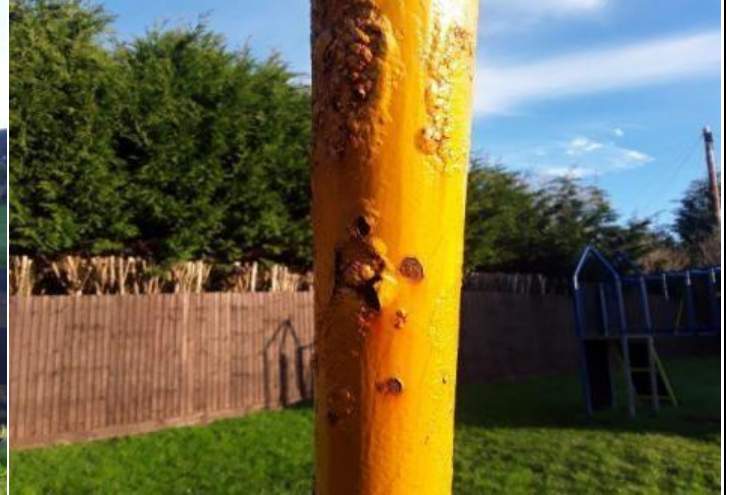
**Finding:** The paintwork on this item has been damaged or repainted worn exposing the metal underneath which is rusting

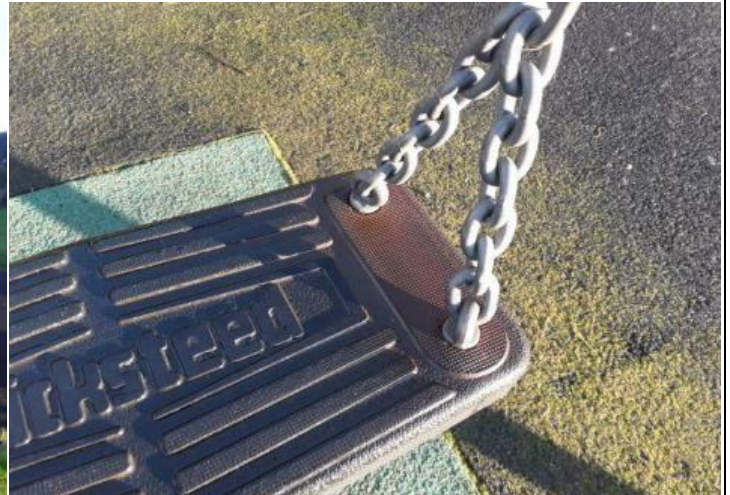
**Finding:** The swing seat connectors are loose

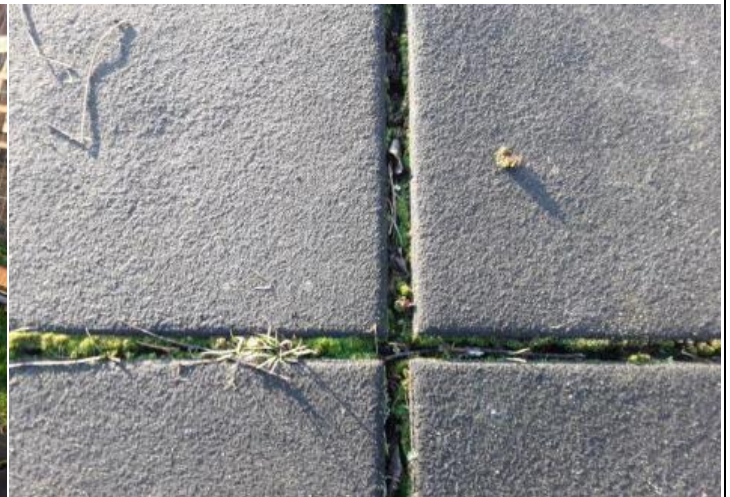
**Finding:** There are gaps opening in between the tiles

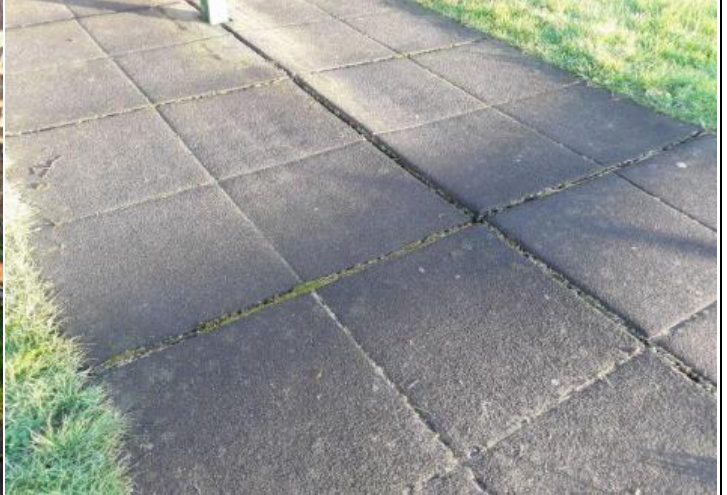
**Finding:** There is algae or moss growth on the surface **Action:** Clean and treat appropriately resulting in slippery conditions

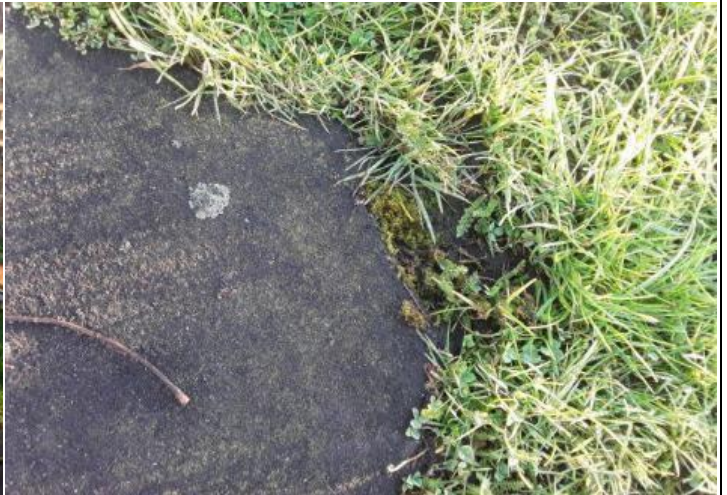
**Finding:** There is some minor damage to the surface

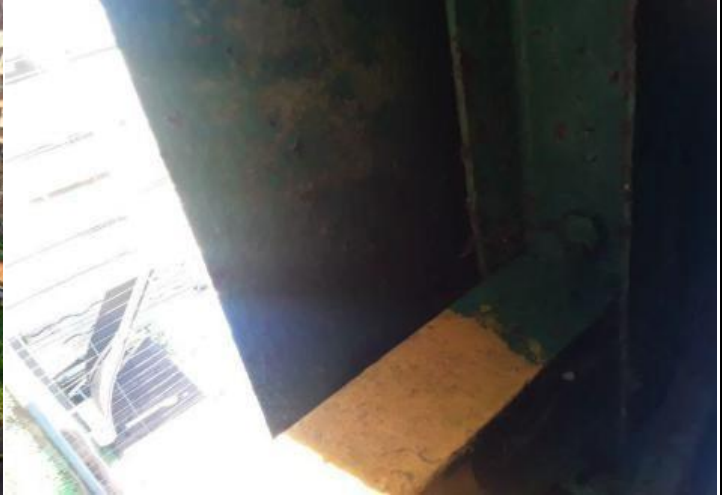
**Finding:** There is no gaiter protection for accessible moving **Action:** Monitor - No remedial work recommended parts (possible shear trap) as recommended in BS EN 1176 Part 1; 4.2.6 Moving Parts

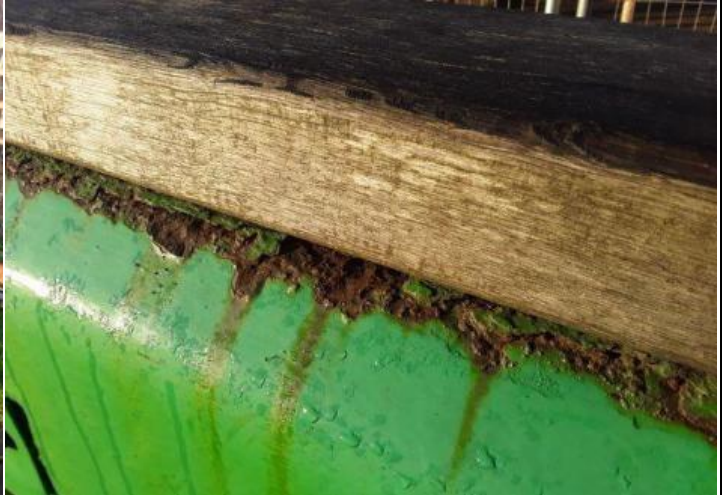
**Finding:** The paintwork on this item has been damaged or repainted worn exposing the metal underneath which is rusting

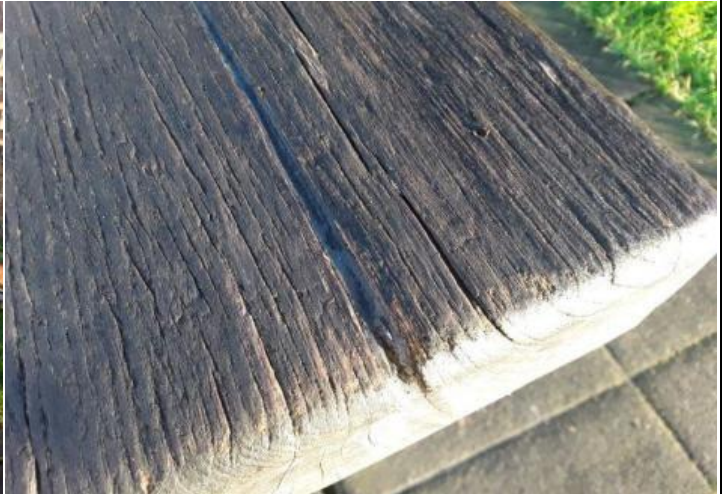
**Finding:** The use of synthetic fillers in timber is not recommended; timber being a natural material will expand and contract as the moisture content changes and the use of fillers can exacerbate the length and depth of these cracks or shakes in the timber. The only treatment that is normally required is the removal of any rough or sharp edges unless the structural integrity of the item is affected.

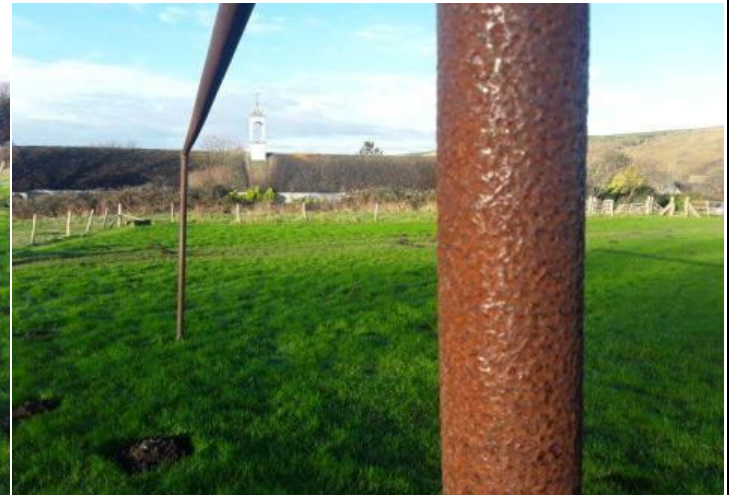
**Finding:** The paintwork on this item has been damaged or repainted worn exposing the metal underneath which is rusting

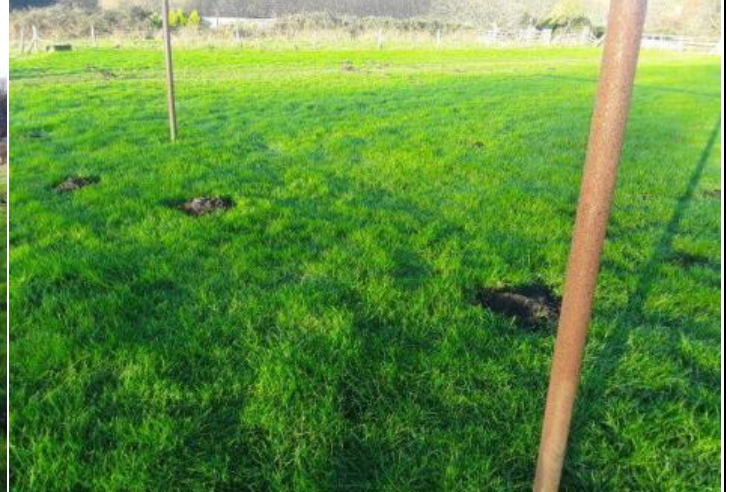
**Finding:** The item is slightly loose in its foundations

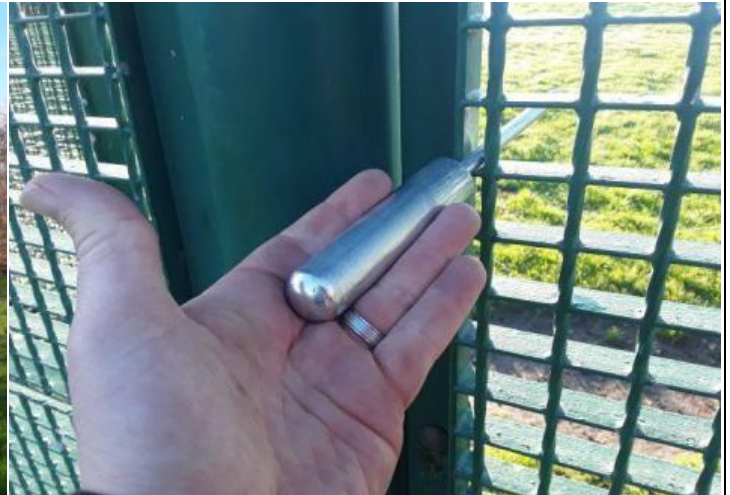
**Finding:** There is/are finger entrapments in the framework recommended and the item fails to meet the requirements of BS EN 15312 Clause 4.4.2.2 Entrapment of fingers

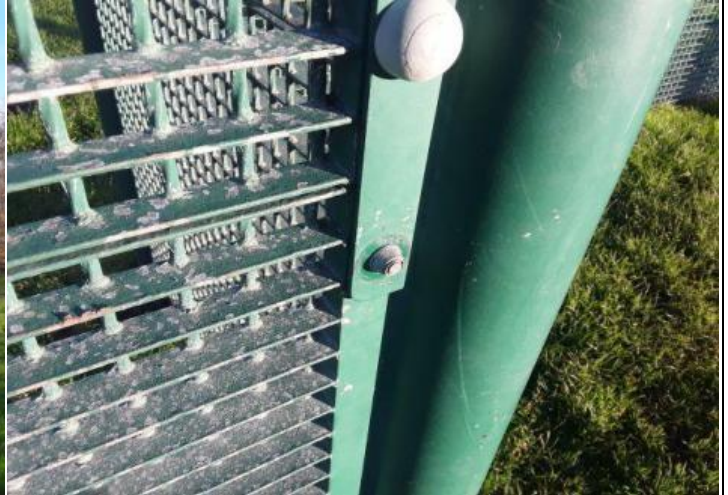
**Finding:** There is/are bolt cap covers missing or damaged covers on the item

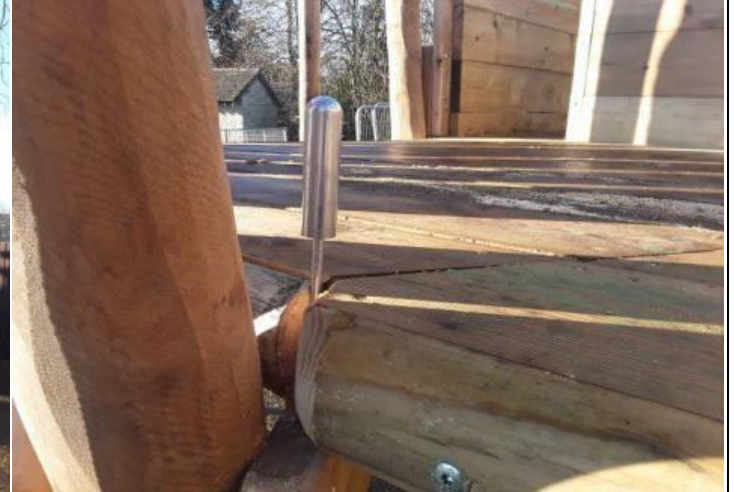
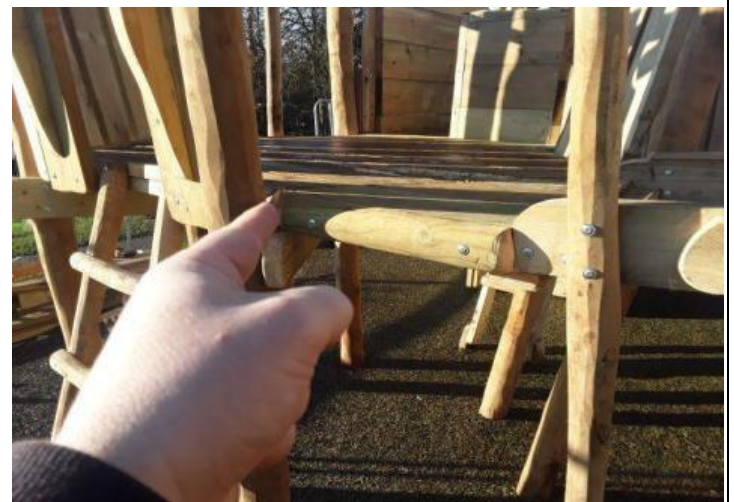
**Finding:** There is/are finger entrapment/s in the platforms  
contractor and the item fails to meet the requirements of BS EN 1176  
Part 1 4.2.7.6 Entrapment of fingers

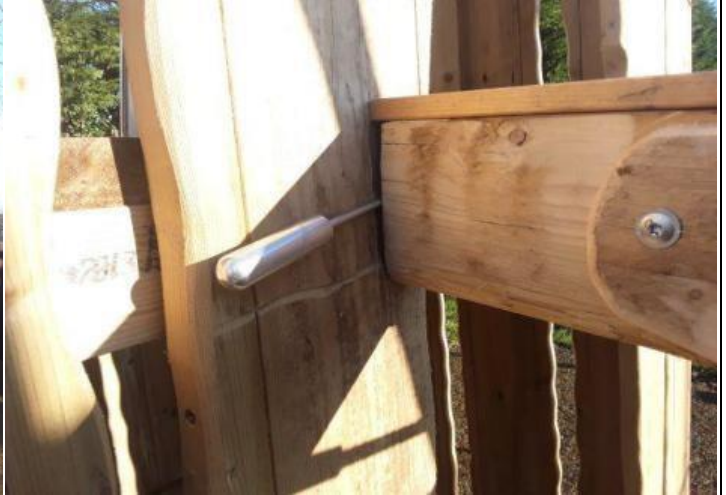
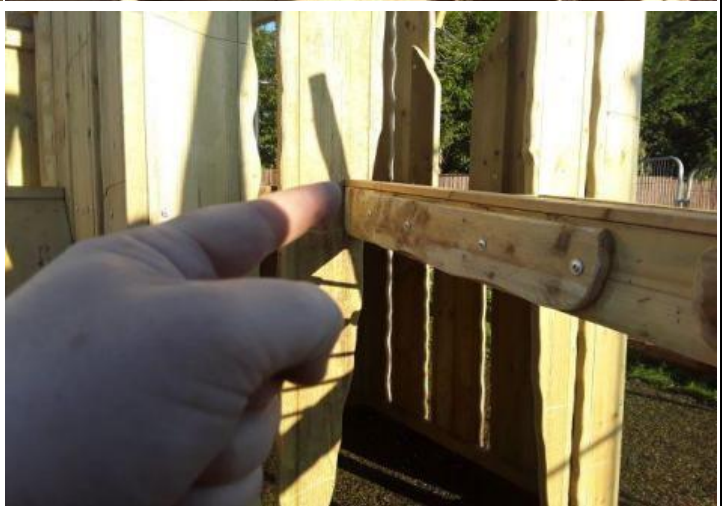
**Finding:** There is/are finger entrapment/s between the rope **Action:** Refer to contractor bridge and framework and the item fails to meet the requirements of BS EN 1176 Part 1 4.2.7.6 Entrapment of fingers
