# the play inspection company

## Post Installation Report

Corfe Castle Parish Council

West Street Play Area

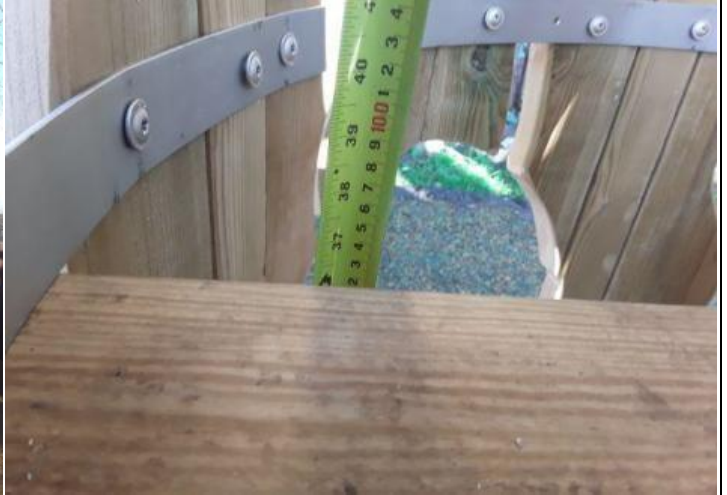
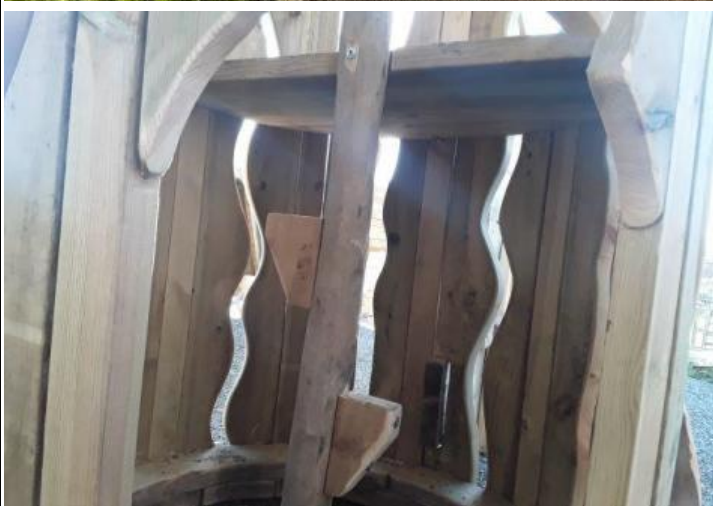
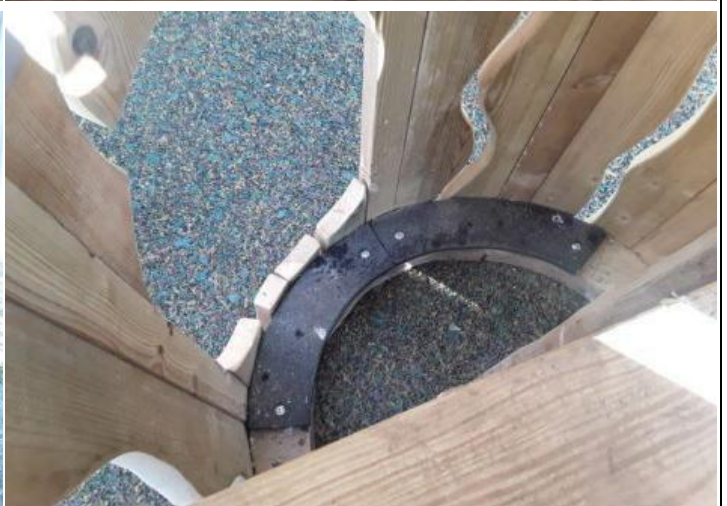
**Finding:** There are falls in excess of 600mm (920mm) **Action:** Refer to contractor between adjacent components on the structure, in contravention of the recommendations set out in BS EN 1176 Part 1; 4.2.8.4

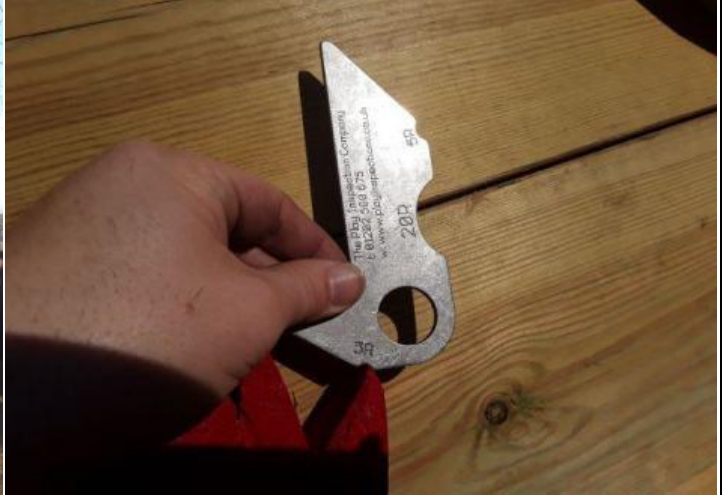
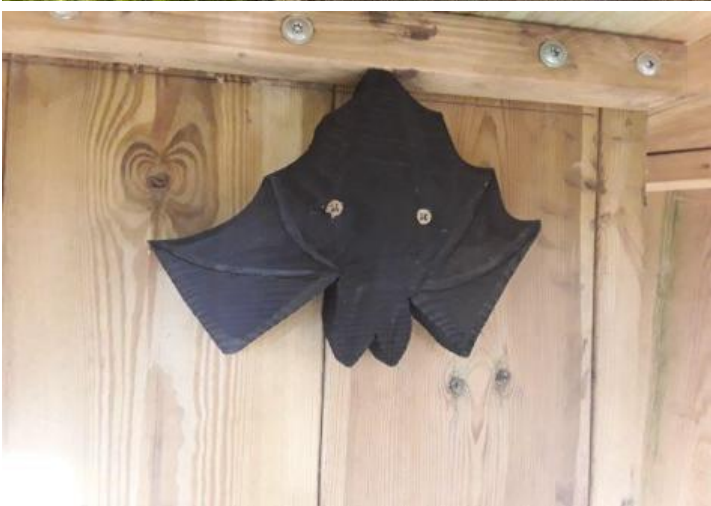
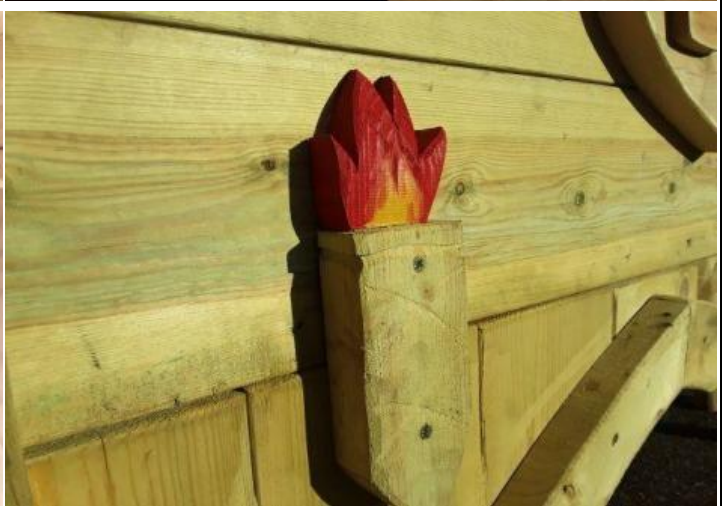
**Finding:** The decorative figures have exposed edges and corners with a radius of less than 3mm and fails the

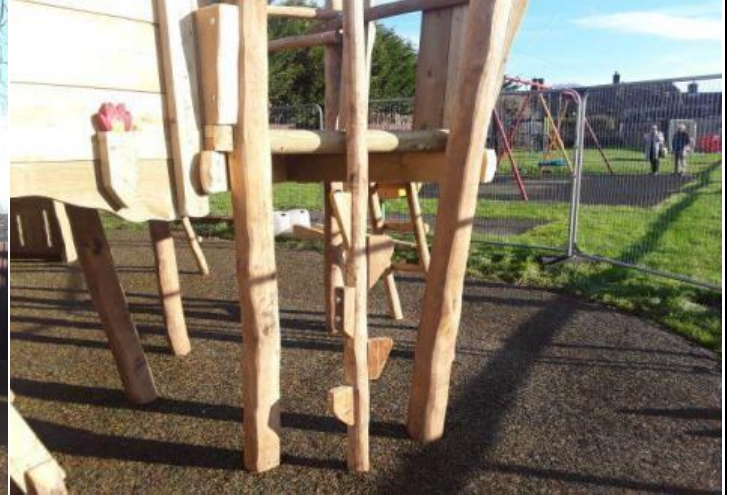
**Finding:** There are openings leading from platforms in excess of 1.0m (1.5m) in height to steep play elements and no hand supports complying with grip or grasp are provided, in contravention of BS EN 1176 Part 1: 4.2.9.4

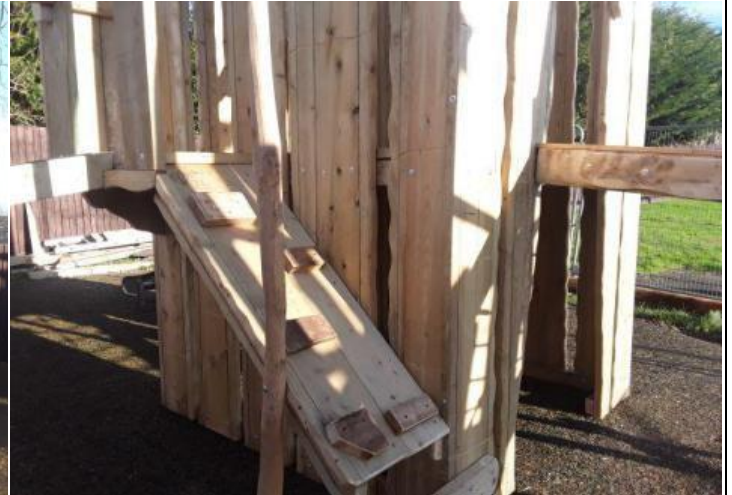
**Finding:** There are openings leading from platforms in excess of 1.0m (1.4m) in height to steep play elements and no hand supports complying with grip or grasp are provided, in contravention of BS EN 1176 Part 1: 4.2.9.4

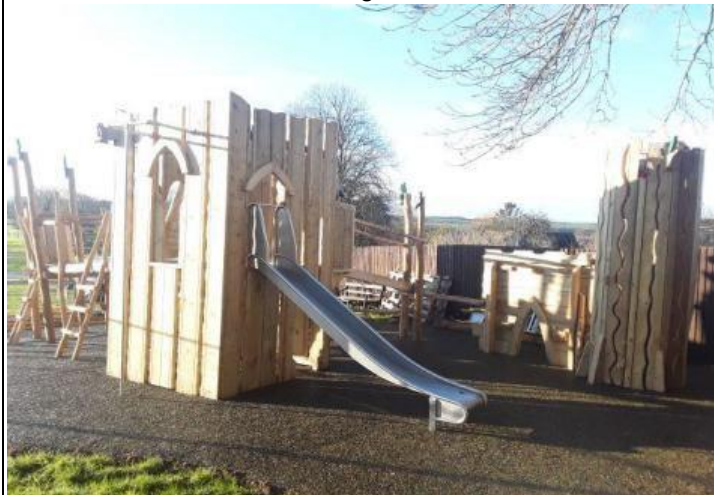
**Finding:** There are openings leading from platforms in excess of 1.0m (1.4m) in height to steep play elements and no hand supports complying with grip or grasp are provided, in contravention of BS EN 1176 Part 1: 4.2.9.4

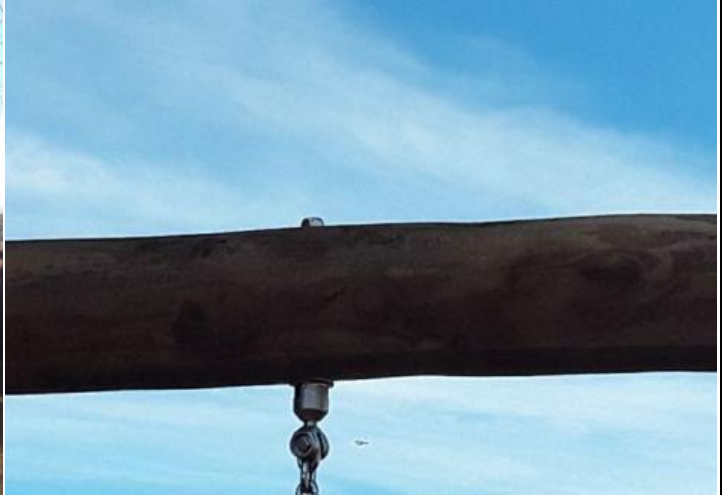
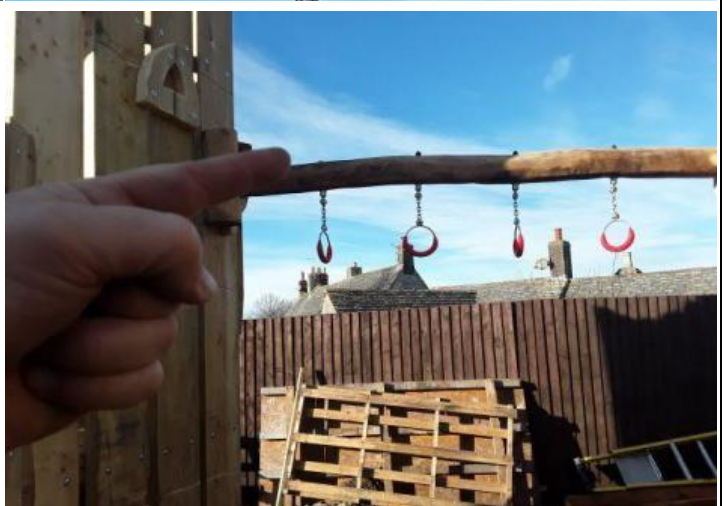
**Finding:** There is/are bolt cap covers missing or damaged covers on the item

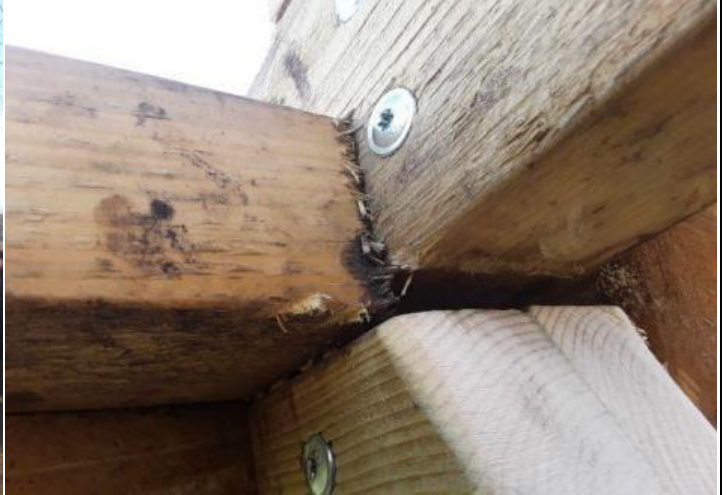
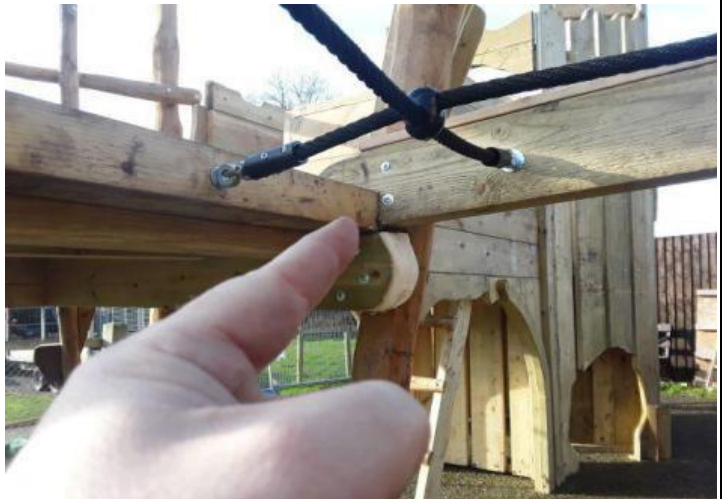
**Finding:** Parts of the timber are rough or splintered
