# *PLAY AREA SAFETY INSPECTION REPORT*

## CORFE CASTLE PARISH COUNCIL

Park Name: West St. Play Area.  
Location: West St. Corfe Castle BH20 5HQ

Inspection undertaken December 2023  
This report issued 12<sup>th</sup> January 2024

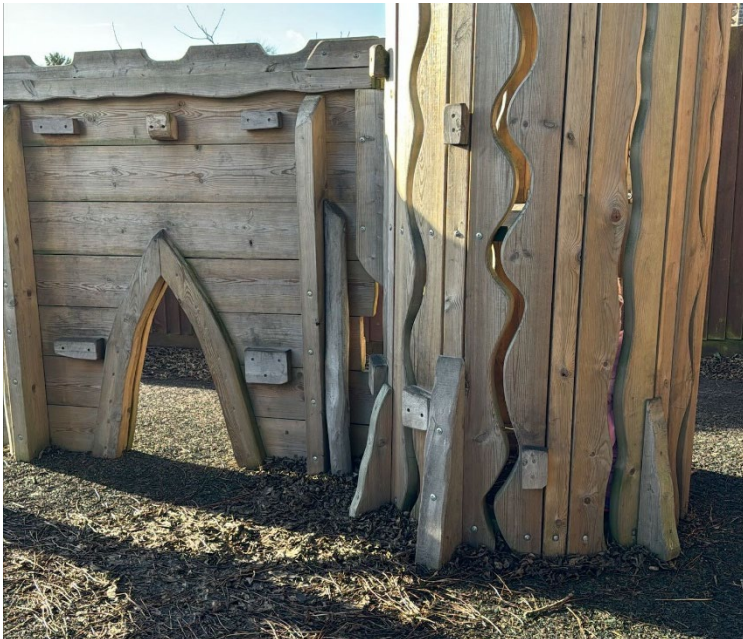
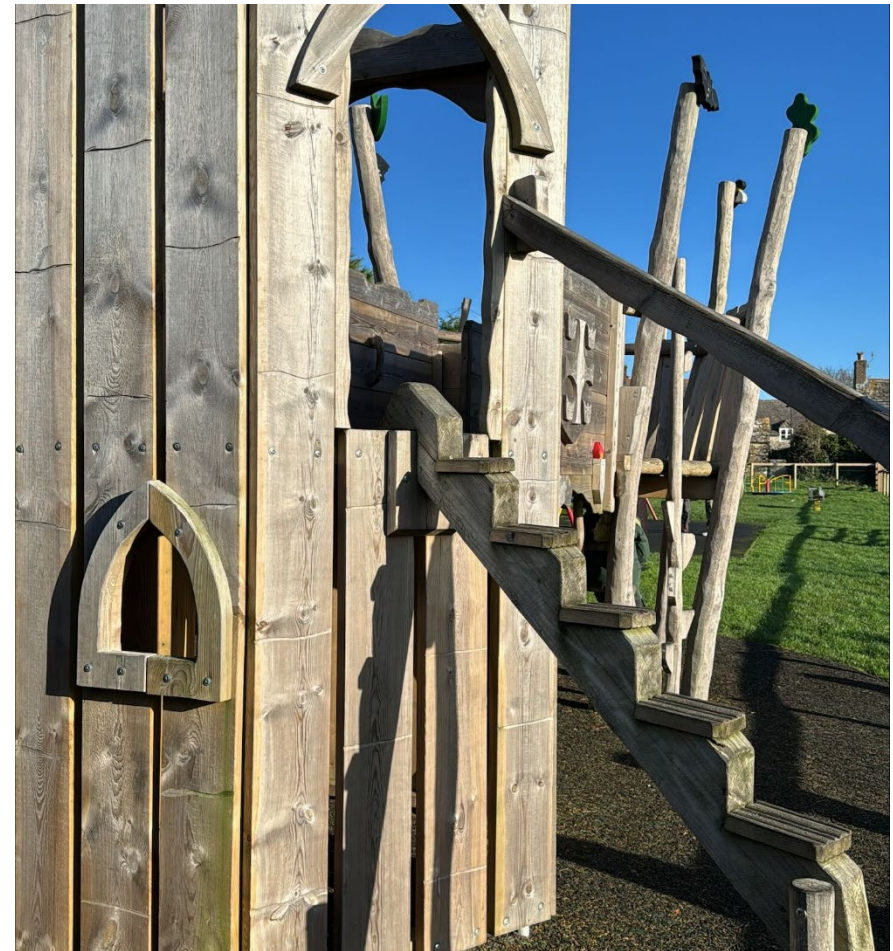
## 4.1 Twin Tower with Slide

There are no significant issues with this unit.

The unit is designed to have challenging elements and as such the higher-level components are not easily accessible. As with any such unit there is a higher risk level associated with its use, but this is within acceptable limits and suitable controls are present.

| Item | Issue | Recommendation |
|---|---|---|
| 4.1 | Fall from height | Monitor use for any reported falls |

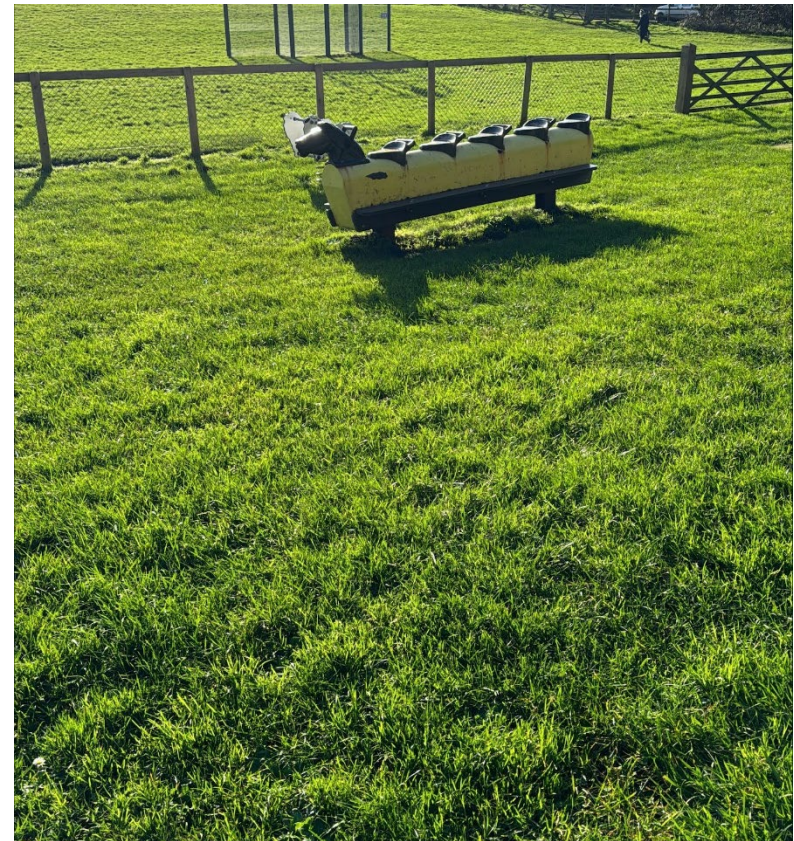
## 4.2 Wicksteed Rocking Horse See-Saw

There is significant wear in the dampers and corrosion in the posts and so plans should be made to replace this unit over the next 2-3 years.

There are no other significant issues.

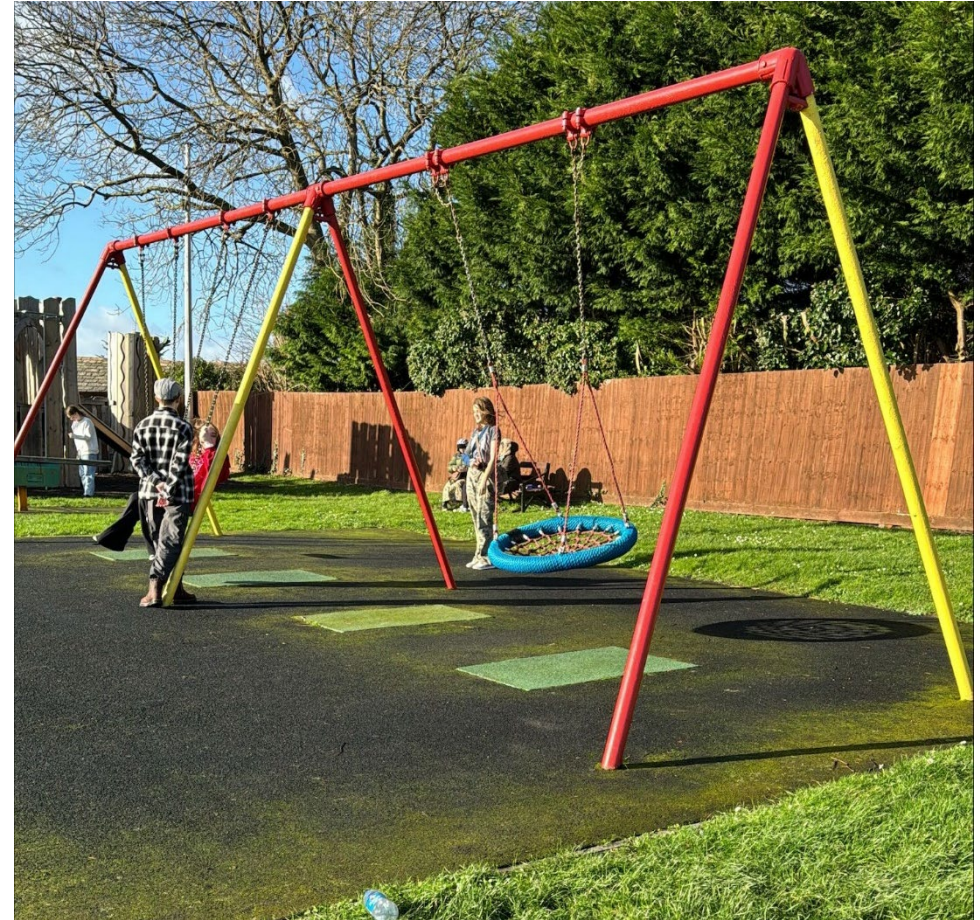
### 4.3 Wicksteed 2 Bay Swing Set

The surfacing on the two-bay swing is in a poor state of repair.

There are no significant issues with this unit other than the surfacing (see Q2 report).

| Item | Issue | Recommendation |
|---|---|---|
| 4.3 | Gateway shackles can fail | Remove them |

| Item | Issues | Recommendation (s) | Supply Only | Supply & fit |
|---|---|---|---|---|
| 4.3 | Gateway shackles can fail | Remove, Fit standard shackles and adjust chains | | £25 |

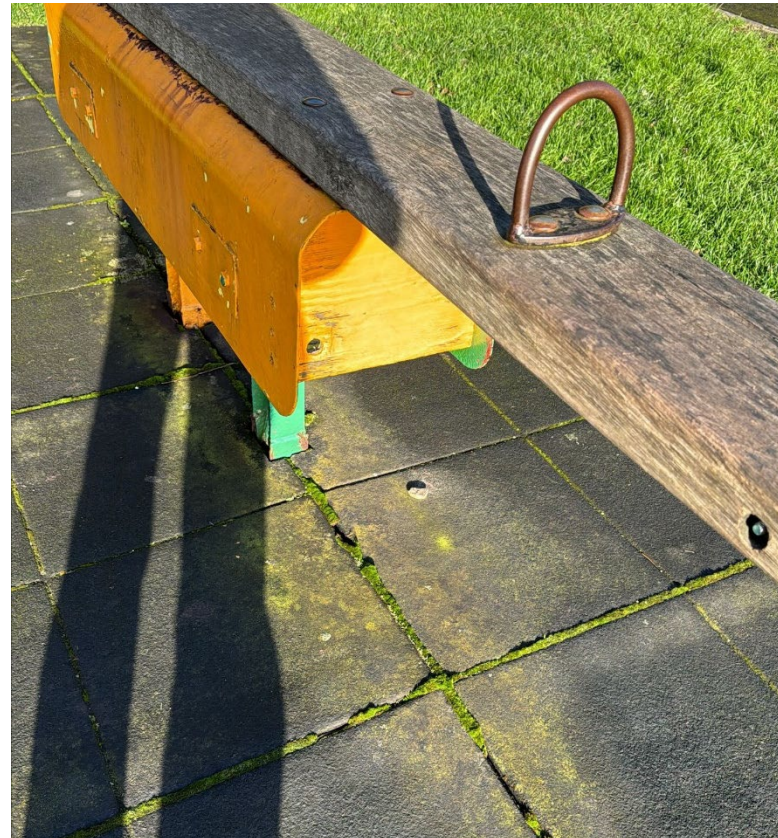
#### 4.4 Wicksteed Non-Bump See-Saw

There are no significant issues with this item other than age and corrosion.

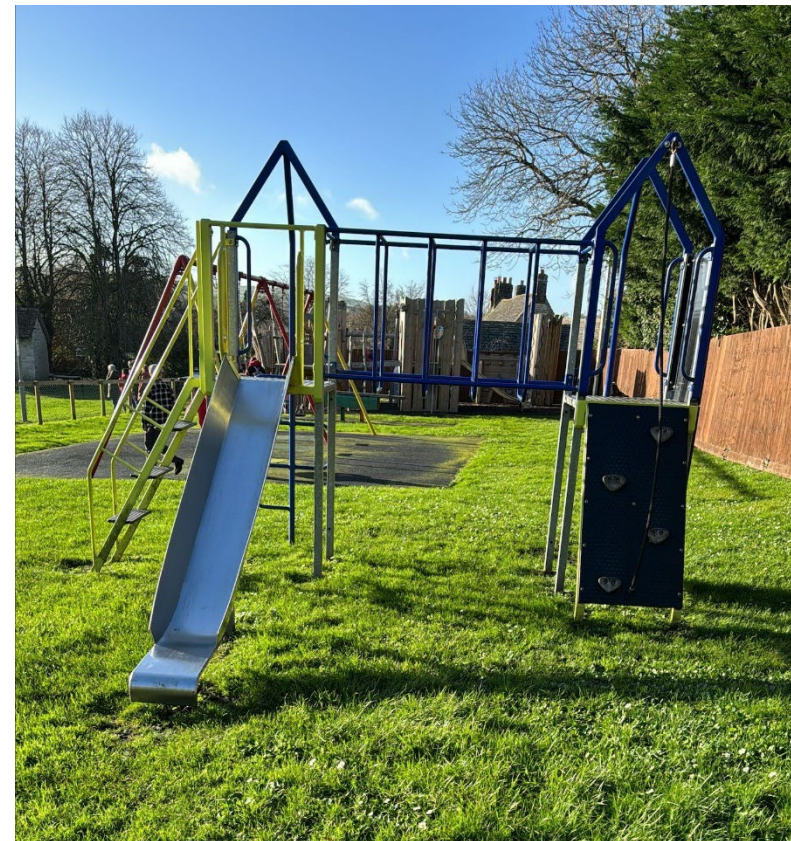
## 4.5 SMP Multi-play unit

There are no significant issues with this unit.

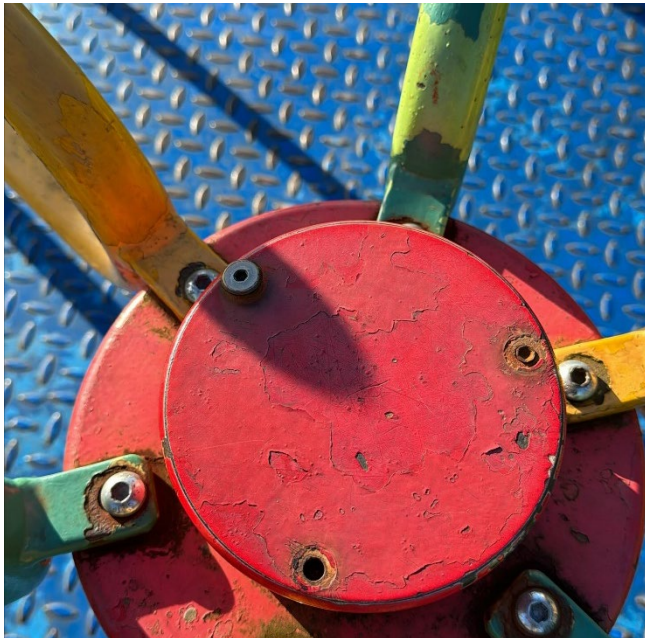
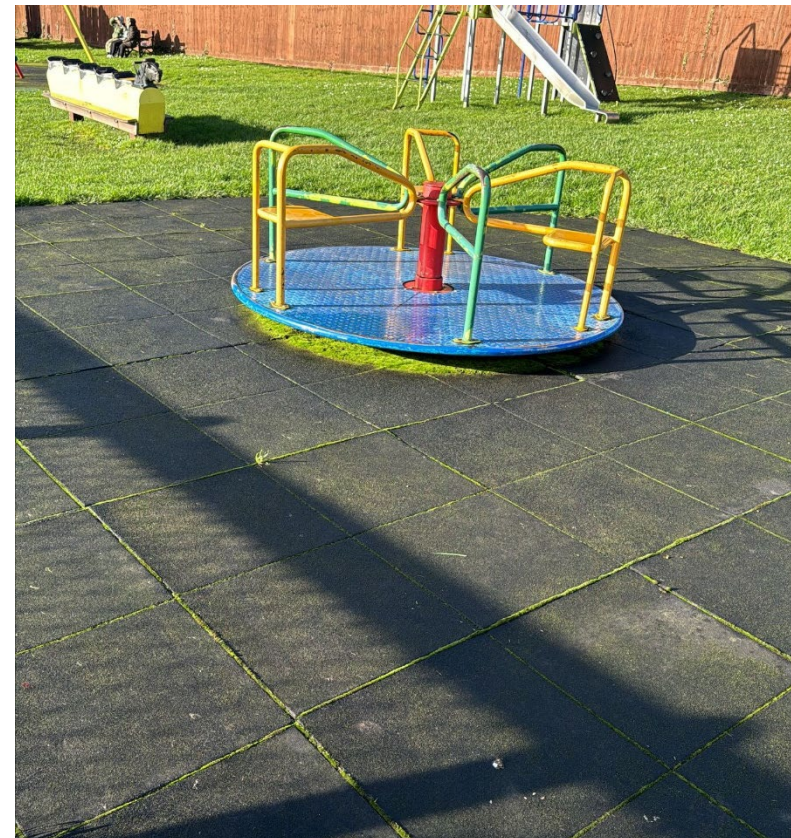
## 4.6 Wicksteed Rotaplay

There are several minor issues with this unit (see Q2 Report) which remain unchanged. There are missing/broken fittings on the cover plate. This is under review for replacement but if the unit is retained then repairs will be required in the next six months which could be problematic as other fittings are now very seized due to age and corrosion.

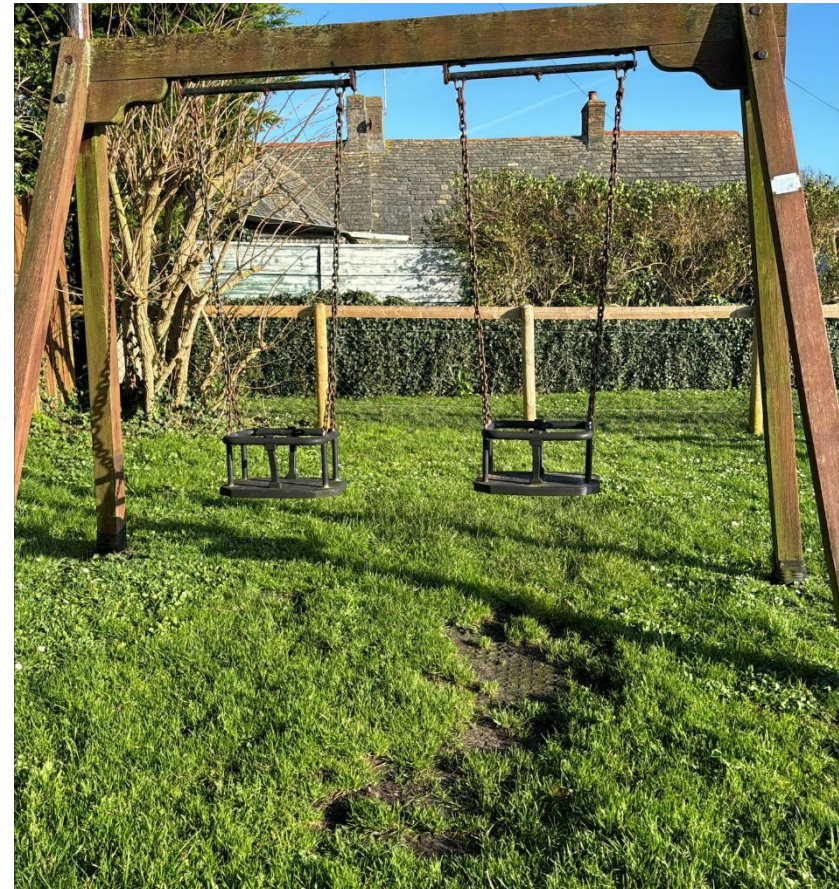
## 4.7 *Taylor Made Toddler Duo*

The timber toddler swing is at the point where it could fail and should be removed / replaced, and tenders are being sought for this work.

There are various issues with this unit (see Q2 report) and tenders are now being sought for a replacement unit.

There are no new issues.

| Item | Issue | Recommendation |
|---|---|---|
| 4.7 | Beyond maintenance | Remove |

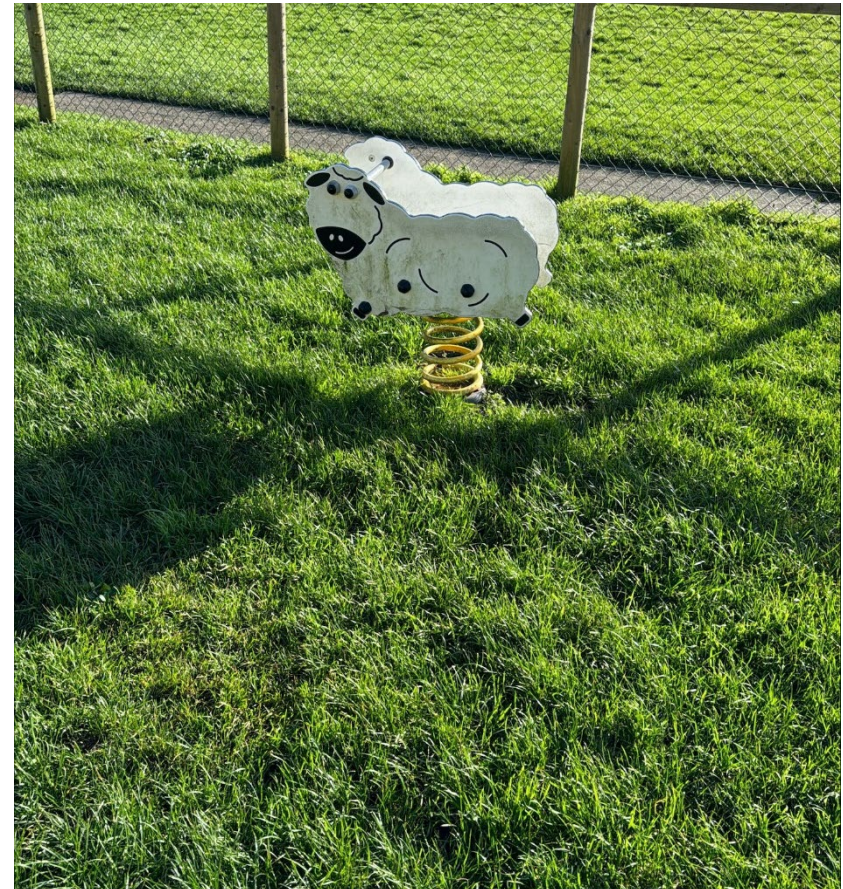
## 4.8 *Fahr Baa (Sheep) Springer*

There are no significant issues.

There is no notable change since Q3.

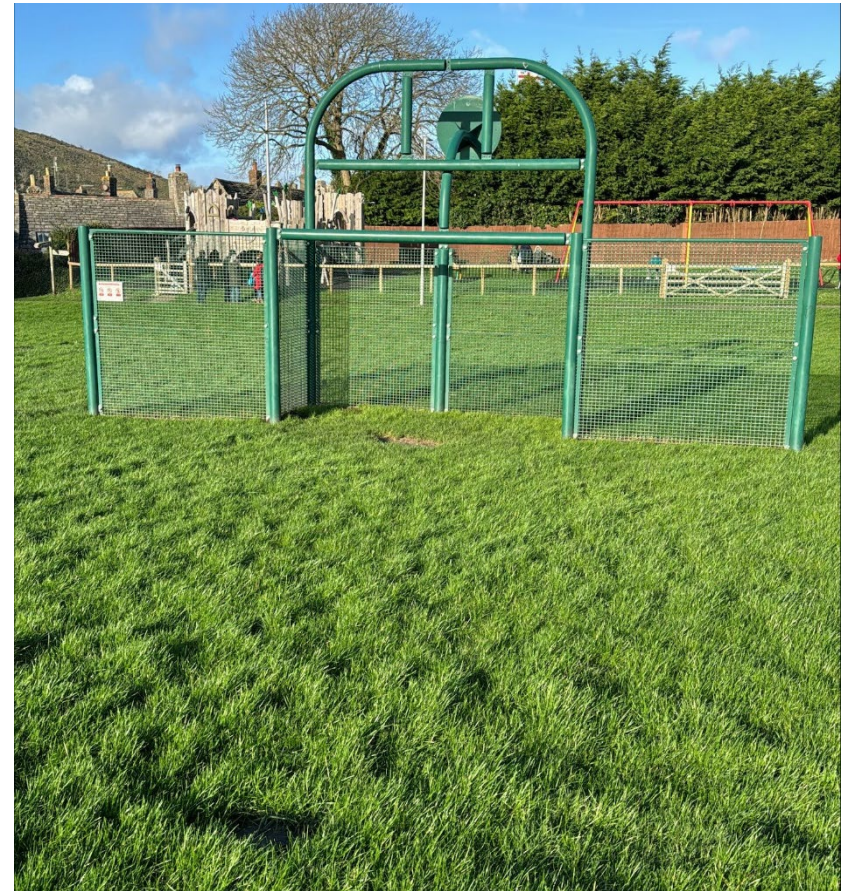
## 4.9 MUGA Goal End

Powder coating on the MUGA end is failing.

There are no issues with this unit other than the condition of the powder coating previously reported.

| Item | Issue | Recommendation |
|---|---|---|
| 4.9 | Powder coating failing | Re-powder coat panels |

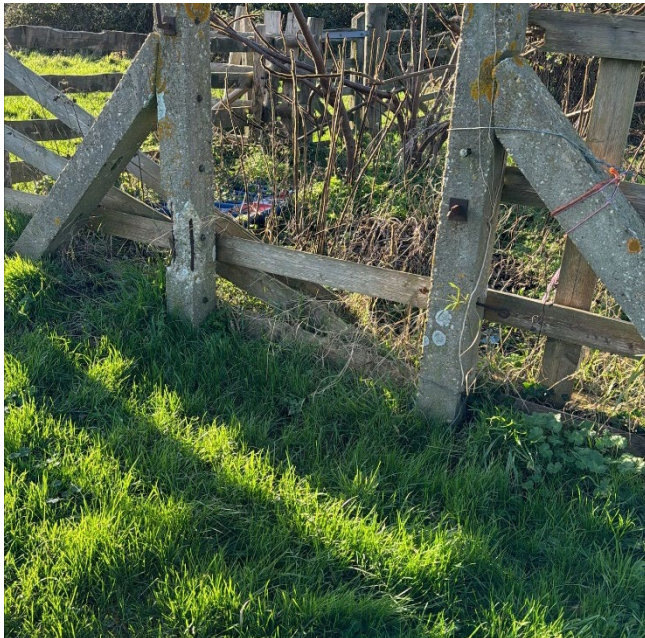
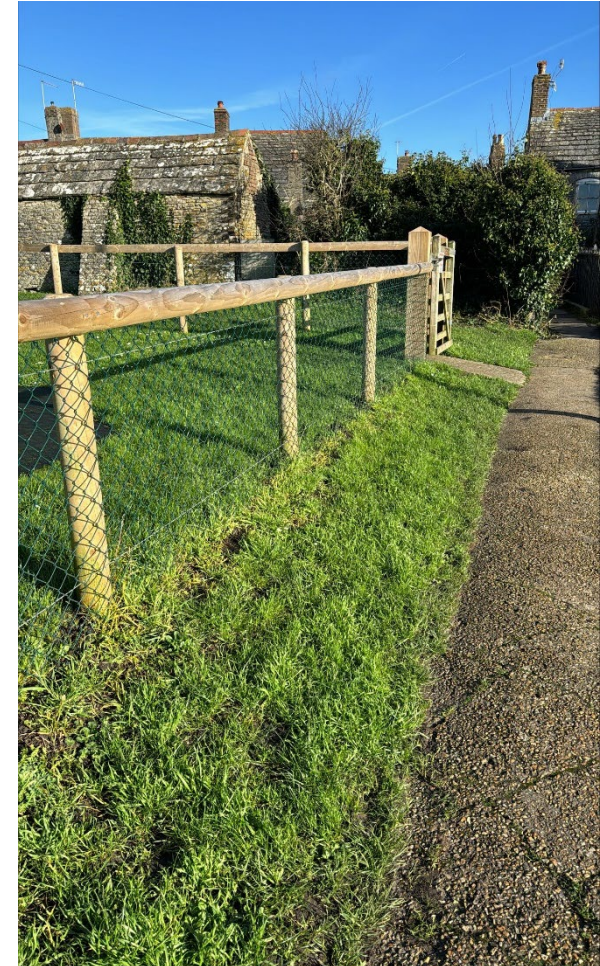
## 4.10 Fencing & Gates

There is an area of disrepair in the fencing near the small car park. It should be noted then when an area is in a state of disrepair it can encourage petty acts of vandalism and the limited investment required to make these small improvements can be worthwhile to prevent more troublesome problems occurring.

There are no significant issues with the gates or most of the fencing.

There is a section of fencing in a state of disrepair next to the parking area which continues to pose a minor hazard.

| Item | Issue | Recommendation |
|---|---|---|
| 4.10 | Damaged area by car park | Repair /Tidy up broken sections |

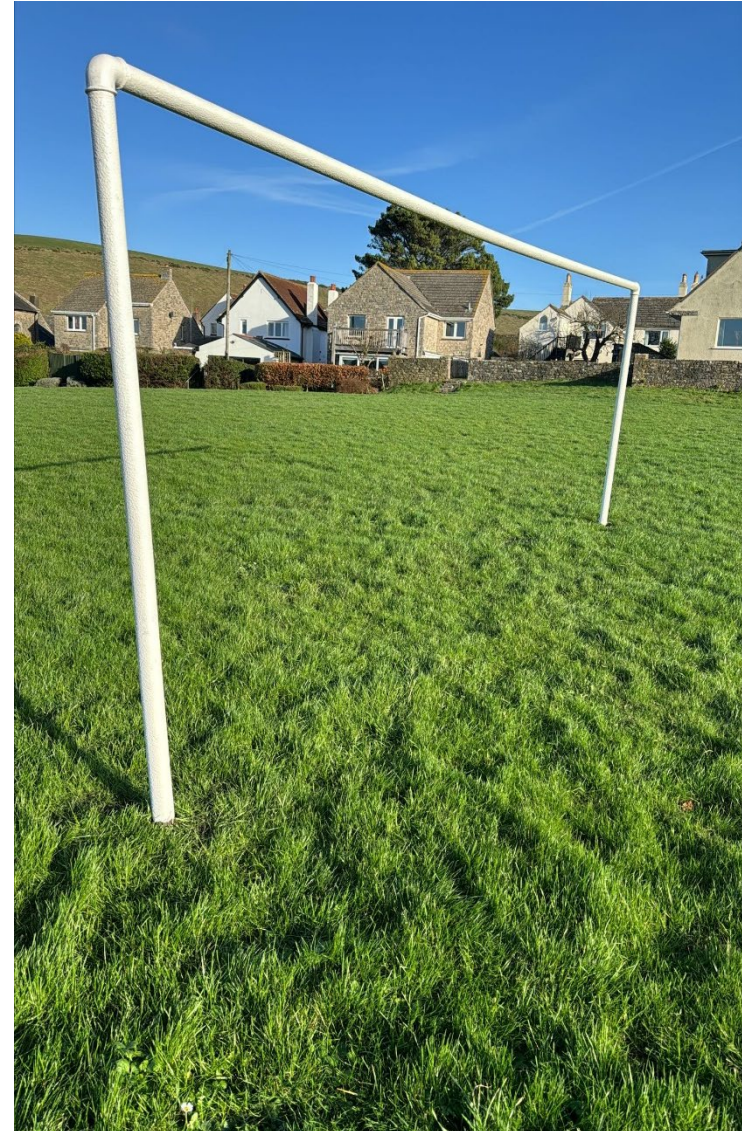
## 4.11 Goal

The visual appearance and protection against corrosion on this unit have been greatly improved by painting.

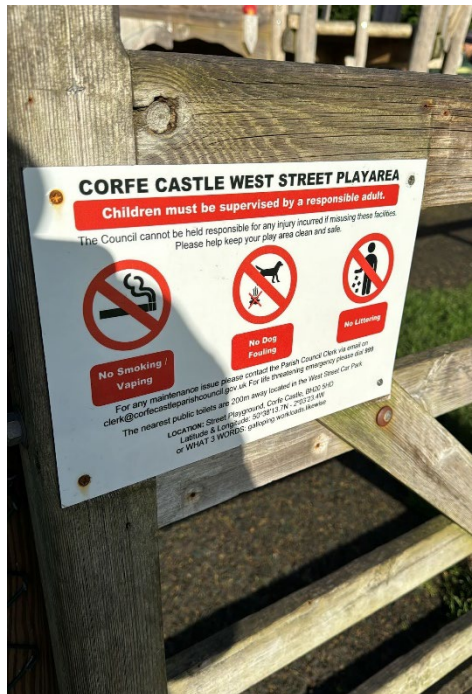
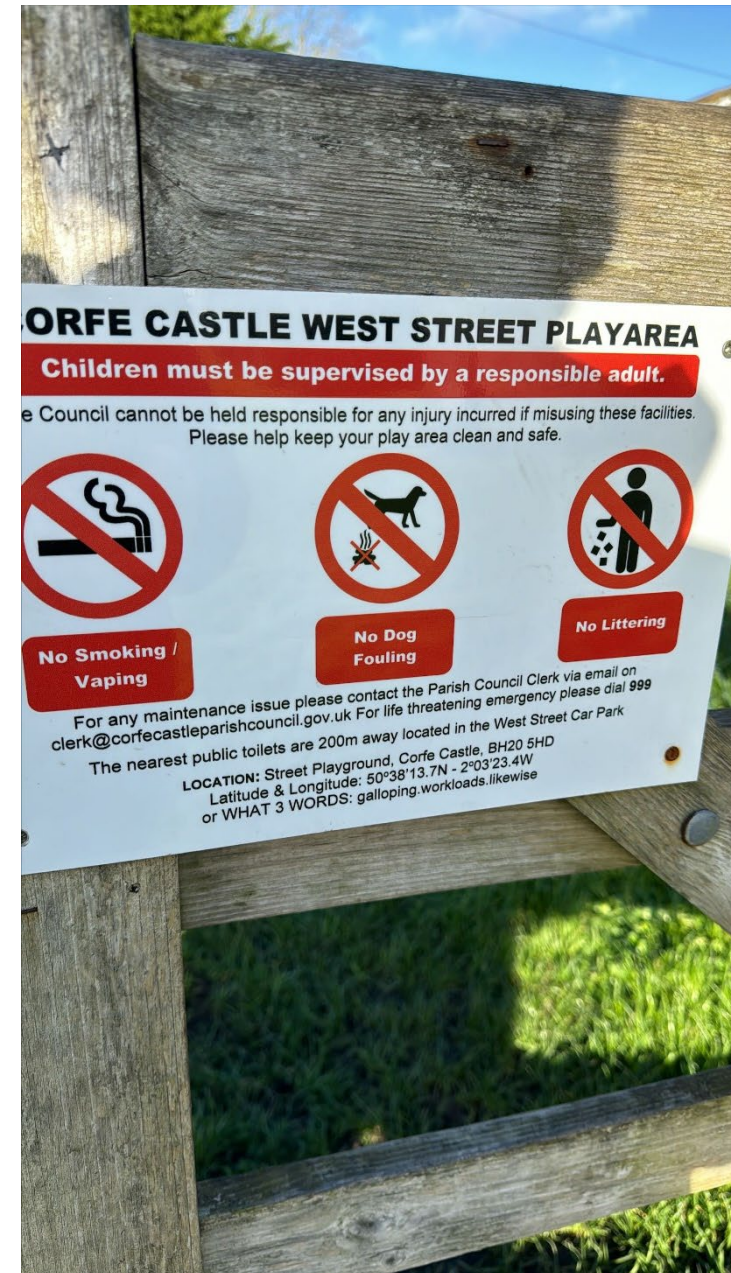
## 4.12 Signage

There is clear sign displaying operator & emergency contact details and location information and this is displayed in several locations.

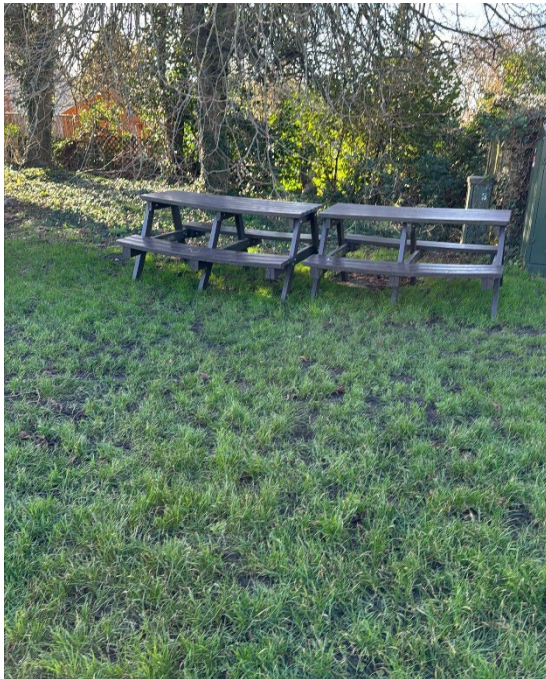
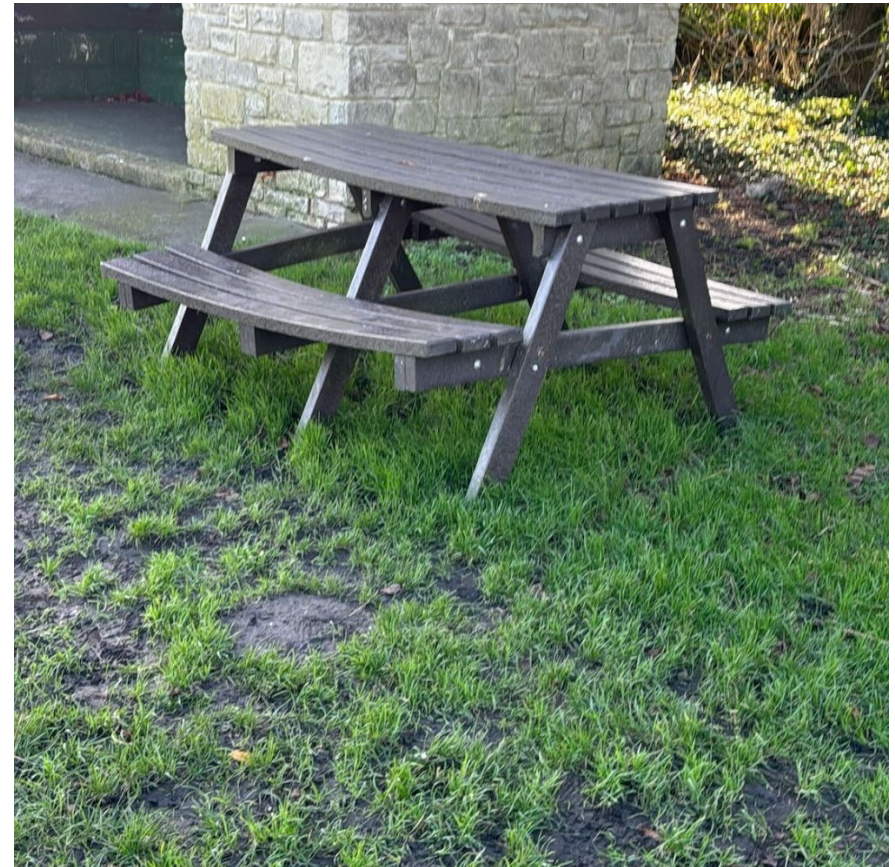
## 4.13 Seating

The picnic tables are twisting and causing additional load on the fixings as well as deforming the plastic. The fixings on these benches will pull free of the plastic if the frame is placed under strain. Investing in more durable recycled plastic benches is a sensible use of Parishioners' funds but only if the units are properly installed and maintained.

Timbers should be regularly treated to prevent decay – the two benches are overdue for this.

| Item | Issue | Recommendation |
|---|---|---|
| 4.13 | Untreated timber | Treat timbers |
| 4.13 | Unsupported tables | Provide bases |

The recycled benches should be reset on a base to prevent strain on the frame. The distortion can be clearly seen in the picture (right).

The wooden benches should be treated against decay.

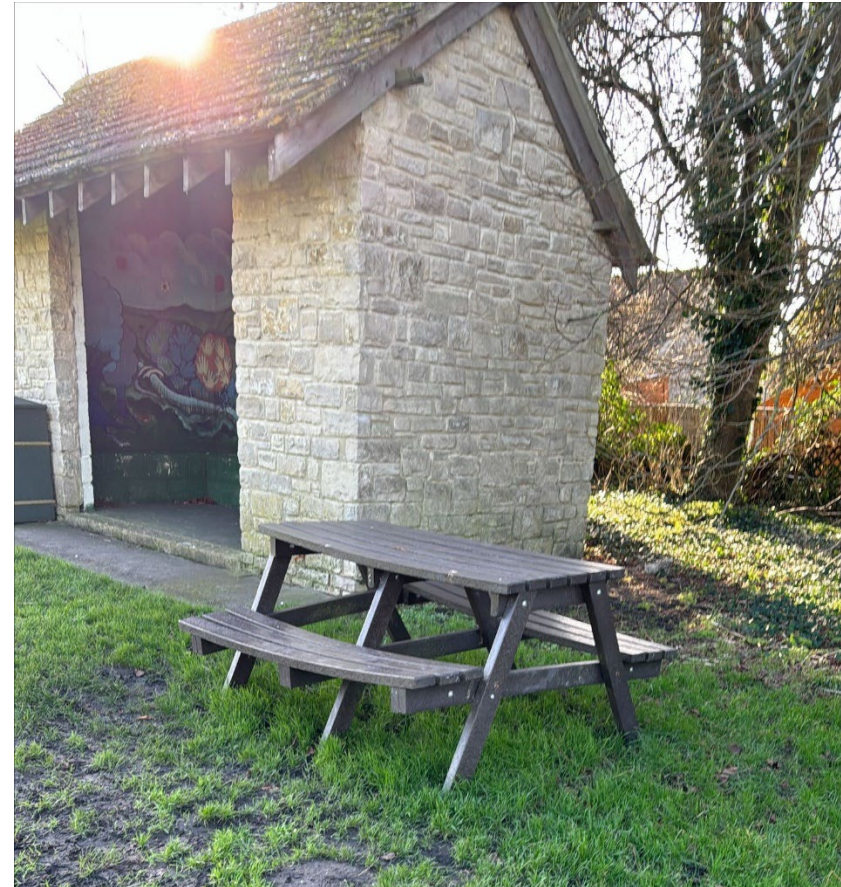
#### 4.14 Ancilliaries

There is stone built shelter with cast seating. There are no obvious issues with this structure.

There is a refuse bin adjacent to the shelter and there are no obvious issues with the bin.
