# *PLAY AREA SAFETY INSPECTION REPORT*

## CORFE CASTLE PARISH COUNCIL

Park Name: West St. Play Area.  
Location: West St. Corfe Castle BH20 5HQ

Inspection undertaken March 2024  
This report issued 16<sup>th</sup> April 2024

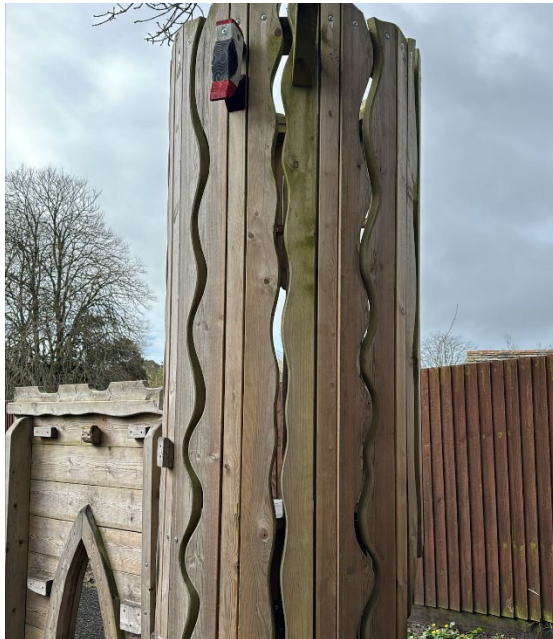
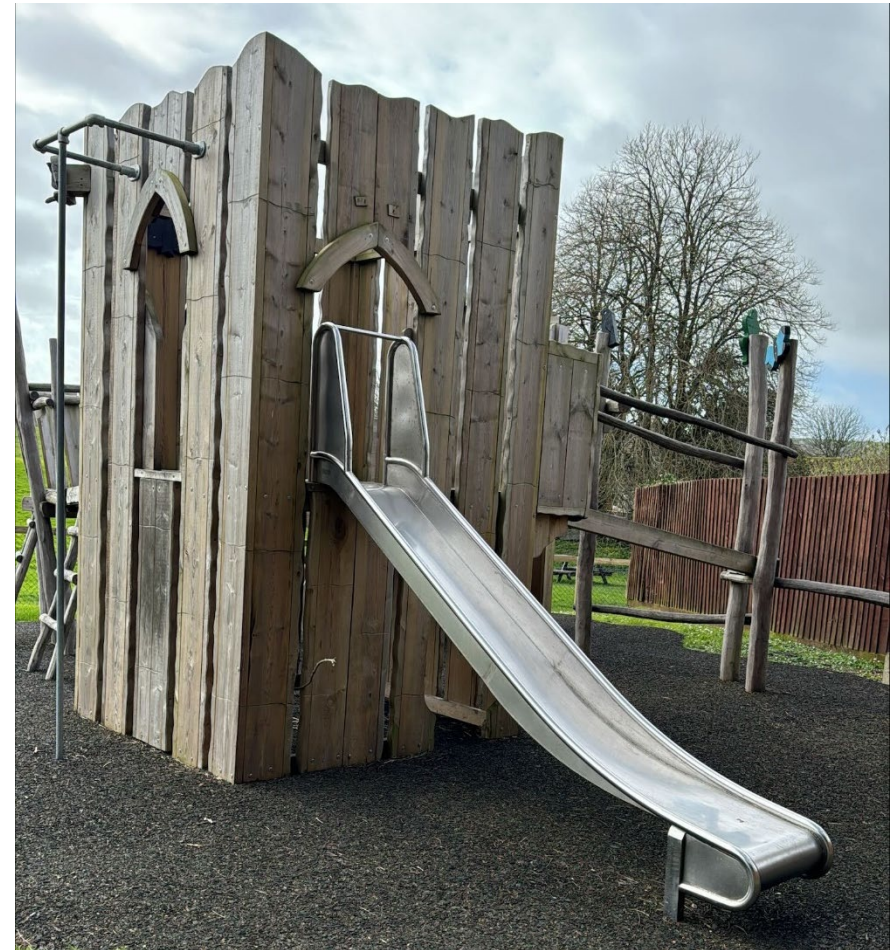
## 4.1 Twin Tower with Slide

There are no significant issues with this unit.

The unit is designed to have challenging elements and as such the higher-level components are not easily accessible. As with any such unit there is a higher risk level associated with its use, but this is within acceptable limits and suitable controls are present.

| Item | Issue | Recommendation |
|---|---|---|
| 4.1 | Fall from height | Monitor use for any reported falls |

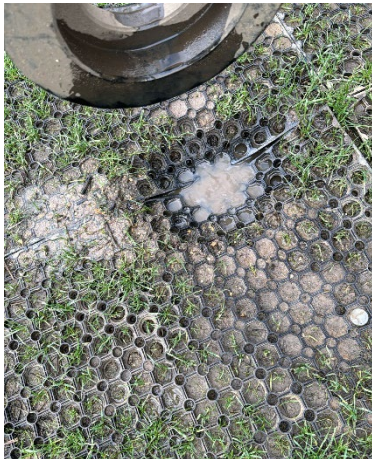
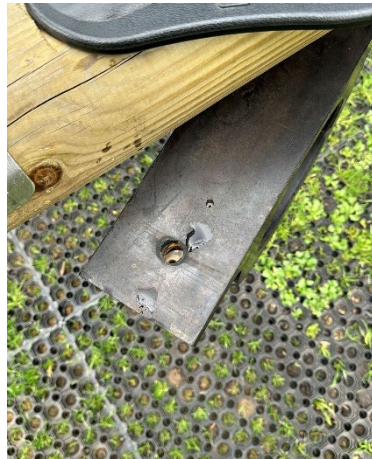
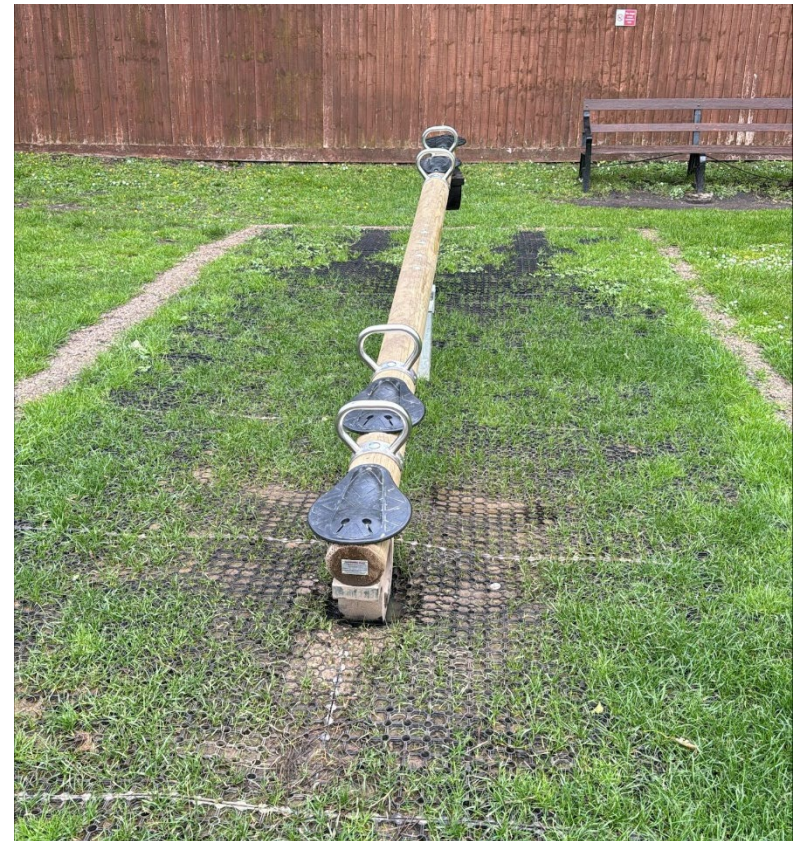
## 4.2 See-Saw

This newly installed item is in reasonable condition. Some post installation corrective action is required and this was notified on the day of inspection. An area of ground had not been sufficiently compacted and a hole had formed below the bump pad. One bump pad had been overtightened without the use of a washer and the screw head had punched through.

| Play Equipment | | | | | |
|---|---|---|---|---|---|
| 9 | See-Saw | Requires attention | 5 /Low | Correct installation errors | Within 3 months |

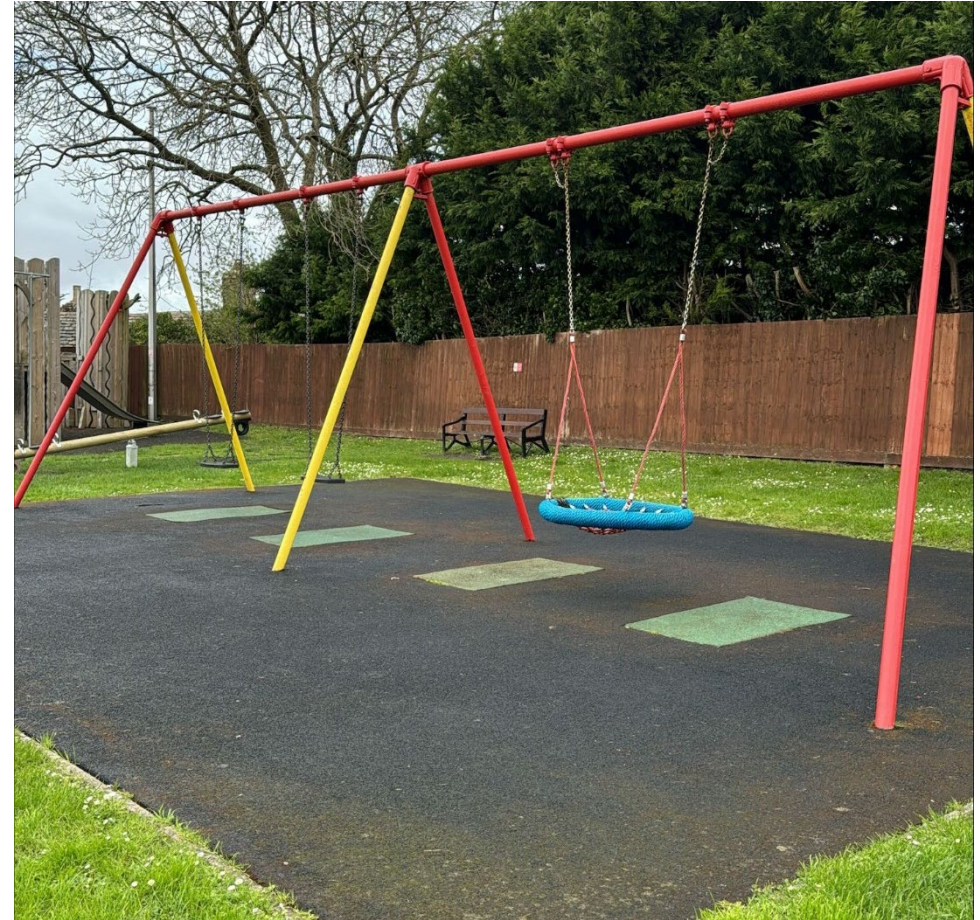
### 4.3 Wicksteed 2 Bay Swing Set

The surfacing on the two-bay swing is in a poor state of repair.

There are no significant issues with this unit other than the surfacing, which is in average condition.

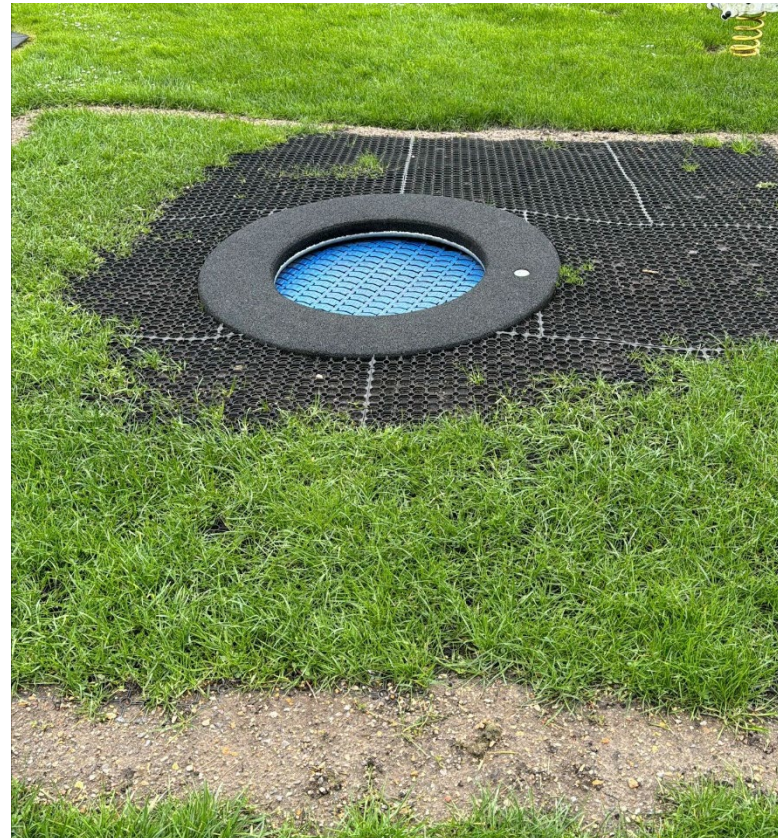
#### 4.4 Round Trampoline – RADO 125

This newly installed item is in excellent condition.

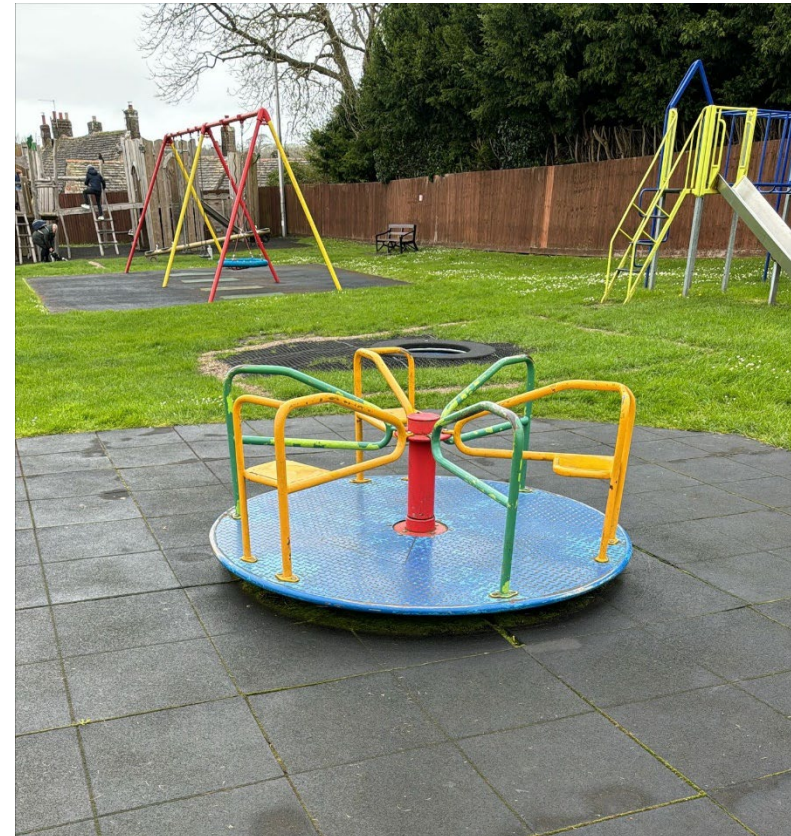
## 4.6 Wicksteed Rotaplay

There are several minor issues with this unit (see Q2 Report) which remain unchanged.

Otherwise this unit is in reasonable condition.

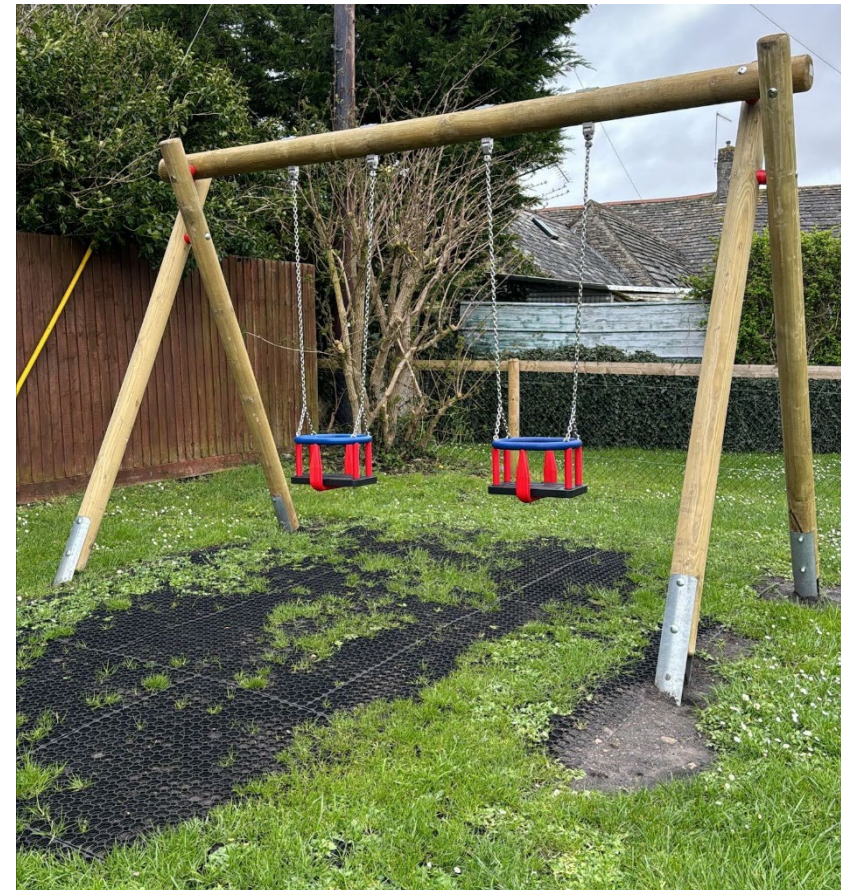
#### 4.7 *Single Bay Toddler swing set*

This newly installed item is in excellent condition.

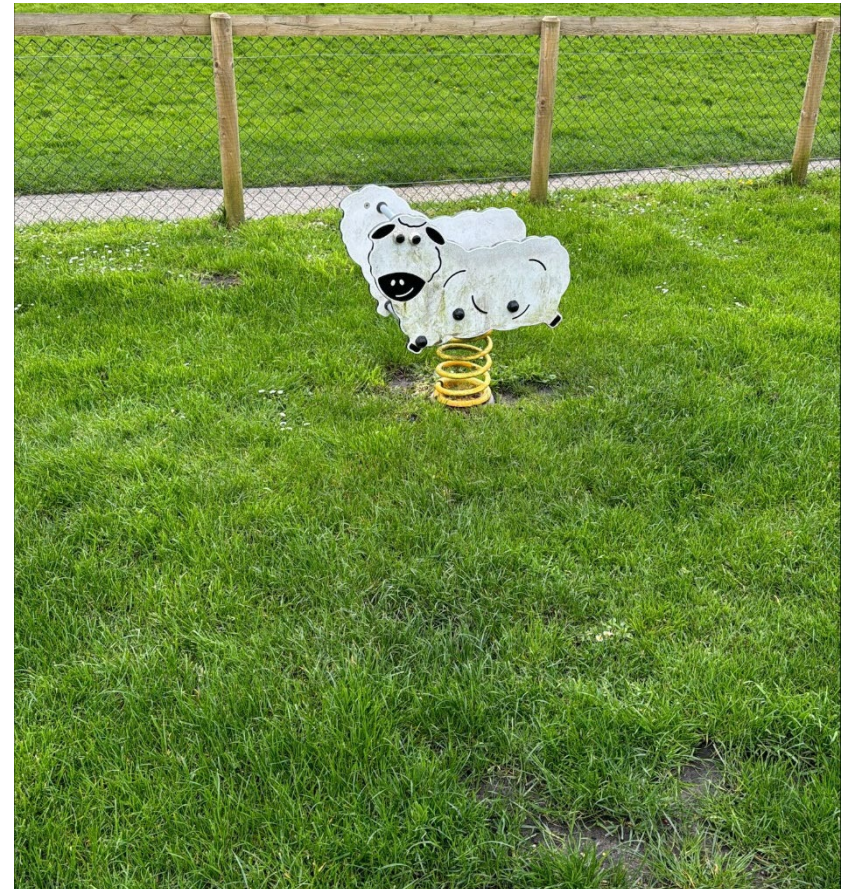
#### 4.8 *Fahr Baa (Sheep) Springer*

This item is in reasonable condition.

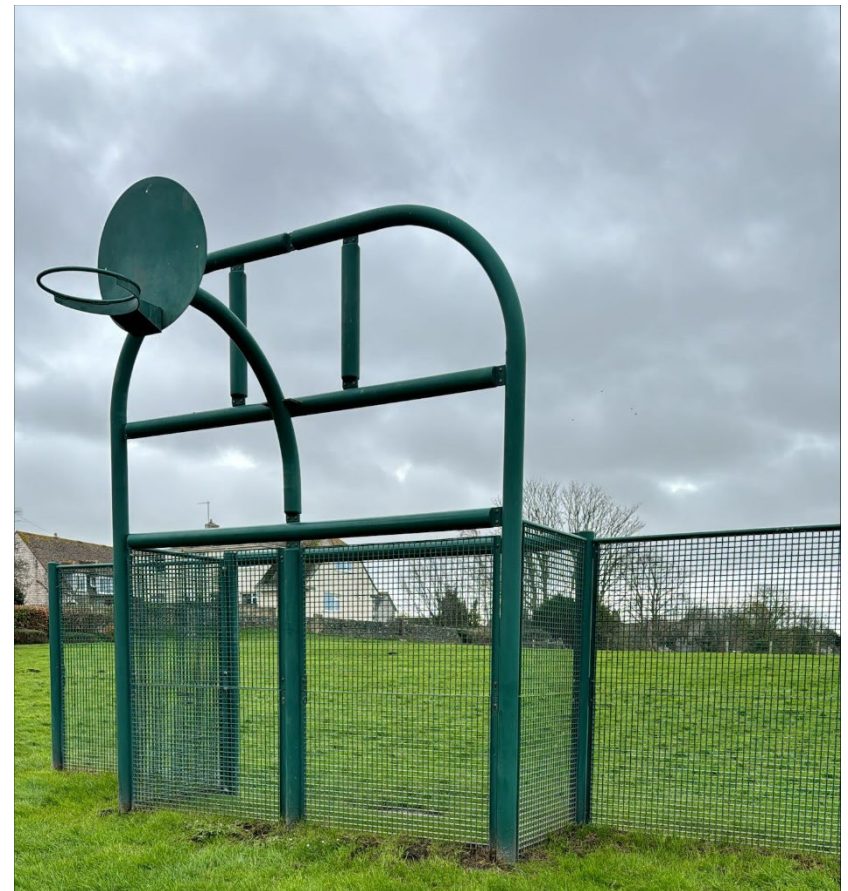
## 4.9 MUGA Goal End

Powder coating on the MUGA end is failing.

There are no issues with this unit other than the condition of the powder coating previously reported.

| Item | Issue | Recommendation |
|---|---|---|
| 4.9 | Powder coating failing | Re-powder coat panels |

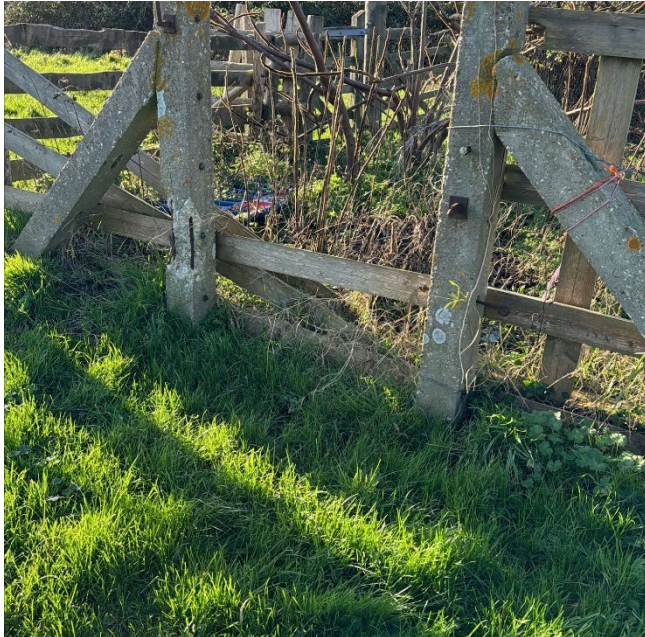
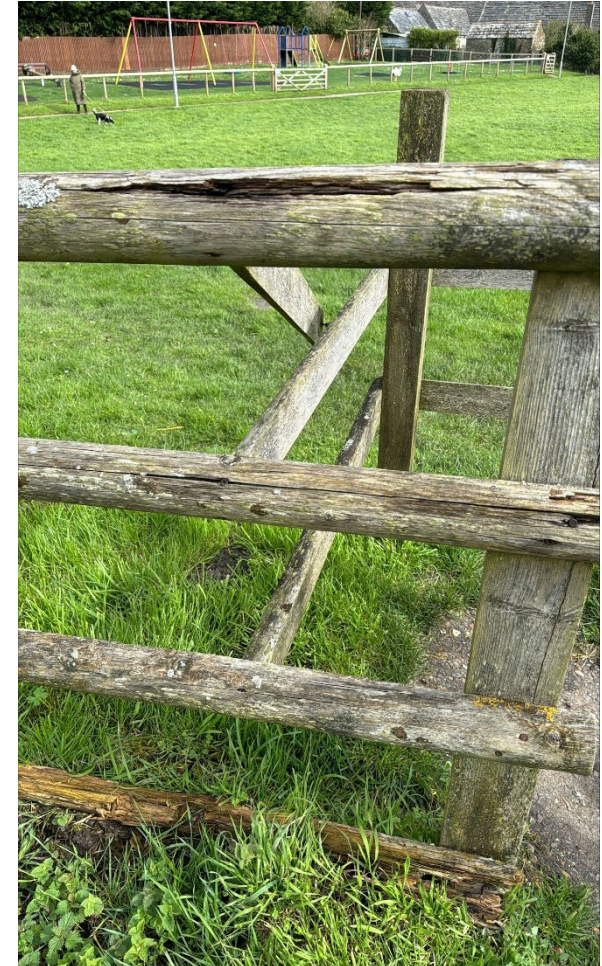
## 4.10 Fencing & Gates

There is an area of disrepair in the fencing near the small car park. The gate at this location is now loose in the ground. This area requires attention as the failing timbers will expose fixings such as nails as they further decay which could pose a risk of more significant injury.

There are no significant issues with the gates or most of the fencing other than the kissing gate from the car park area which is now decaying and is loose in the ground.

There is a section of fencing in a state of disrepair next to the parking area which continues to pose a minor hazard.

| Item | Issue | Recommendation |
|---|---|---|
| 4.10 | Damaged area by car park | Repair /Tidy up broken sections |

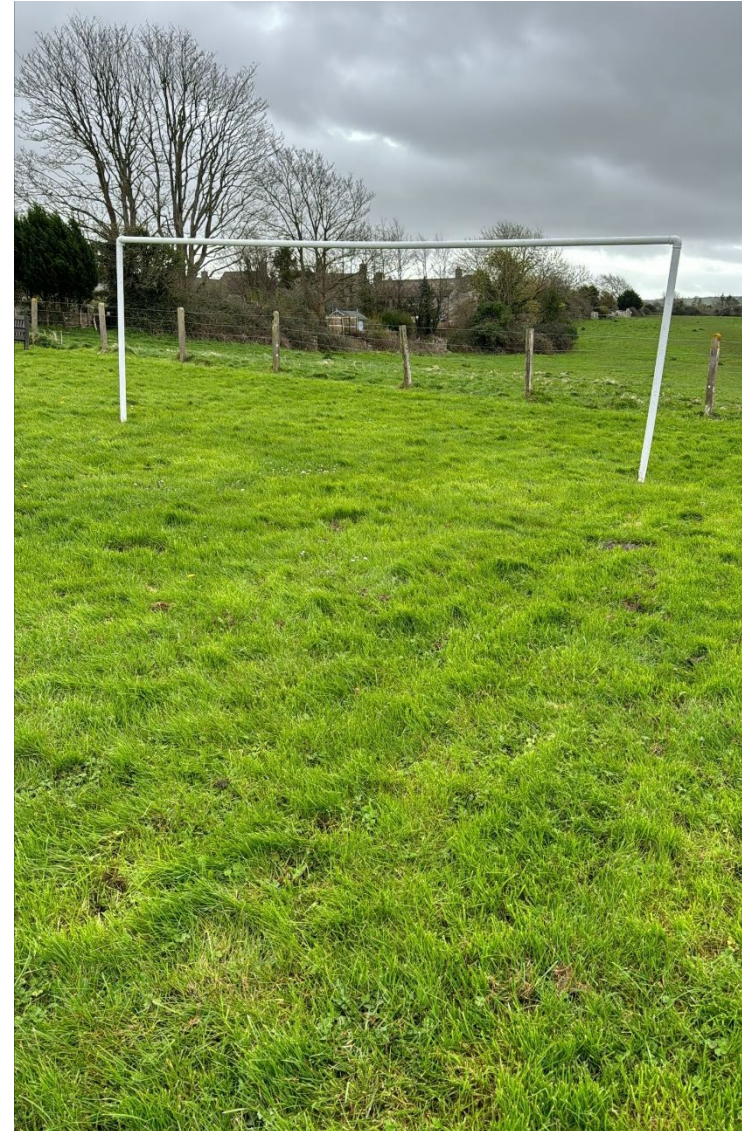
## 4.11 Goal

This unit is in average condition.

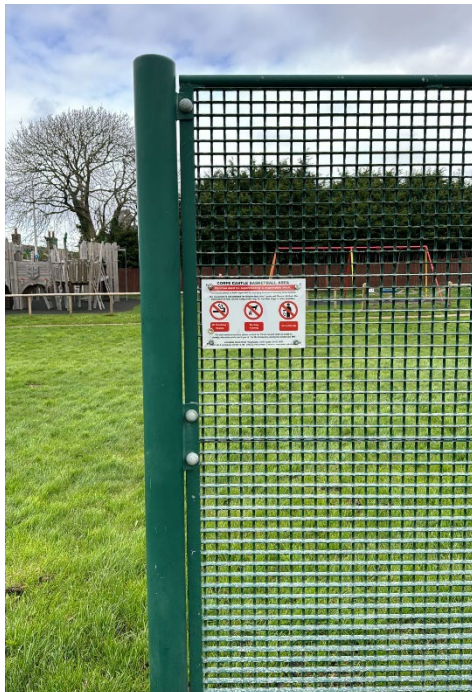
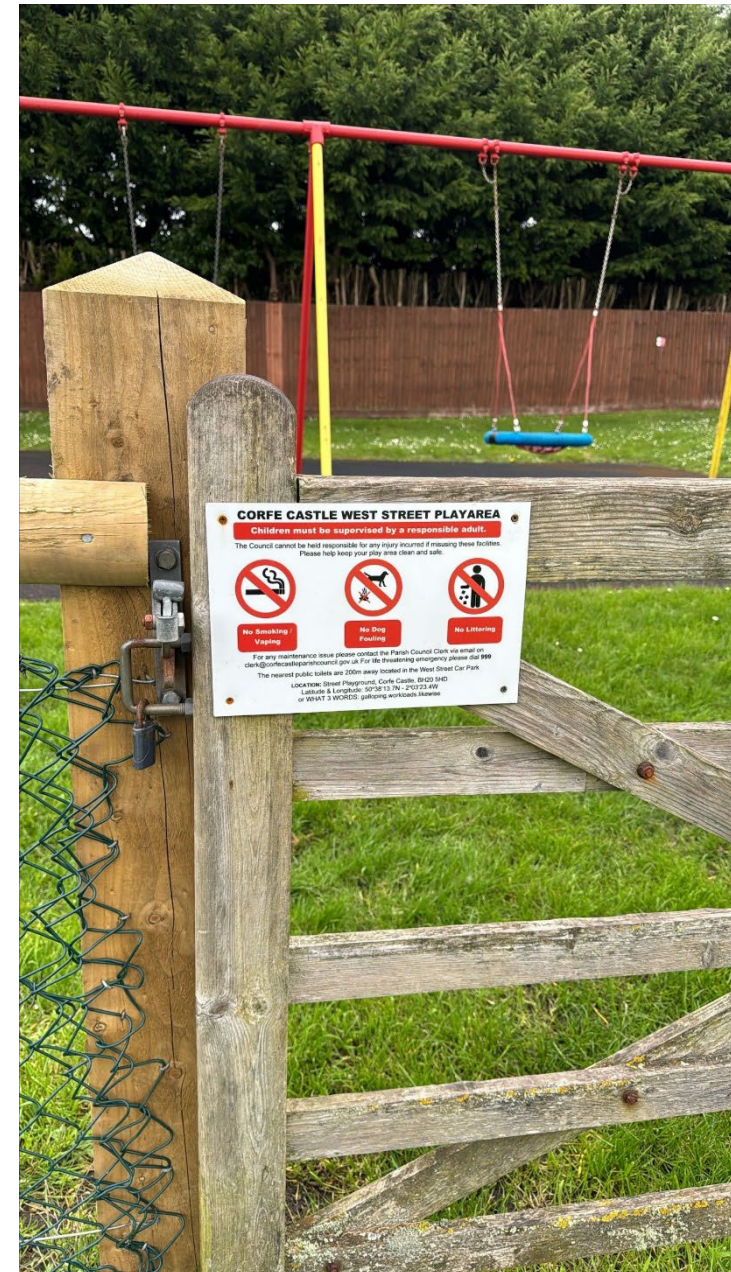
## 4.12 Signage

There is clear sign displaying operator & emergency contact details and location information and this is displayed in several locations.

There is an appropriate sign displayed on the MUGA goal end.

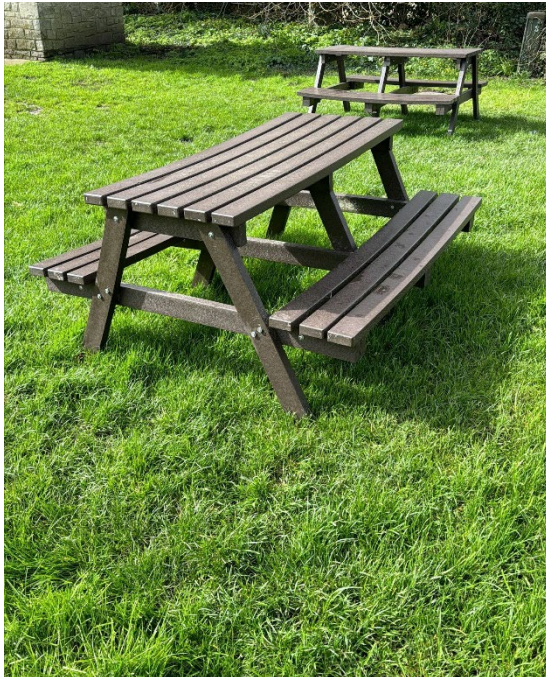
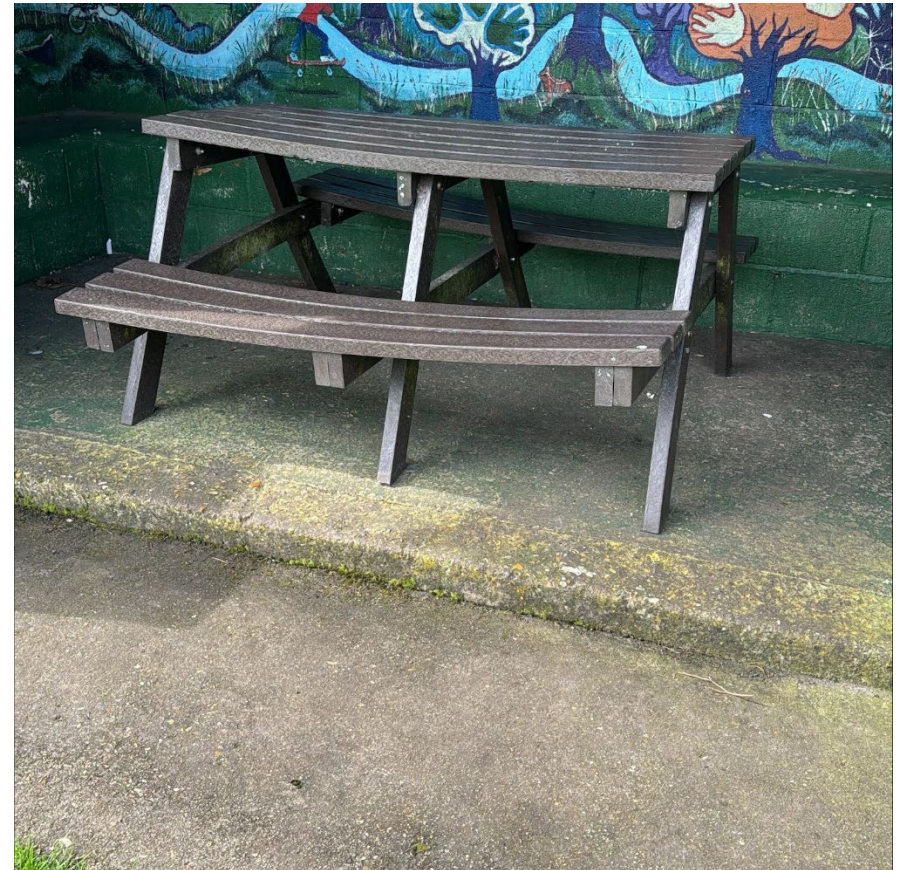
## 4.13 Seating

The picnic tables are twisting and causing additional load on the fixings as well as deforming the plastic. The fixings on these benches will pull free of the plastic if the frame is placed under strain. Investing in more durable recycled plastic benches is a sensible use of Parishioners' funds but only if the units are properly installed and maintained.

One recycled bench has been moved into the shelter (whether by user or by design is unknown) and the effect of the previous distortion can be clearly seen in the picture (right).

| Item | Issue | Recommendation |
|---|---|---|
| 4.13 | Untreated timber | Treat timbers |
| 4.13 | Unsupported tables | Provide bases |

Consideration should be given to setting the tables on bases and fixing them in position.

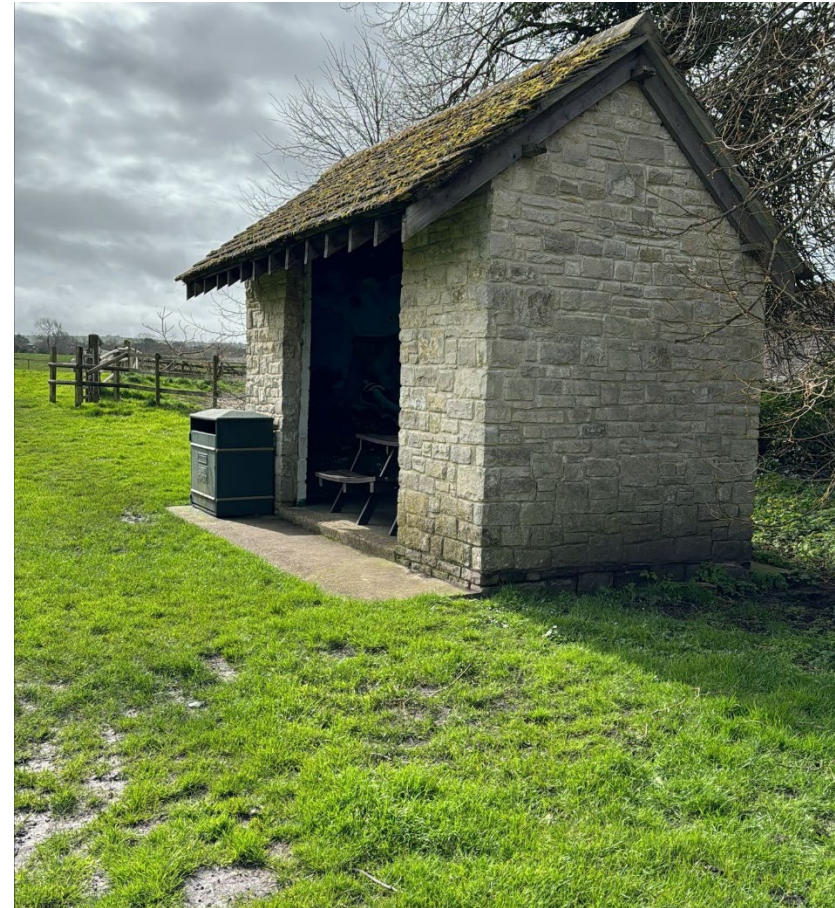
#### 4.14 Ancilliaries

There is stone built shelter with cast seating. There are no obvious issues with this structure.

There is a refuse bin adjacent to the shelter and there are no obvious issues with the bin.
