# *PLAY AREA SAFETY INSPECTION REPORT*

## CORFE CASTLE PARISH COUNCIL

Park Name: West St. Play Area.  
Location: West St. Corfe Castle BH20 5HQ

Inspection undertaken June 2024  
This report issued 8<sup>th</sup> August 2024

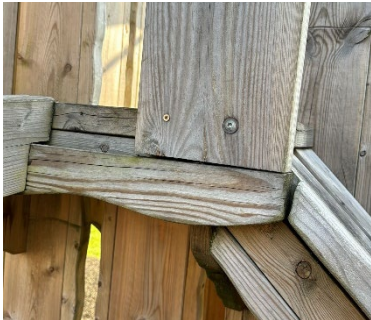
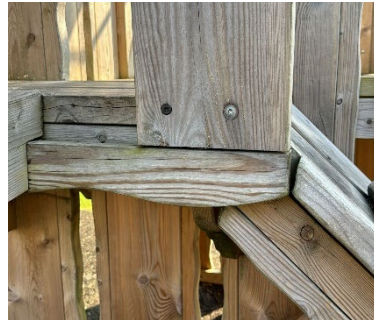
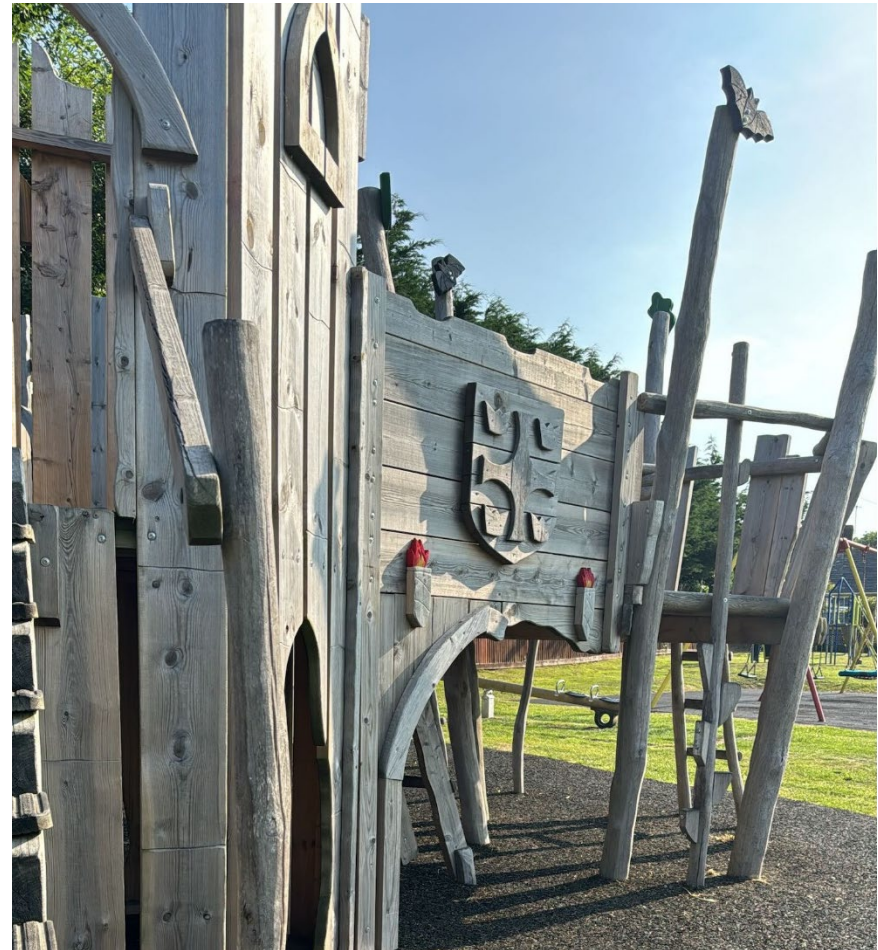
## 4.1 Twin Tower with Slide

| Play Equipment | | | | | |
|---|---|---|---|---|---|
| 8 | AF Play Tower | Satisfactory | 6 /Low | Keep suitably maintained /Monitor | Ongoing |

There are no significant issues with this unit.

One loose section of rail was identified and repaired during the inspection.

| Item | Issue | Recommendation |
|---|---|---|
| 4.1 | Fall from height | Monitor use for any reported falls |

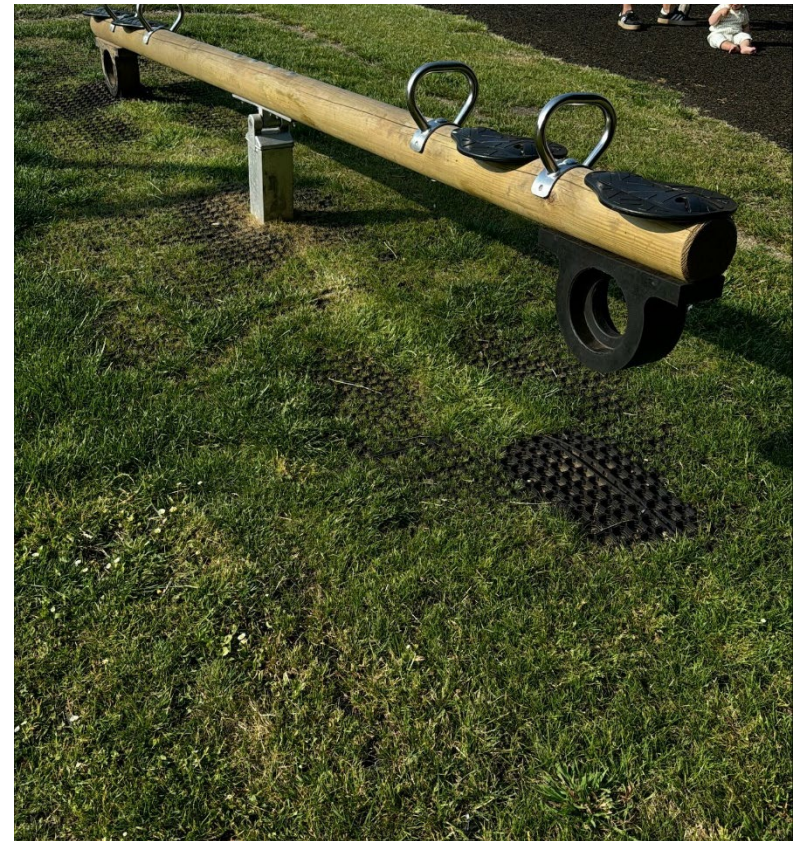
## 4.2 See-Saw

This newly installed item is in good condition.

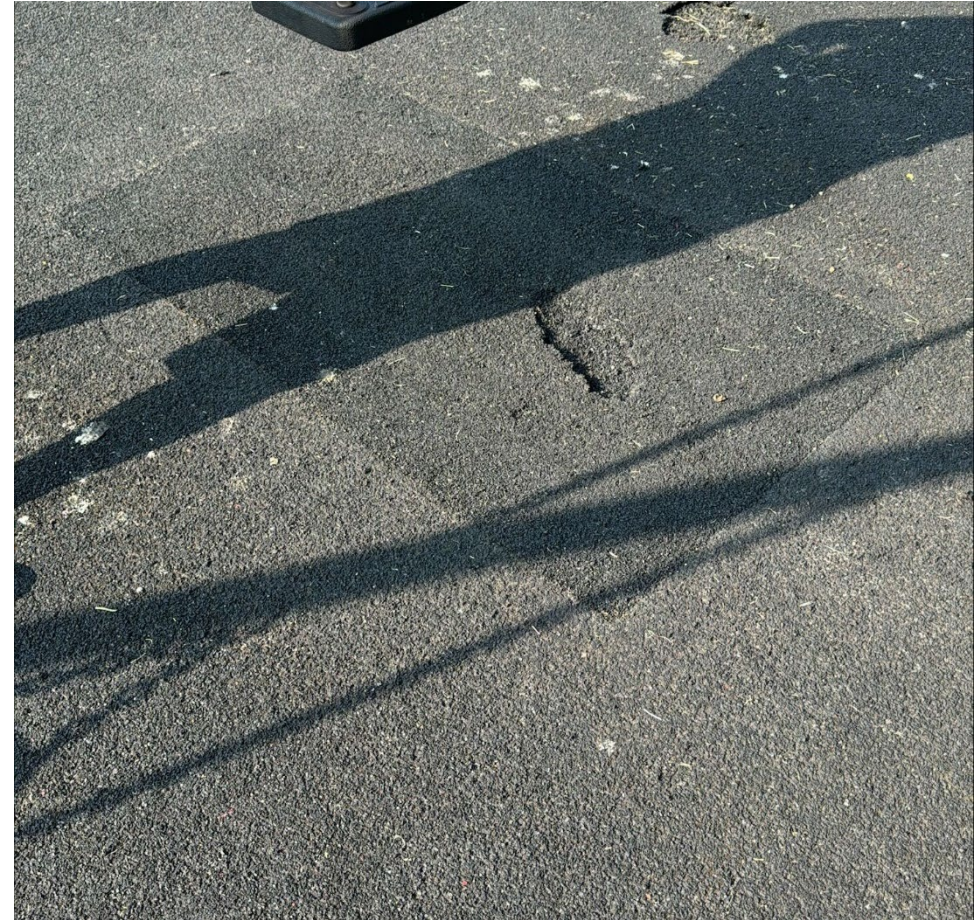
### 4.3 Wicksteed 2 Bay Swing Set

The surfacing on the two-bay swing has been repaired.

There are no significant issues with this unit other than the surfacing, which was undergoing repairs at the time of the inspection.

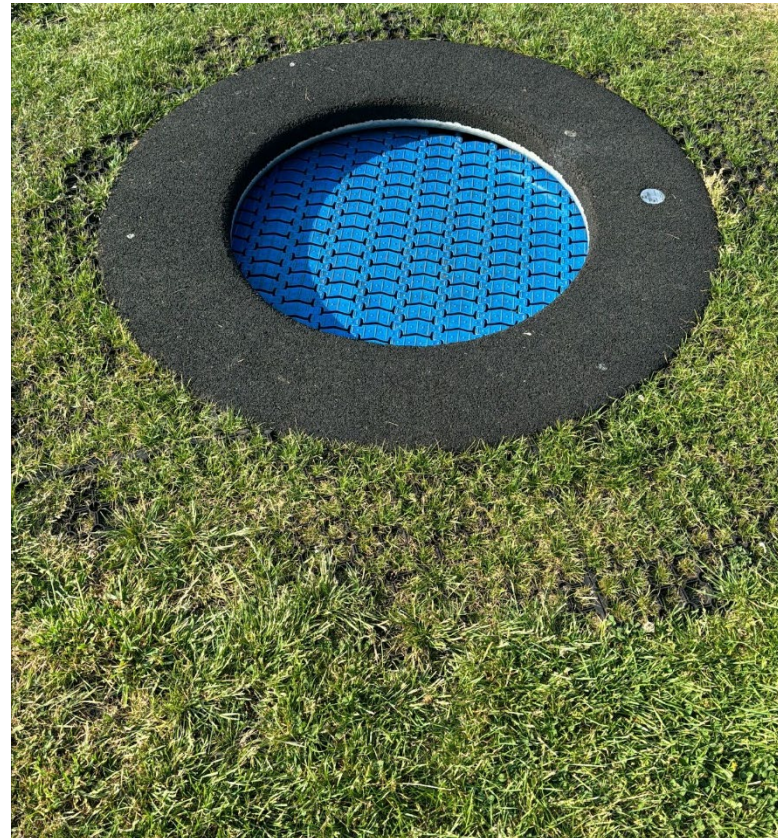
#### 4.4 Round Trampoline – RADO 125

This item is in excellent condition.

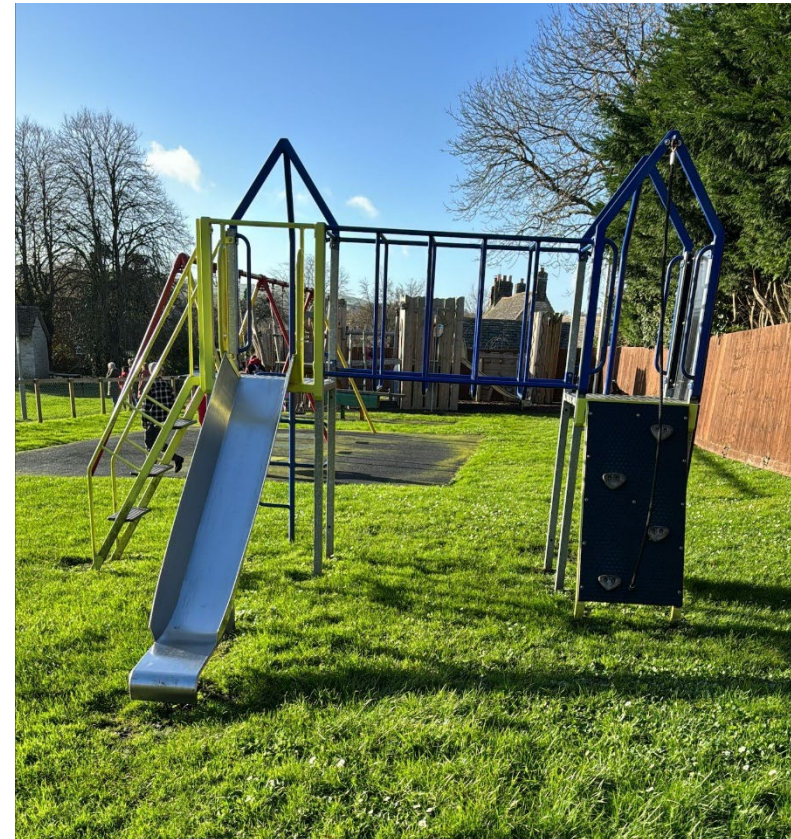
## 4.5 SMP Multi-play unit

There are no significant issues with this unit.

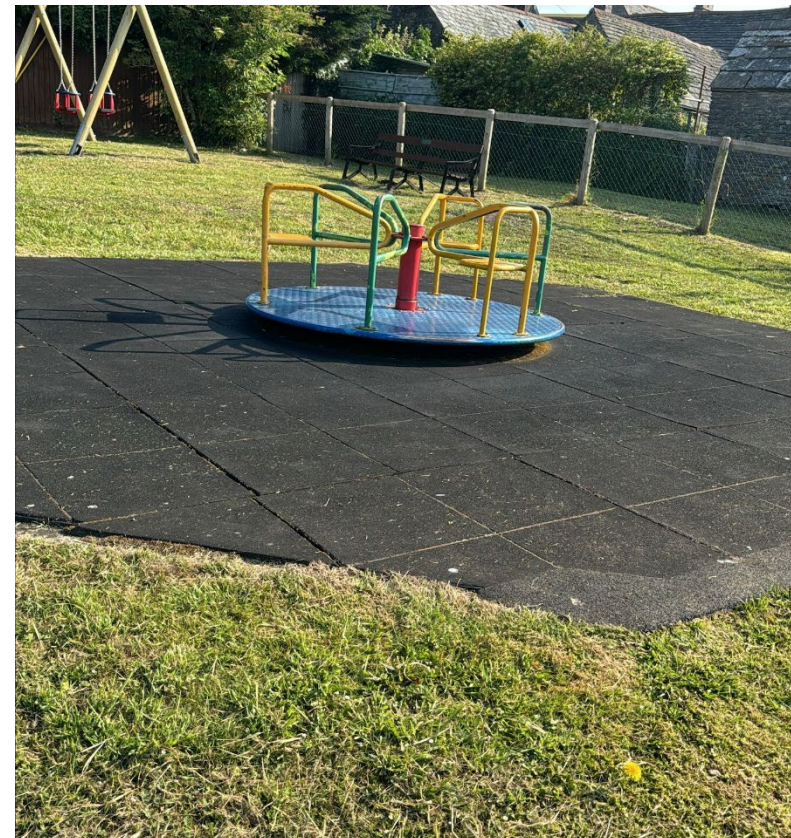
## 4.6 Wicksteed Rotaplay

There are several minor issues (previously reported) with this unit which is otherwise in reasonable condition.

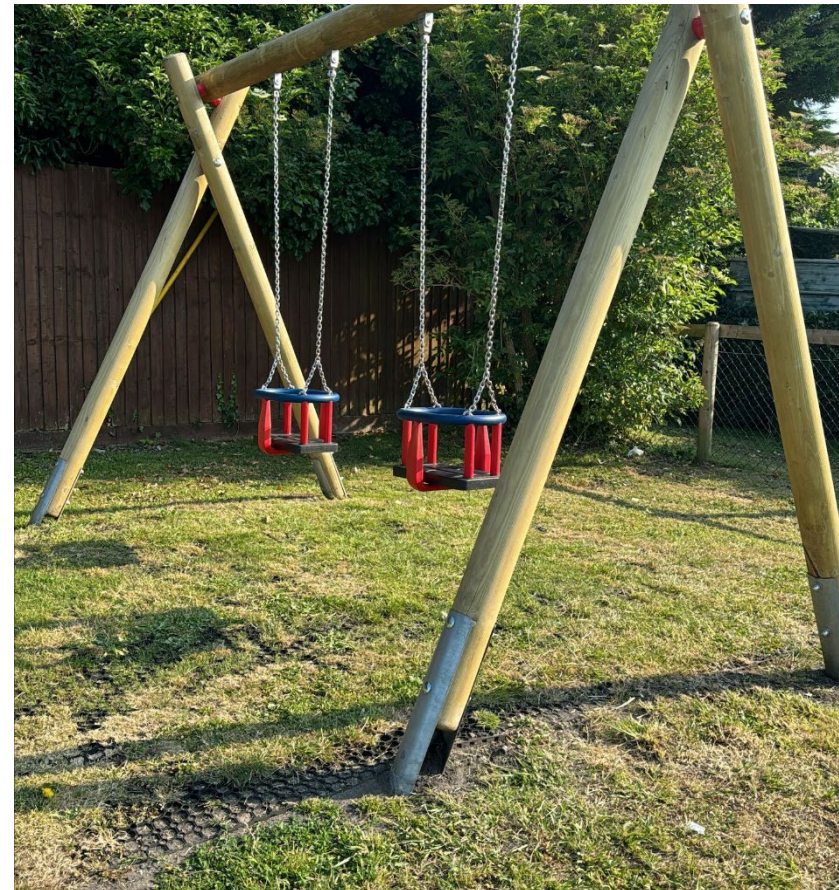
#### **4.7 Single Bay Toddler swing set**

This item is in excellent condition.

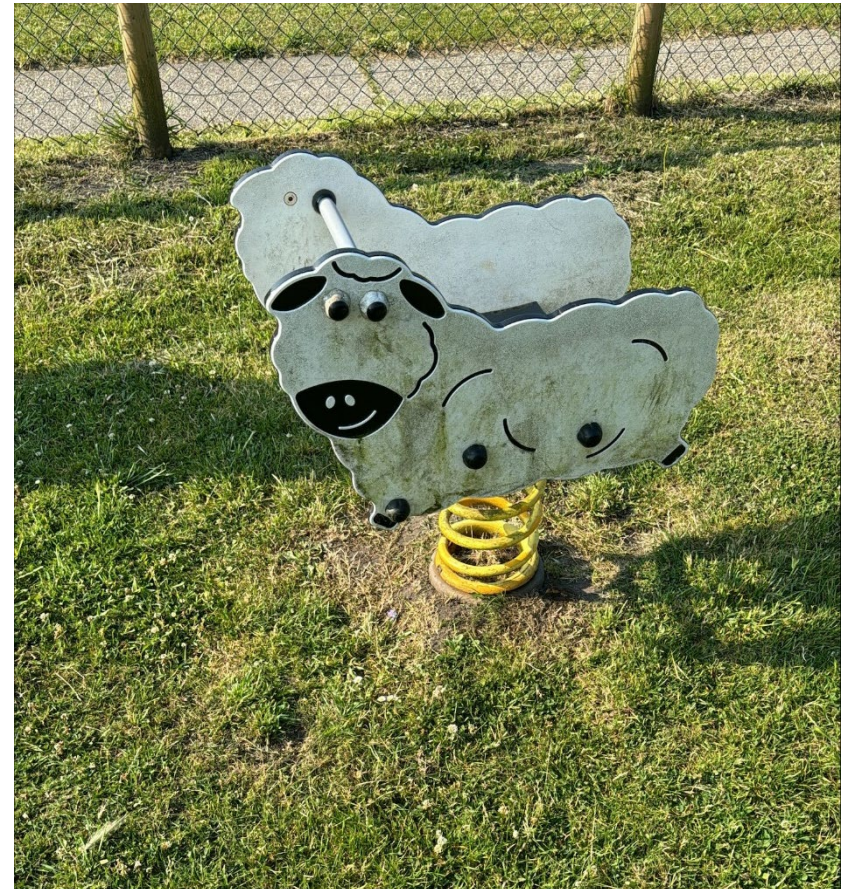
#### 4.8 *Fahr Baa (Sheep) Springer*

This item is in reasonable condition.

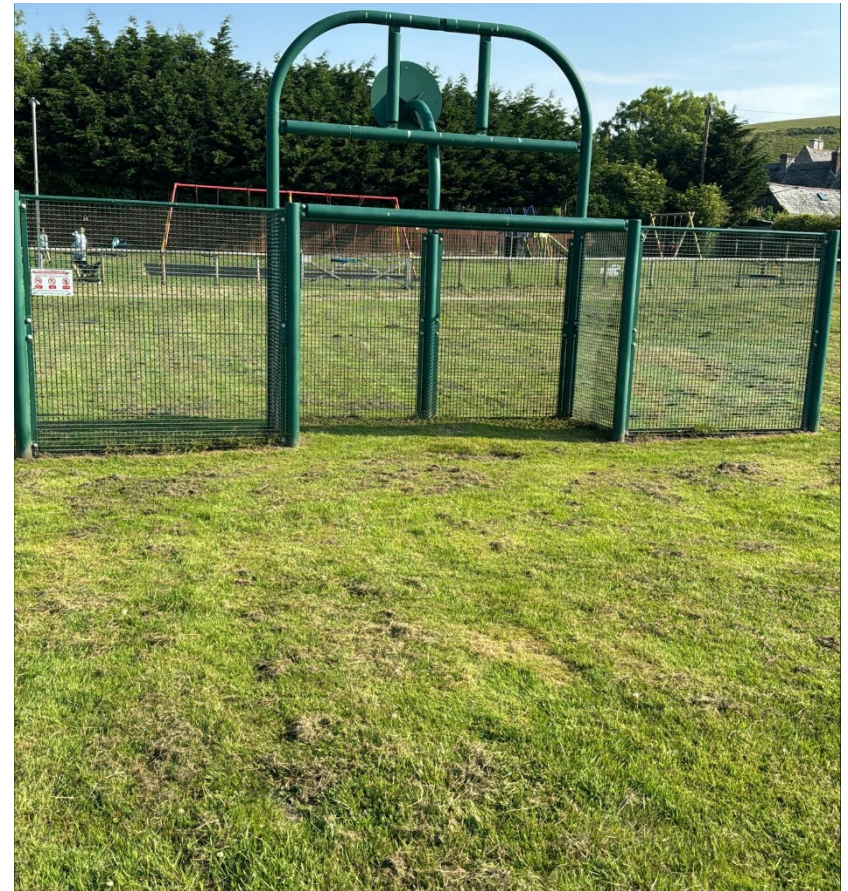
## 4.9 MUGA Goal End

Powder coating on the MUGA end is failing.

There are no issues with this unit other than the condition of the powder coating previously reported.

| Item | Issue | Recommendation |
|---|---|---|
| 4.9 | Powder coating failing | Re-powder coat panels |

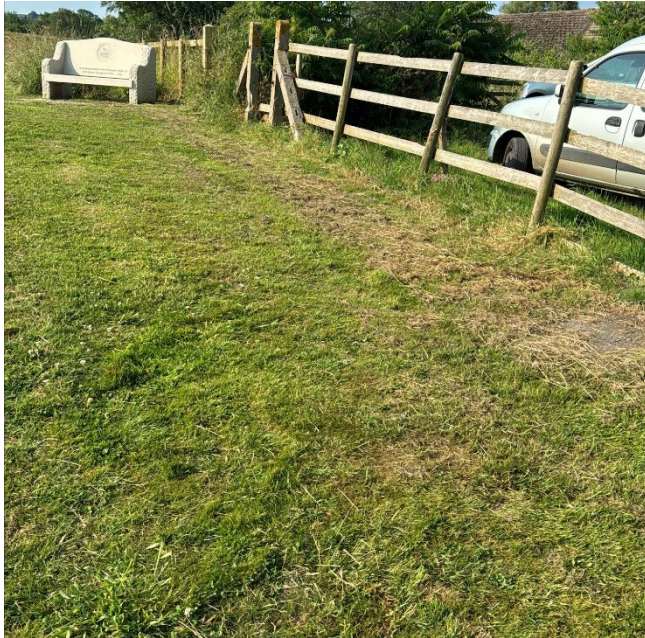
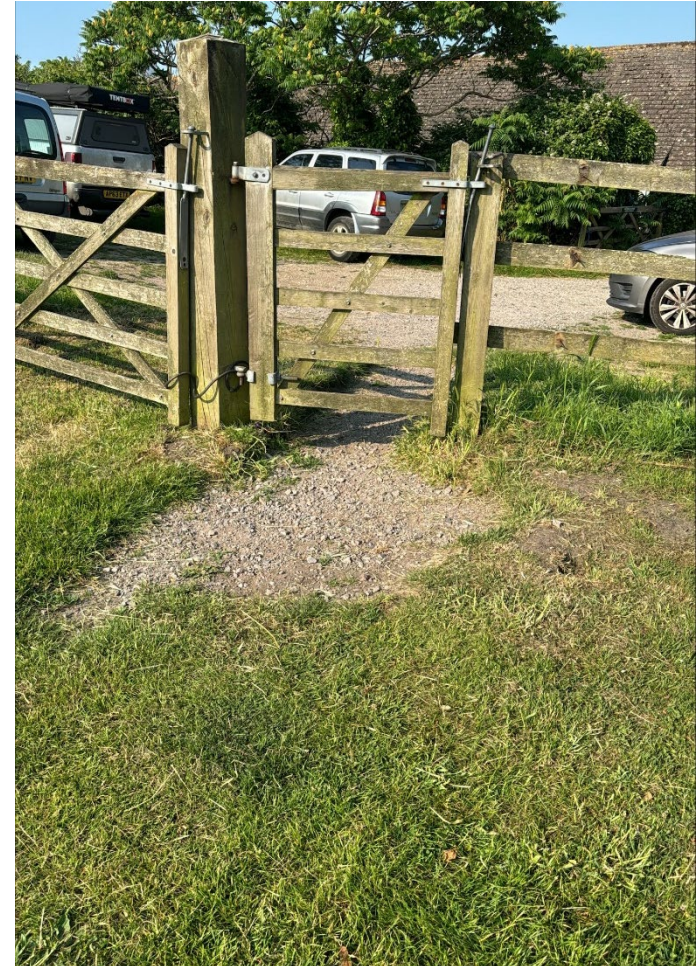
## 4.10 Fencing & Gates

The fencing is mostly in good condition. There is still one small section in need of attention next to the car park.

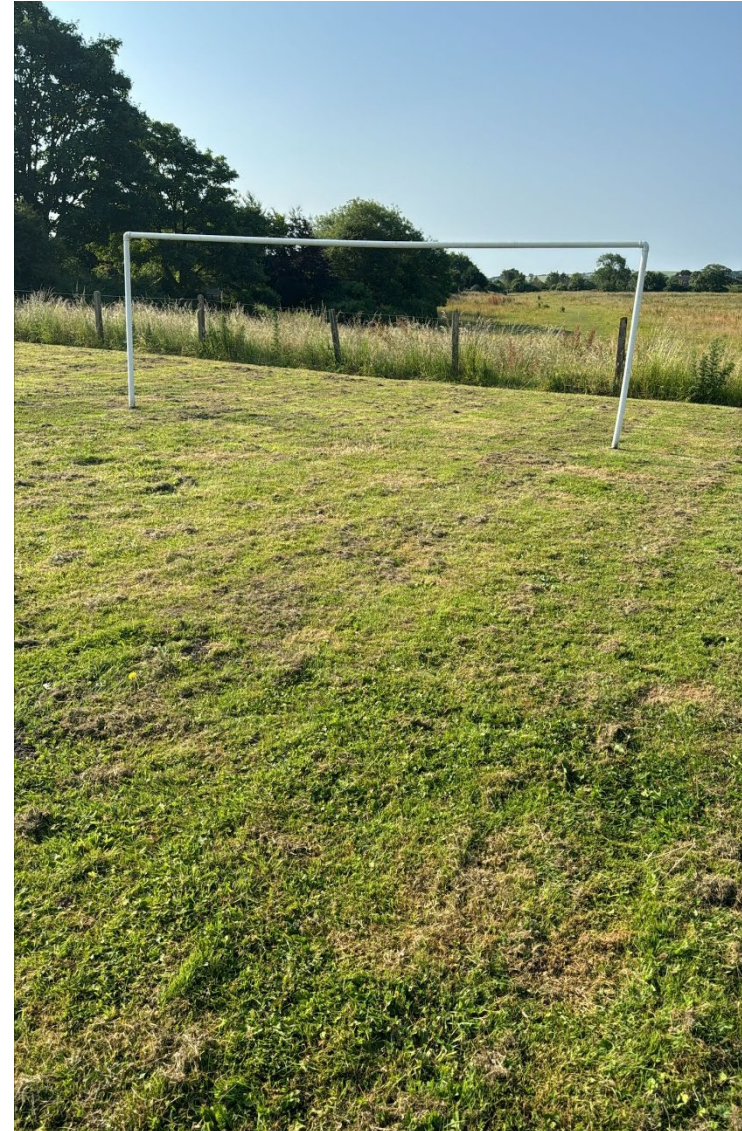
## 4.11 Goal

This unit is in average condition.

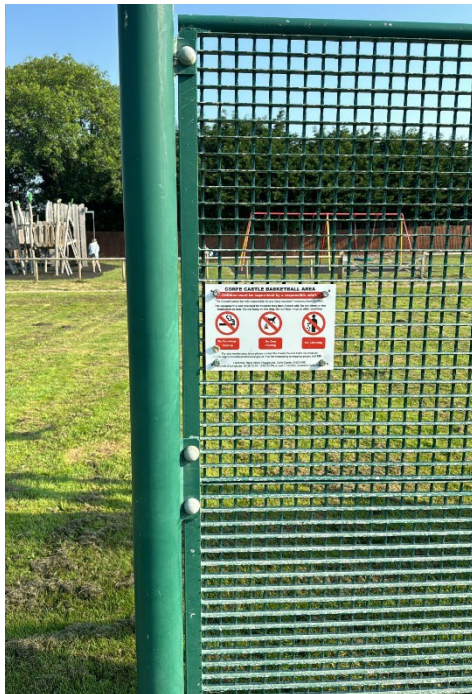
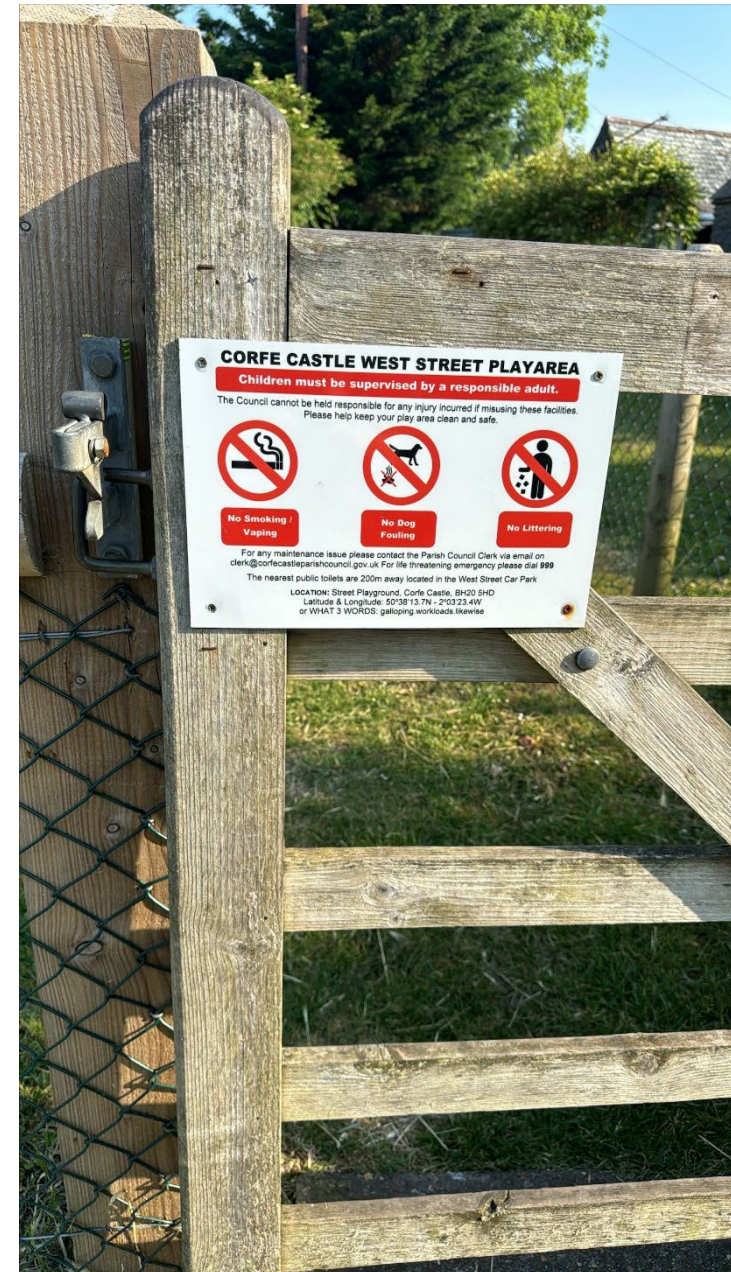
## 4.12 Signage

There is clear sign displaying operator & emergency contact details and location information and this is displayed in several locations.

There is an appropriate sign displayed on the MUGA goal end.

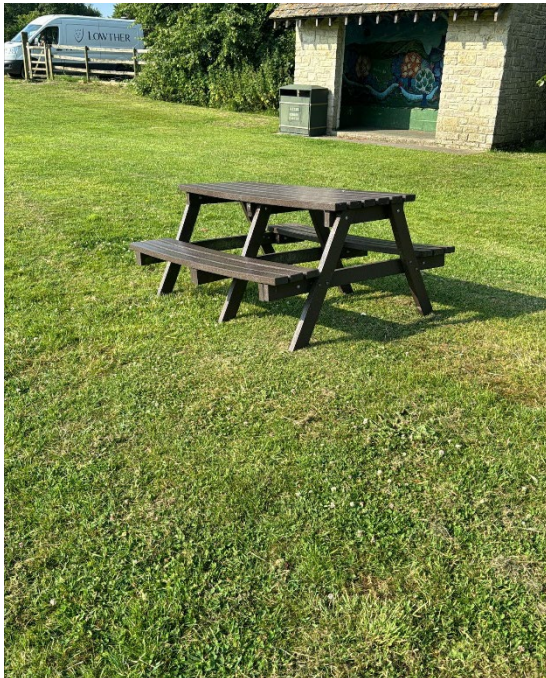
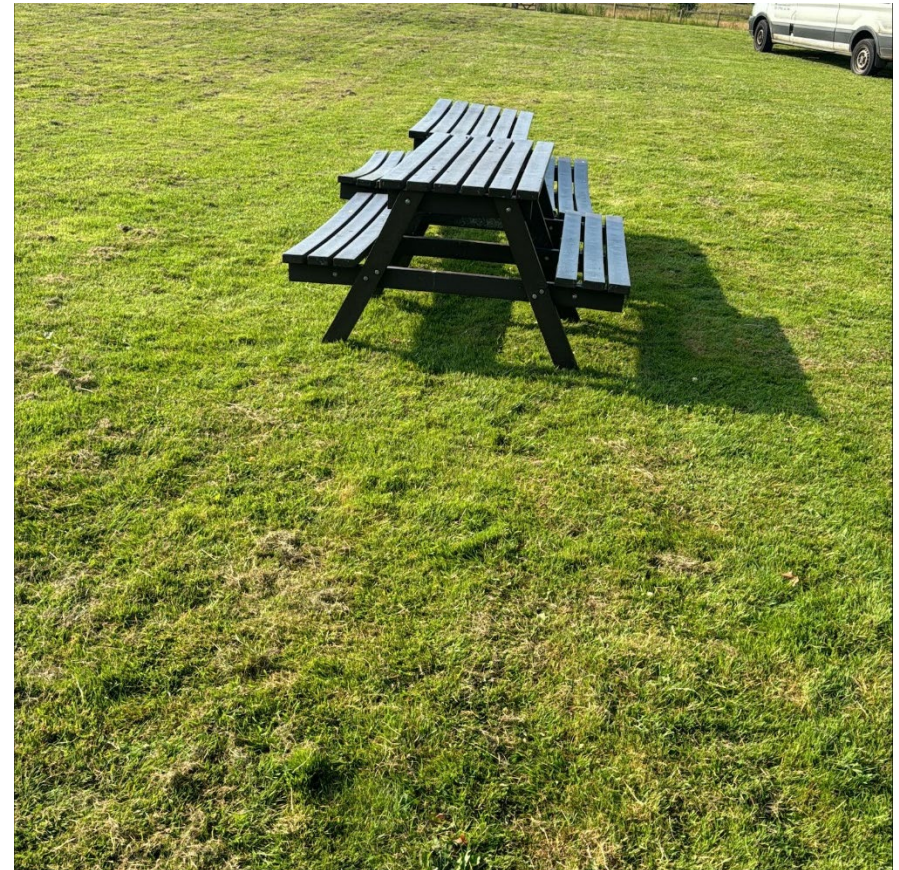
## 4.13 Seating

The picnic tables are twisting and causing additional load on the fixings as well as deforming the plastic. This was discussed with a councillor on site during the visit.

| Item | Issue | Recommendation |
|---|---|---|
| 4.13 | Untreated timber | Treat timbers |
| 4.13 | Unsupported tables | Provide bases |

Timbers should be regularly treated to prevent decay.

Consideration should be given to setting the tables on bases and fixing them in position. This was discussed during the visit.

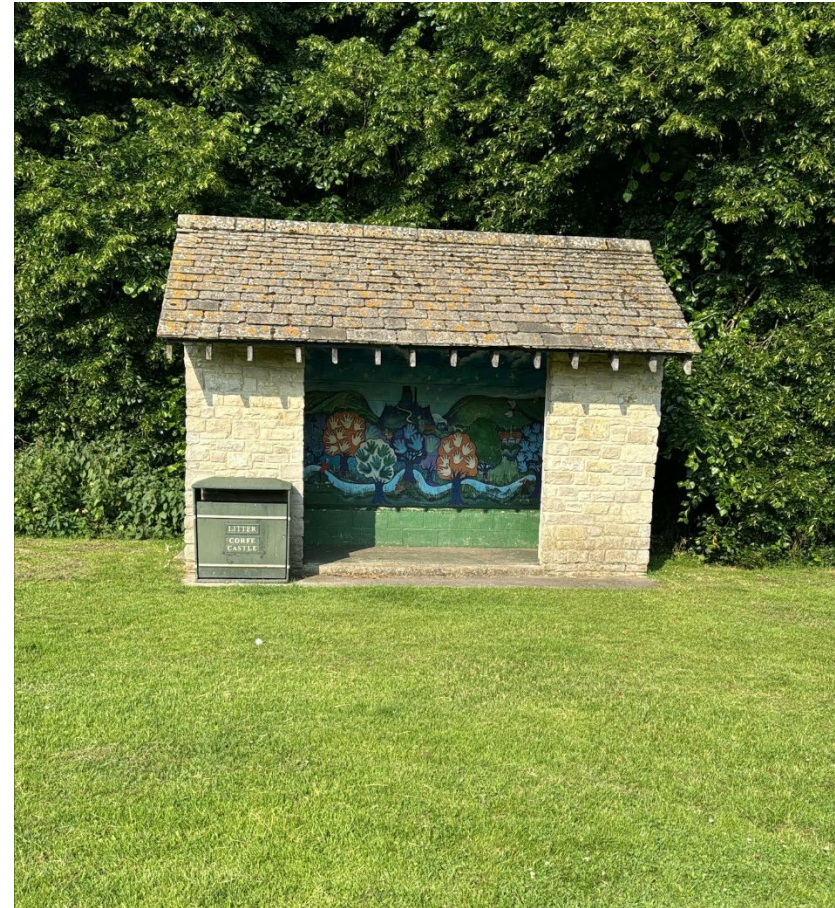
#### 4.14 Ancilliaries

There is stone built shelter with cast seating. There are no obvious issues with this structure.

There is a refuse bin adjacent to the shelter and there are no obvious issues with the bin.
