# *PLAY AREA SAFETY INSPECTION REPORT*

## CORFE CASTLE PARISH COUNCIL

Park Name: West St. Play Area.  
Location: West St. Corfe Castle BH20 5HQ

Inspection undertaken September 2024  
This report issued 16<sup>th</sup> October 2024

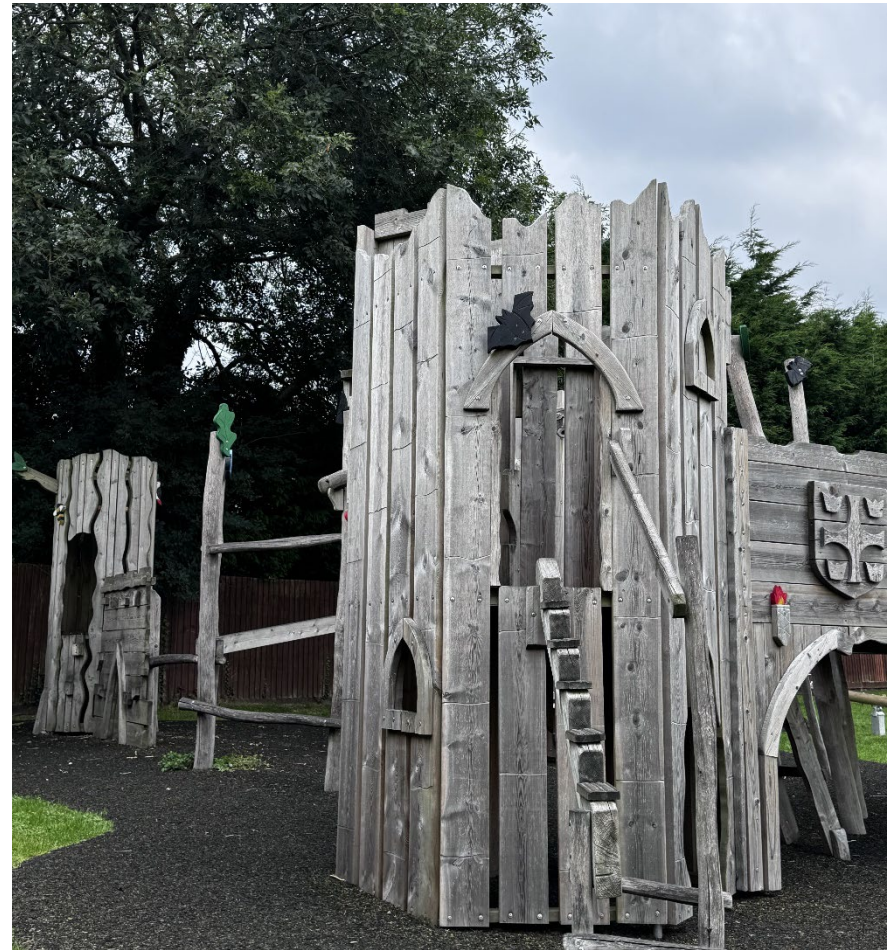
## 4.1 *Twin Tower with Slide*

| Play Equipment | | | | | |
|---|---|---|---|---|---|
| 8 | AF Play Tower | Satisfactory | 6 /Low | Keep suitably maintained /Monitor | Ongoing |

There are no significant issues with this unit.

| Item | Issue | Recommendation |
|---|---|---|
| 4.1 | Fall from height | Monitor use for any reported falls |

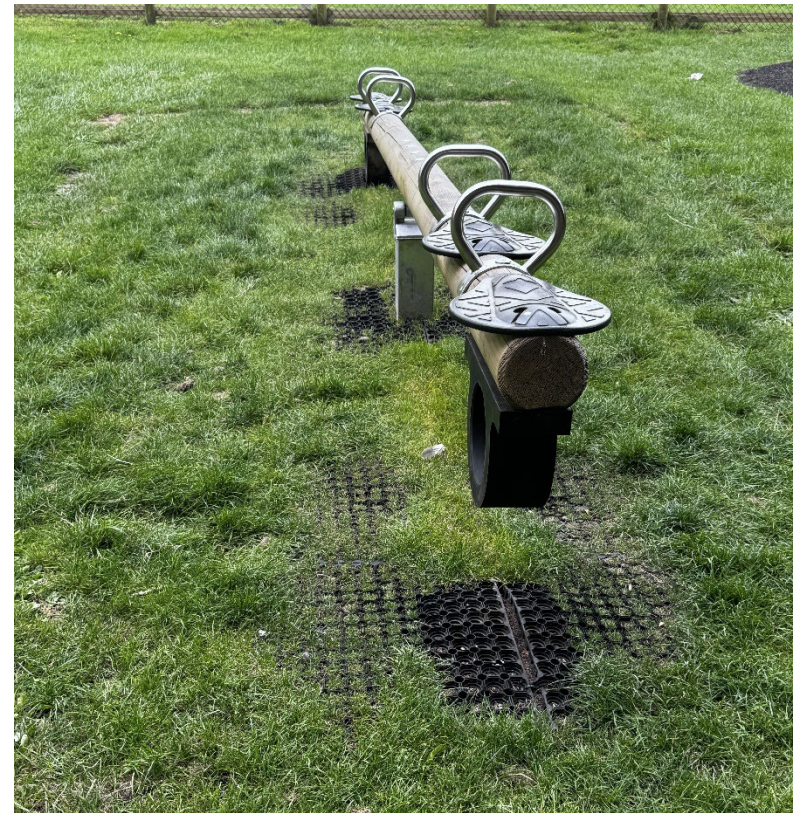
## 4.2 See-Saw

This item is in good condition.

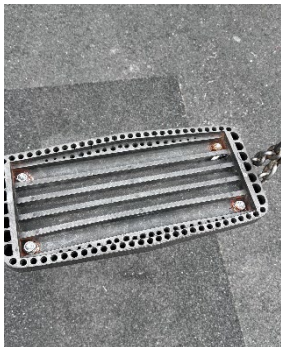
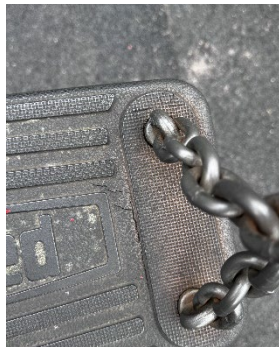
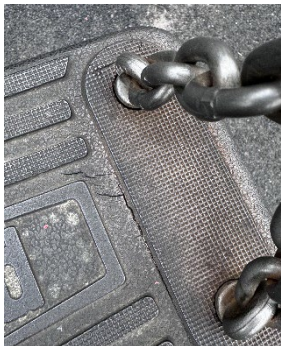
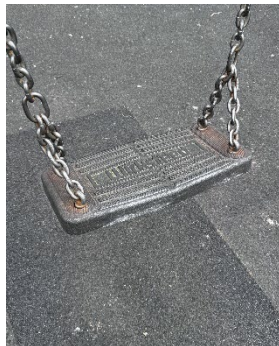
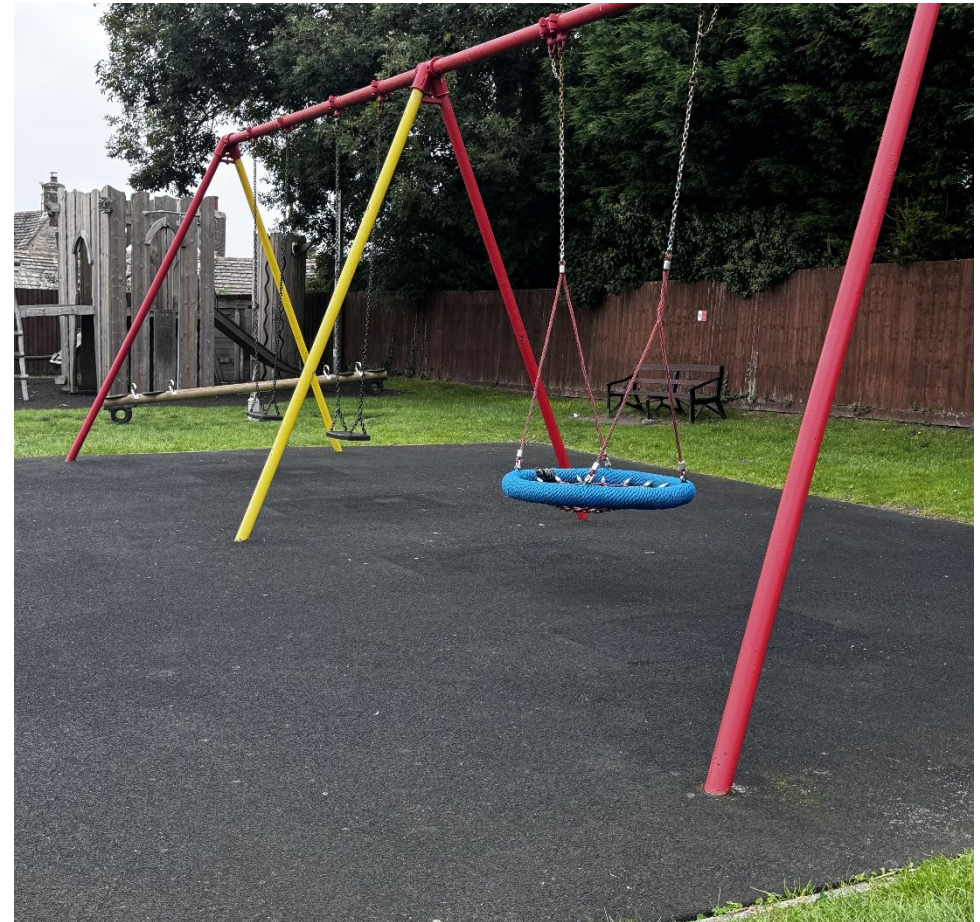
### 4.3 Wicksteed 2 Bay Swing Set

There are no significant issues with this unit.

The flat seats are showing signs of internal corrosion and will be monitored.

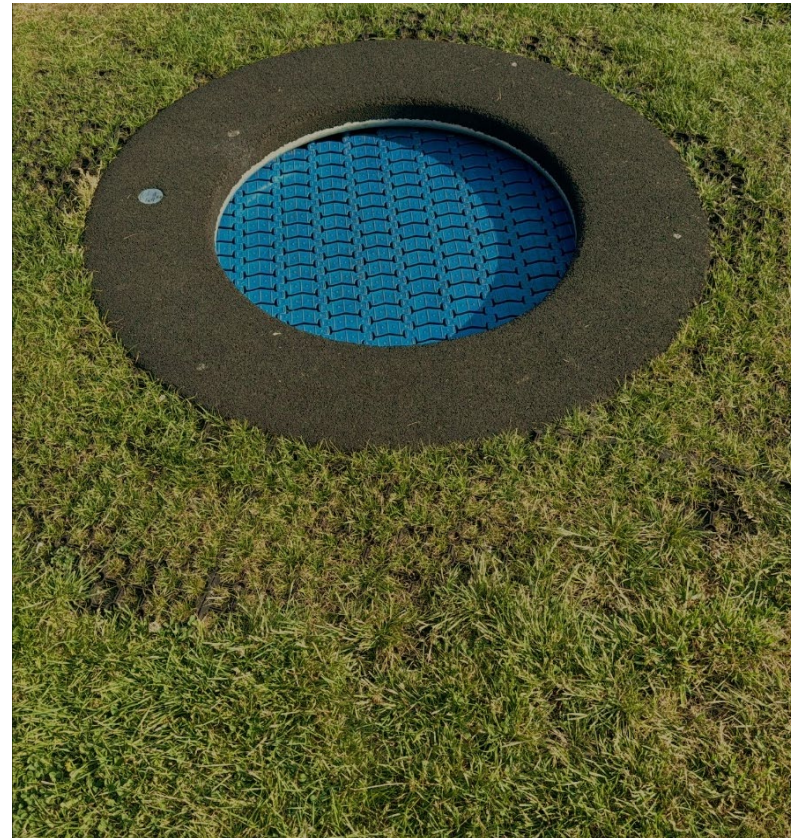
#### 4.4 Round Trampoline – RADO 125

This item is in excellent condition.

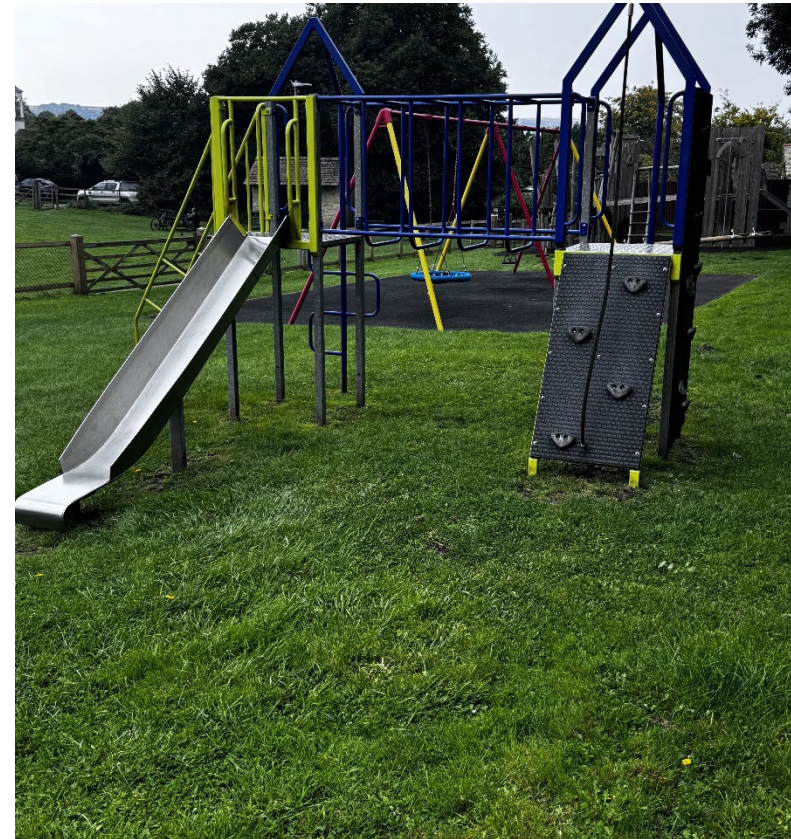
#### 4.5 ***SMP Multi-play unit***

There are no significant issues with this unit.

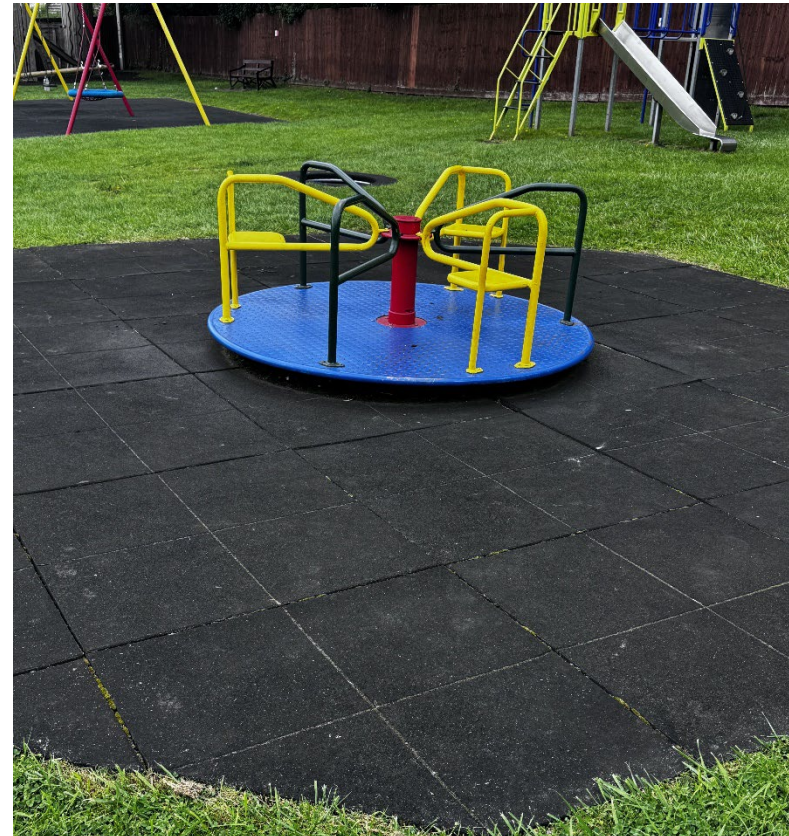
## 4.6 Wicksteed Rotaplay

There are several minor issues (previously reported) with this unit which is otherwise in reasonable condition.

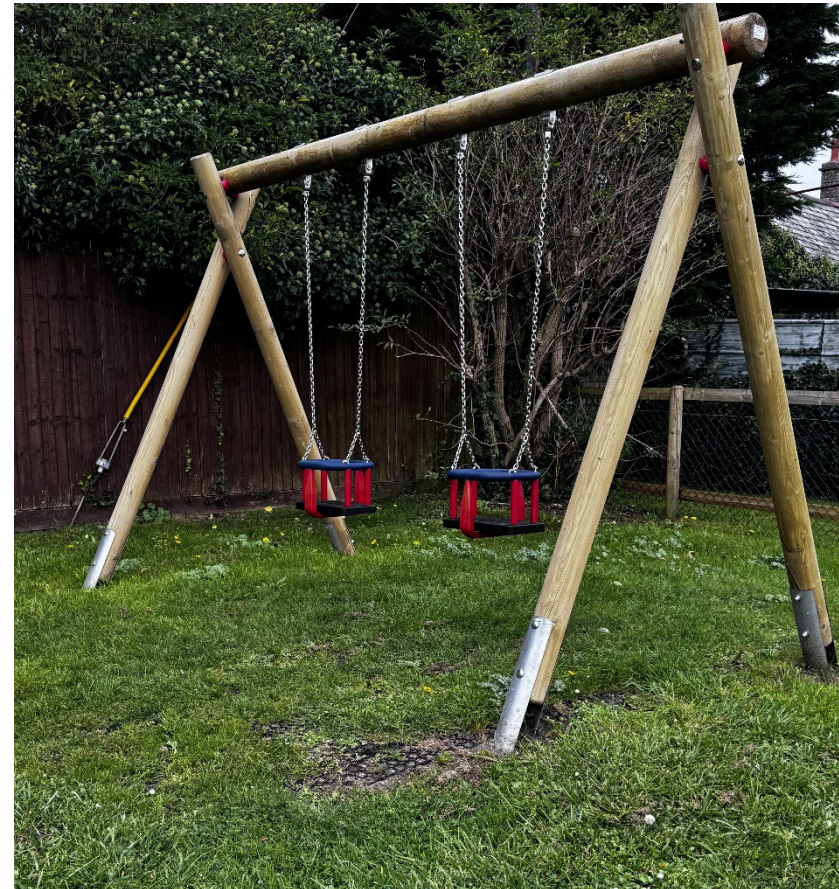
#### 4.7 *Single Bay Toddler swing set*

This item is in excellent condition.

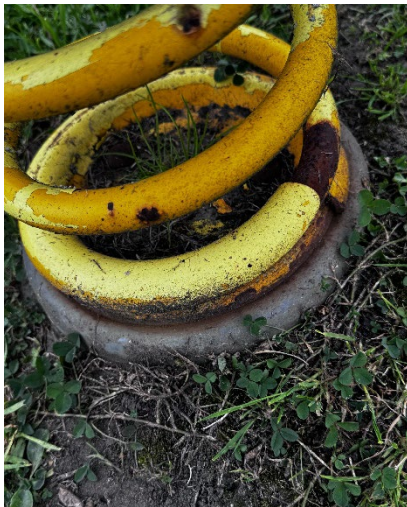
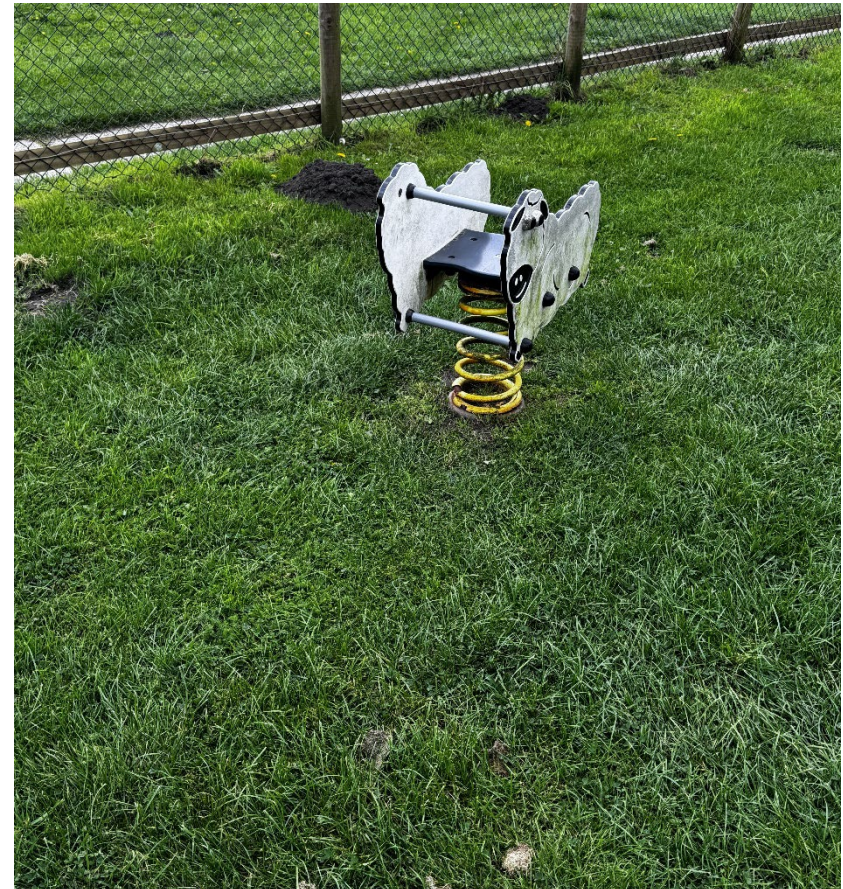
## 4.8 Fahr Baa (Sheep) Springer

This item is in reasonable condition.

There is corrosion on the spring which should be monitored.

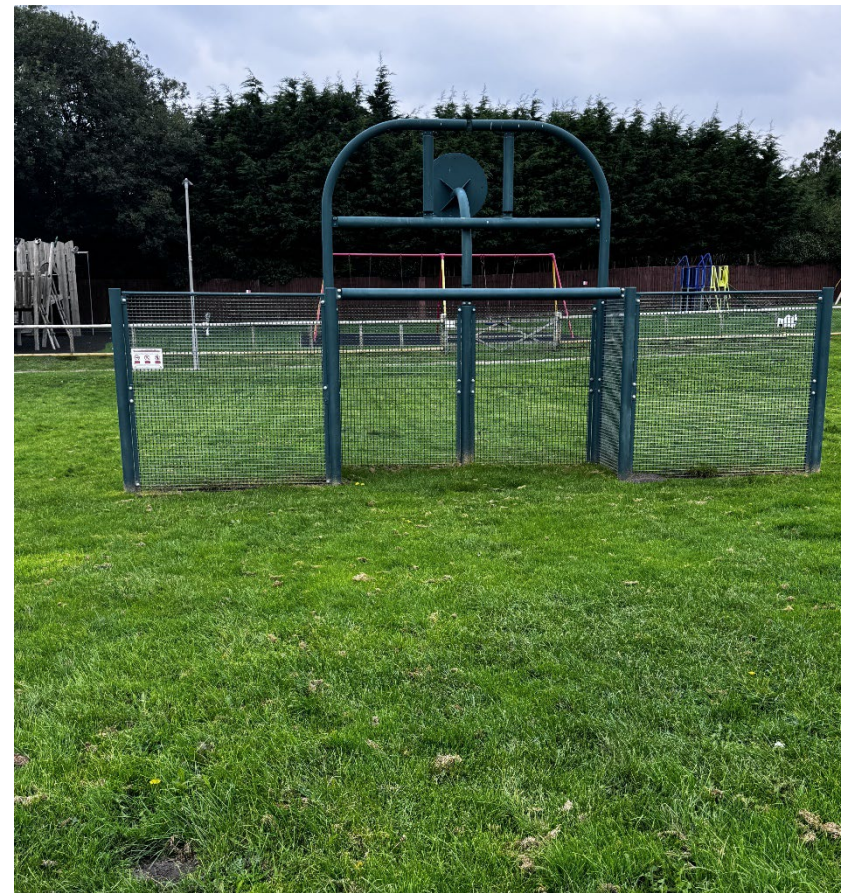
## 4.9 MUGA Goal End

Powder coating on the MUGA end is failing.

There are no issues with this unit.

| Item | Issue | Recommendation |
|---|---|---|
| 4.9 | Powder coating failing | Re-powder coat panels |

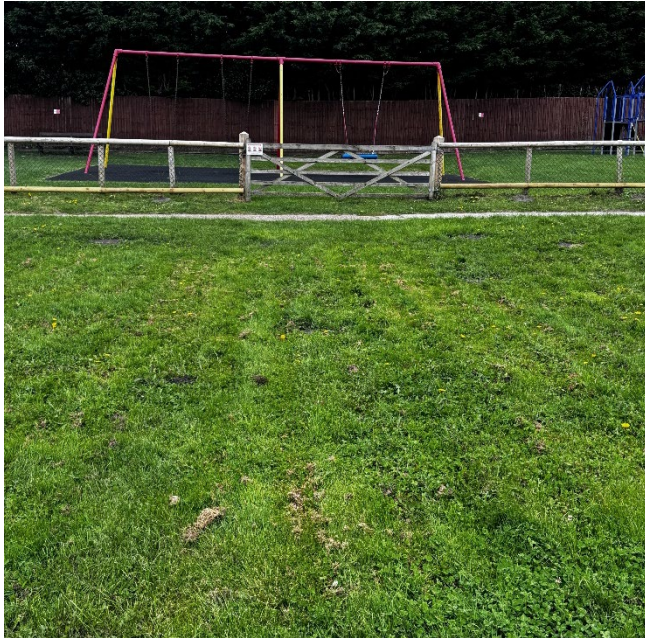
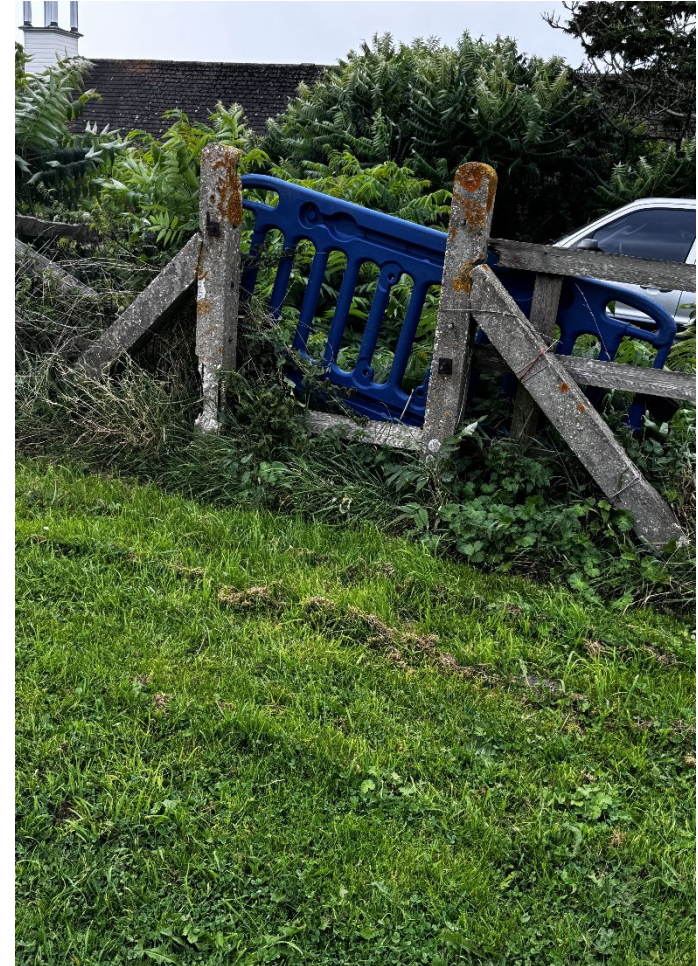
## 4.10 Fencing & Gates

The fencing is mostly in good condition. There is still one small section in need of attention next to the car park.

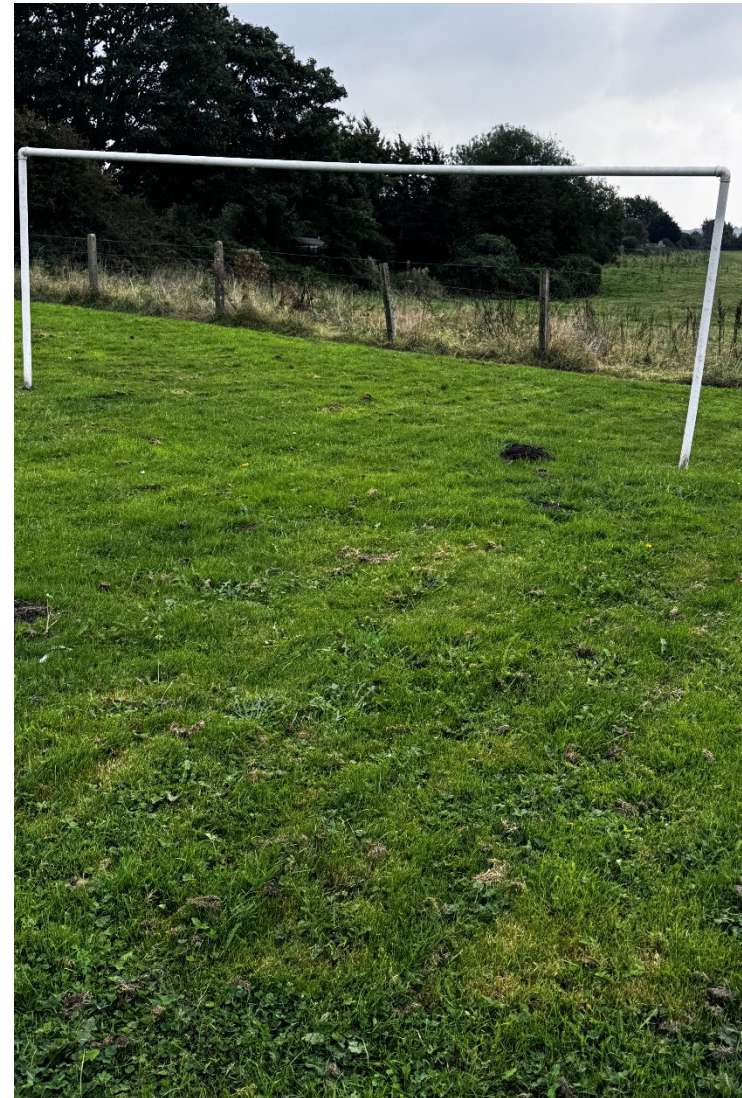
## 4.11 Goal

This unit is in average condition.

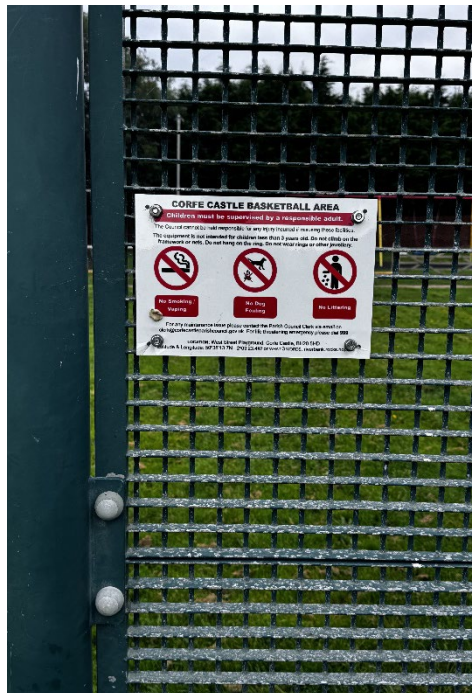
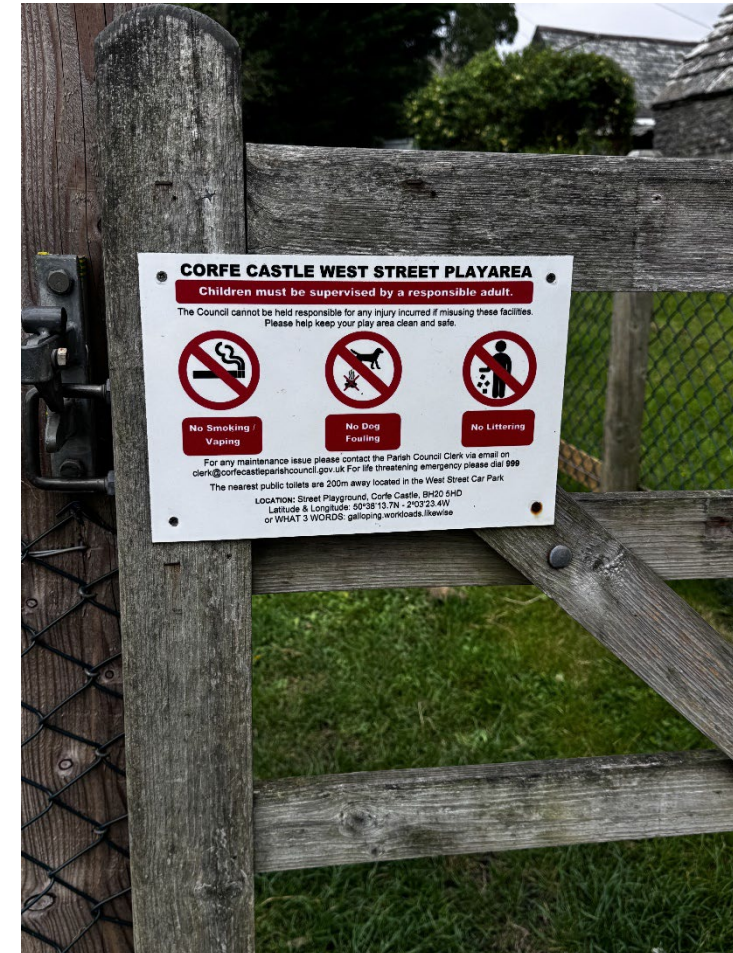
## 4.12 Signage

There is clear sign displaying operator & emergency contact details and location information and this is displayed in several locations.

There is an appropriate sign displayed on the MUGA goal end.

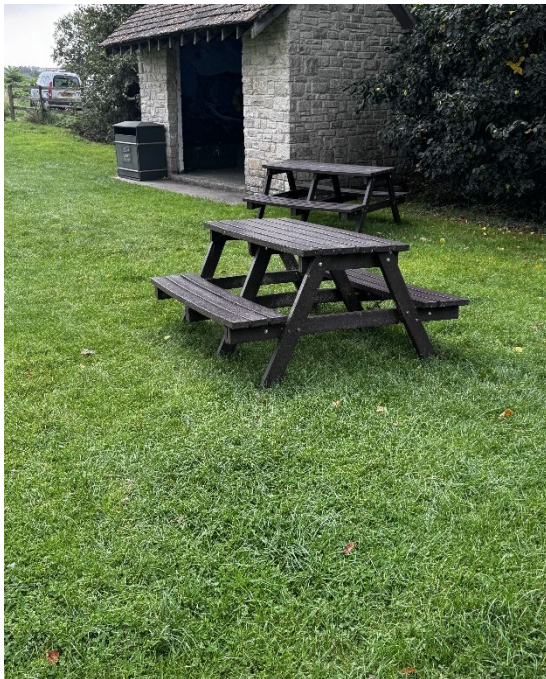
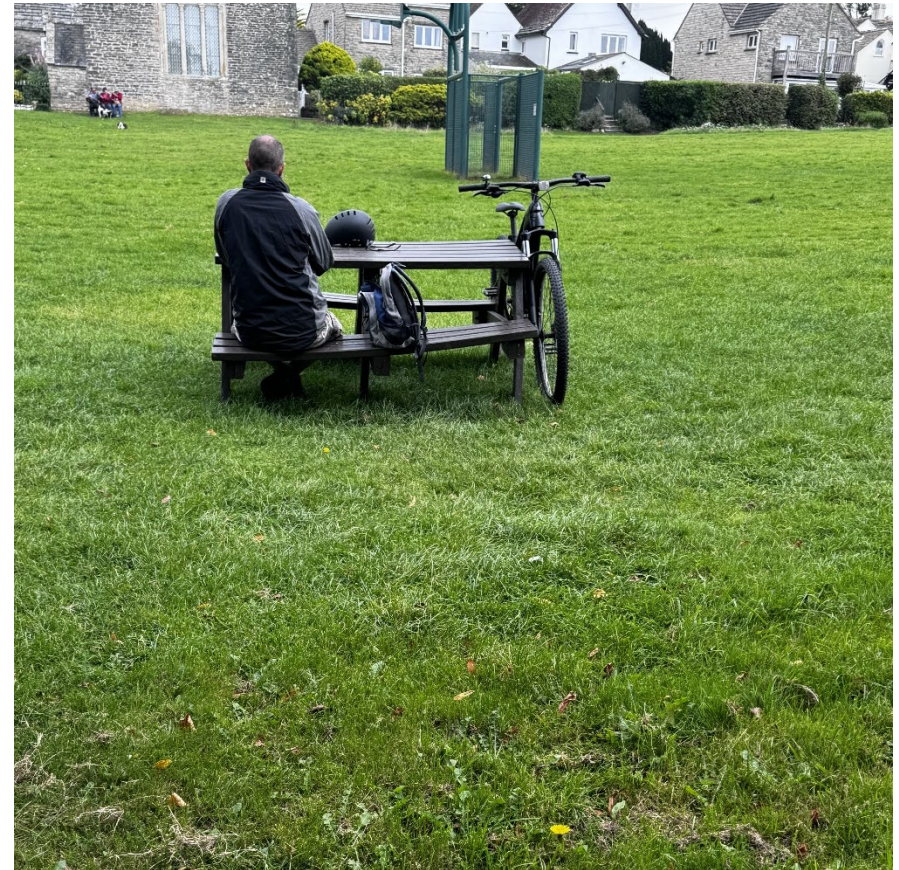
## 4.13 Seating

The picnic tables are twisting and causing additional load on the fixings as well as deforming the plastic.

This distortion caused by the uneven setting is clearly visible in the picture (right) when the seat is under load.

| Item | Issue | Recommendation |
|---|---|---|
| 4.13 | Untreated timber | Treat timbers |
| 4.13 | Unsupported tables | Provide bases |

Timbers should be regularly treated to prevent decay.

Consideration should be given to setting the tables on bases and fixing them in position.

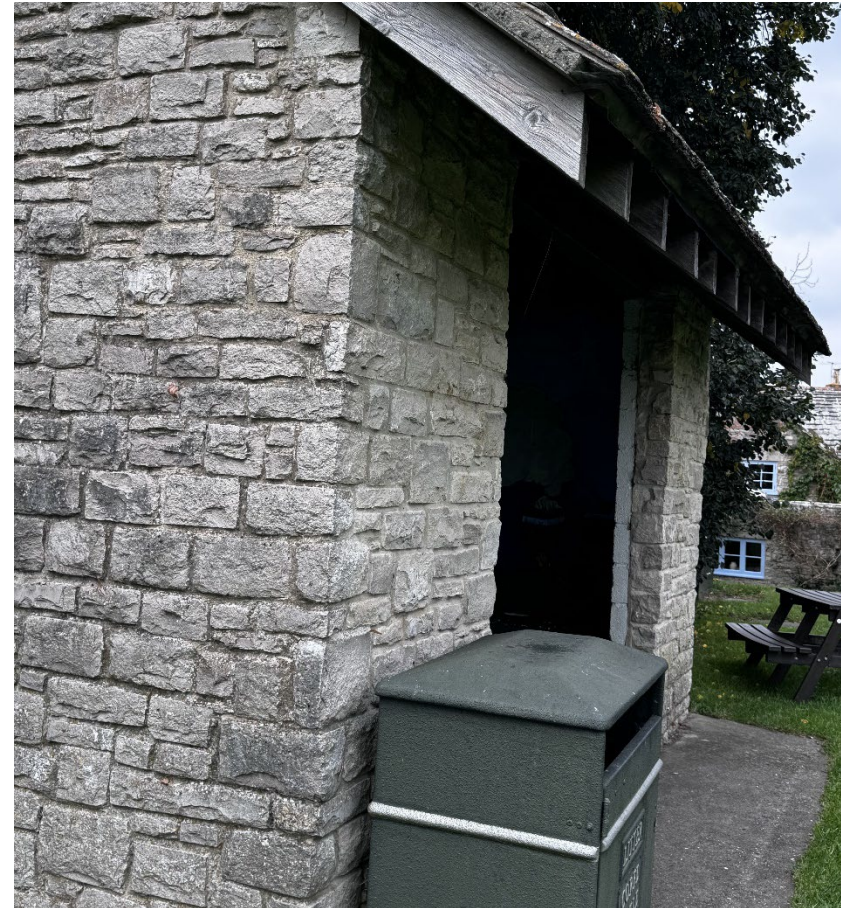
#### 4.14 Ancillaries

There is stone built shelter with cast seating. There are no obvious issues with this structure.

There is a refuse bin adjacent to the shelter and there are no obvious issues with the bin.
