## Annual Inspection

Corfe Castle Parish Council

West Street Play Area

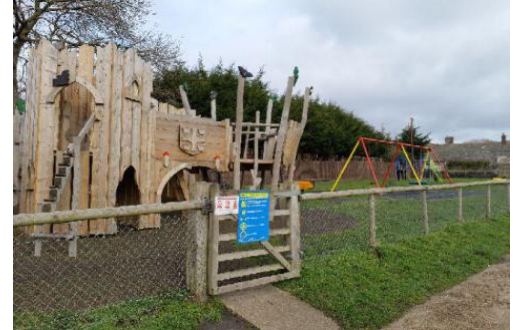
**Item:** Site General  
**Manufacturer:** Owner/Operator  
**Surface Type:** N/A  
**Item Quantity:** 1  
**Equipment Compliance:** N/A  
**Surface Area Compliance:** N/A

It is recommended that signage, with information including the site address, contact information for maintenance issues and emergency contact details are provided for the facility - Provide in accordance with the recommendations

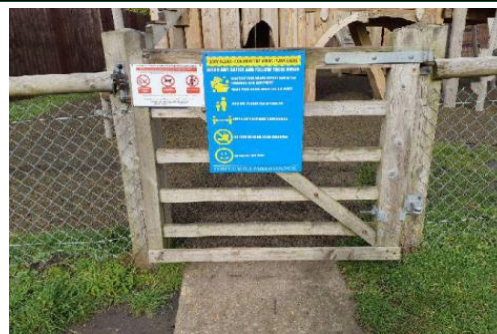
**Item:** Gate  
**Manufacturer:** Not Identified  
**Surface Type:** Concrete  
**Item Quantity:** 2  
**Equipment Compliance:** N/A  
**Surface Area Compliance:** N/A

There are trip hazards present - Reinstate surrounding surfaces to level to remove the trip points

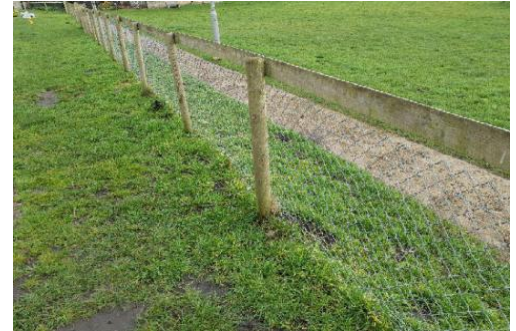
**Item:** Fence - Timber & Mesh Infill  
**Manufacturer:** Not Identified  
**Surface Type:** Grass  
**Item Quantity:** 1  
**Equipment Compliance:** N/A  
**Surface Area Compliance:** N/A

There are stiff twisted wires protruding into the play area - Remove sharp protrusions

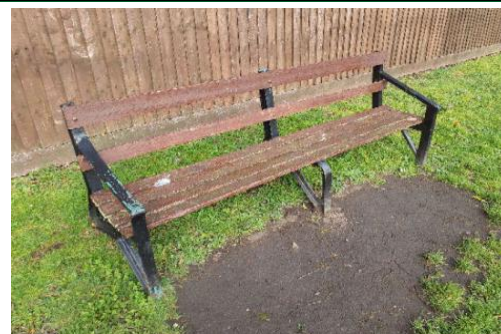
**Item:** Bench  
**Manufacturer:** Not Identified  
**Surface Type:** Concrete  
**Item Quantity:** 1  
**Equipment Compliance:** N/A  
**Surface Area Compliance:** N/A

The surface has eroded and the foundations are exposed - Reinstate surrounding surfaces to cover the foundations

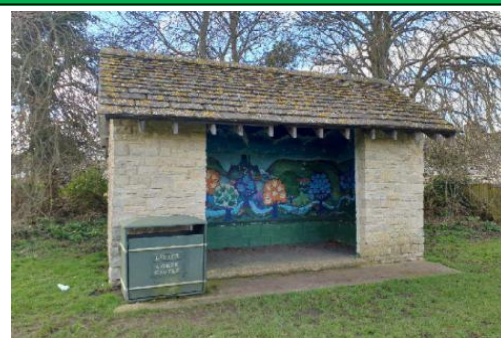
**Item:** Shelter  
**Manufacturer:** Not Identified  
**Surface Type:** Concrete  
**Item Quantity:** 1  
**Equipment Compliance:** N/A  
**Surface Area Compliance:** N/A

The structural integrity of a building such as this falls outside the scope of our expertise - Ensure the structure is inspected regularly by a relevant professional

There is some damage to the seating - Monitor for any further deterioration and repair as required

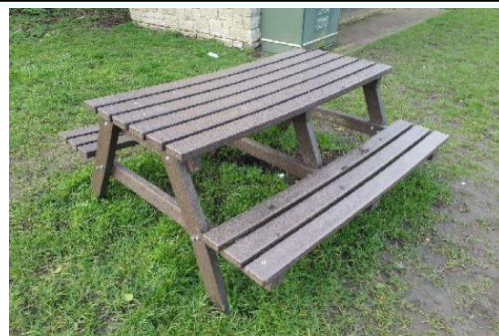
**Item:** Picnic Table  
**Manufacturer:** Not Identified  
**Surface Type:** Grass  
**Item Quantity:** 3  
**Equipment Compliance:** N/A  
**Surface Area Compliance:** N/A

The area around the item has eroded and may become slippery - Reinstate eroded area

There is some evidence of fire damage to the item - Monitor for any further deterioration and repair as required

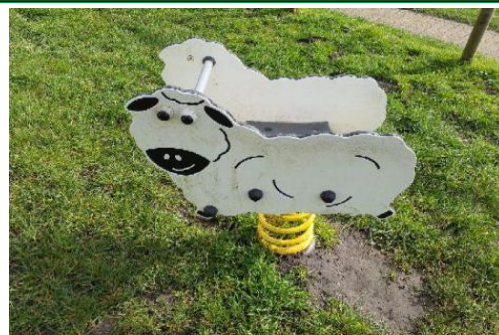
**Item:** Spring Sheep  
**Manufacturer:** Fahr Industries  
**Surface Type:** Grass Matrix Tiles  
**Item Quantity:** 1  
**Equipment Compliance:** No  
**Surface Area Compliance:** Yes  
**Life Expectancy:** 3 - 5 Years  
**Total Findings:** 7

The area around the item has eroded and may become slippery - Reinstate eroded area

The paintwork on this item has been damaged or worn exposing the metal underneath which is rusting - Treat any rusting components and repaint

The fixings have corroded excessively - Replace all corroded fixings

The main body profile has a radius of less than 20mm in places, in contravention of BS EN 1176 Part 6 - Monitor - No remedial work recommended

A number of fixing(s) have worked loose on the baseplate - Secure all loose fixings

There is a small crack appearing in the baseplate - Monitor use and repair as required

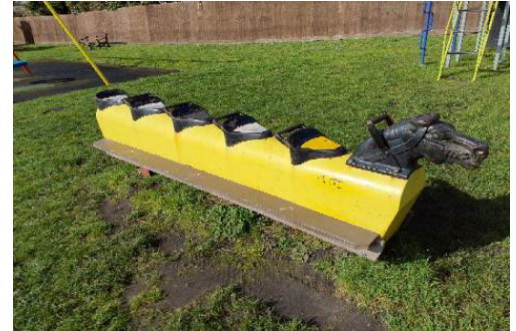
**Item:** Rocking Horse  
**Manufacturer:** Wicksteed Playgrounds  
**Surface Type:** Grass Matrix Tiles  
**Item Quantity:** 1  
**Equipment Compliance:** No  
**Surface Area Compliance:** Yes  
**Life Expectancy:** 5 -10 Years  
**Total Findings:** 6

The item has exposed edges and corners with a radius of less than 3mm and fails the requirements of BS EN 1176 - Provide a 3mm radius to all exposed edges and corners

The seat has minor damage or wear - Monitor for any further deterioration and replace as required

There is no gaiter protection for accessible moving parts (possible shear trap) as recommended in BS EN 1176 Part 1; 4.2.6 Moving Parts - Monitor - No remedial work recommended

There is or are fixings missing on the item - Replace all missing fixings

The paintwork on this item has been damaged or worn exposing the metal underneath which is rusting - Treat any rusting components and repaint

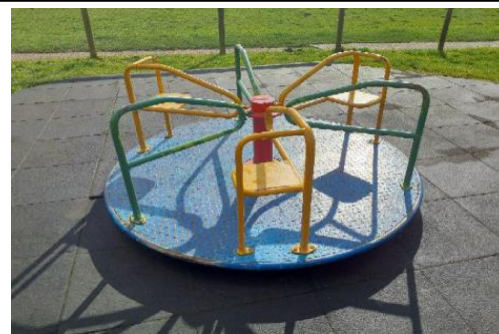
**Item:** Roundabout  
**Manufacturer:** Not Identified  
**Surface Type:** Rubber Tiles  
**Item Quantity:** 1  
**Equipment Compliance:** Yes  
**Surface Area Compliance:** Yes  
**Life Expectancy:** 1 - 3 Years  
**Total Findings:** 9

There are gaps opening in between the tiles - Repair

The paintwork on this item has been damaged or worn exposing the metal underneath which is rusting - Treat any rusting components and repaint

The bearing is showing signs of wear - Monitor for any further deterioration and replace as required

There are gaps opening between the surfacing and the edging surround or between the joints in the surfacing - Monitor for any further deterioration and repair as required

There are areas or parts of the timber on the edging that have rotted or are missing - Replace all affected timbers

A number of fixing(s) have worked loose - Secure all loose fixings

Parts of the steel on this item have corroded excessively and the metal has perforated in places - Ensure all affected areas are treated and repaired

There is moderate damage to the surface - Repair the damaged areas of surfacing

There are trip hazards at the edges of the surface - Reinstate surrounding surface levels to remove the trip points

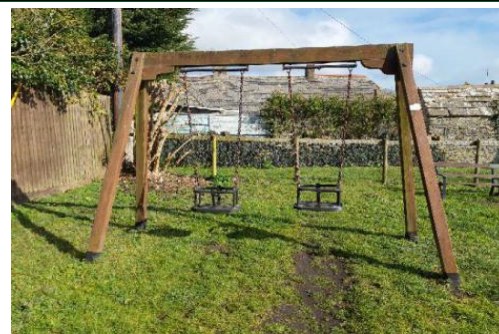
**Item:** 1 Bay 2 Seat (Cradle)  
**Manufacturer:** Taylor Made Play Equipment  
**Surface Type:** Grass Matrix Tiles  
**Item Quantity:** 1  
**Equipment Compliance:** No  
**Surface Area Compliance:** Yes  
**Life Expectancy:** 3 - 5 Years  
**Total Findings:** 11

There is some strimmer / machinery damage apparent on the posts, this can penetrate the preservative applied to the timber and accelerate the rotting process. The timber has been covered making it difficult to now test for rot without removing the plastic covering - Remove the plastic covering to check for any deterioration (rot) and replace as required

The fixings have corroded excessively - Replace all corroded fixings

There is some notable evidence of chain wear - Monitor for any further deterioration and replace when 40% worn

There is some wear to the shackles. - Monitor for any further deterioration and replace when 40% worn

The seats are too close to each other as defined in BS EN 1176 Part 2; this is a low risk failure and no remedial action is required - Monitor - No remedial work recommended

The grass mats are silted up and the soil is compacted; this may have an effect on the impact absorbing properties of the surface - Consider HIC testing impact absorbing properties to ensure the correct surface qualities are maintained for the equipment and replace as required

The seat has damage or wear, possibly from internal corrosion - Dismantle the seat for inspection and replace as required

The paintwork on this item has been damaged or worn exposing the metal underneath which is rusting - Treat any rusting components and repaint

The connecting lugs are showing signs of wear - Monitor for any further deterioration and repair as required

The chain openings are in excess of the 8.6mm as recommended by BS EN 1176 - Monitor - No remedial work recommended

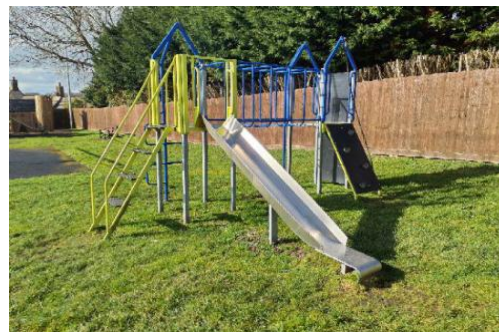
**Item:** Multi Play (Junior)  
**Manufacturer:** S M P (Playgrounds Ltd)  
**Surface Type:** Grass Matrix Tiles  
**Item Quantity:** 1  
**Equipment Compliance:** Yes  
**Surface Area Compliance:** Yes  
**Life Expectancy:** 5 -10 Years  
**Total Findings:** 7

A number of fixing(s) have worked loose - Secure all loose fixings

The paintwork on this item has been damaged or worn exposing the metal underneath which is rusting - Treat any rusting components and repaint

The connecting lugs are showing signs of wear - Monitor for any further deterioration and repair as required

The fixings have corroded excessively - Replace all corroded fixings

There is some wear to the shackles - Monitor for any further deterioration and replace when 40% worn

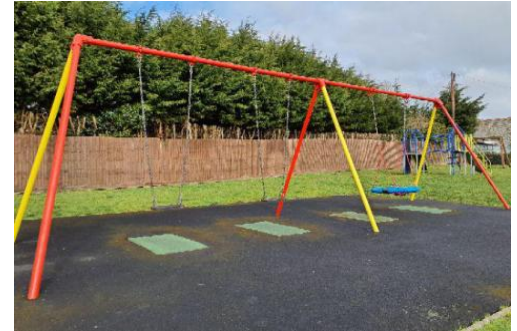
**Item:** 2 Bay 2 Flat 1 Basket Seat  
**Manufacturer:** Not Identified  
**Surface Type:** Wet Pour  
**Item Quantity:** 1  
**Equipment Compliance:** No  
**Surface Area Compliance:** Yes  
**Life Expectancy:** 3 - 5 Years  
**Total Findings:** 12

There are gaps opening between the surfacing and the edging surround or between the joints in the surfacing - Monitor for any further deterioration and repair as required

There is algae, silt or moss growth on the surface resulting in slippery conditions - Clean and treat appropriately

The surface is lifting at the edges and creating trip points - Repair perimeter of surfacing to remove trip points

The repaired surfacing is lifting at the edges and creating trip points - Repair surfacing to remove trip points

Crucifix or T connectors should have at least two complete chain links through the connector to meet with the manufacturers recommendations - Rectify installation to ensure at least two complete links are through the connectors

There is some wear to the shackles. - Monitor for any further deterioration and replace when 40% worn

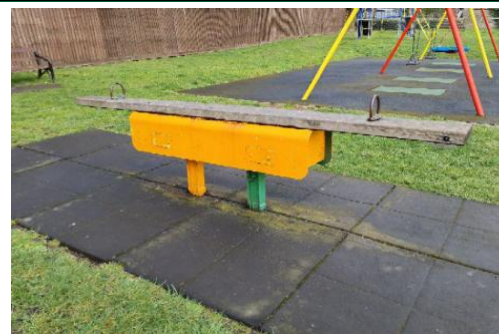
**Item:** See Saw  
**Manufacturer:** Not Identified  
**Surface Type:** Rubber Tiles  
**Item Quantity:** 1  
**Equipment Compliance:** No  
**Surface Area Compliance:** Yes  
**Life Expectancy:** 3 - 5 Years  
**Total Findings:** 9

There are gaps opening in between the tiles - Monitor for any further deterioration and repair as required

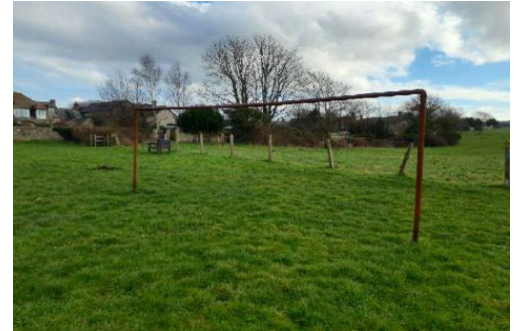
**Item:** Football Goal  
**Manufacturer:** Not Identified  
**Surface Type:** Grass  
**Item Quantity:** 1  
**Equipment Compliance:** N/A  
**Surface Area Compliance:** N/A  
**Life Expectancy:** 3 - 5 Years  
**Total Findings:** 2

NB: We have undertaken a maintenance inspection only of the football goal(s); full load testing falls outside the scope of our inspection. - Implement load testing as required

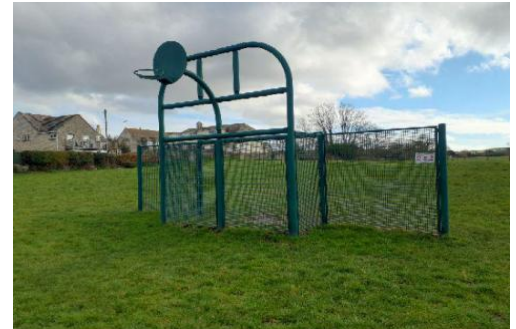
**Item:** Goalmouth and Basketball Post  
**Manufacturer:** Not Identified  
**Surface Type:** Grass Matrix Tiles  
**Item Quantity:** 1  
**Equipment Compliance:** No  
**Surface Area Compliance:** N/A  
**Life Expectancy:** 5 -10 Years  
**Total Findings:** 5

There is/are finger entrapments in the frame and the item fails to meet the requirements of BS EN 15312 Clause 4.4.2.2 Entrapment of fingers - Monitor - No remedial work recommended

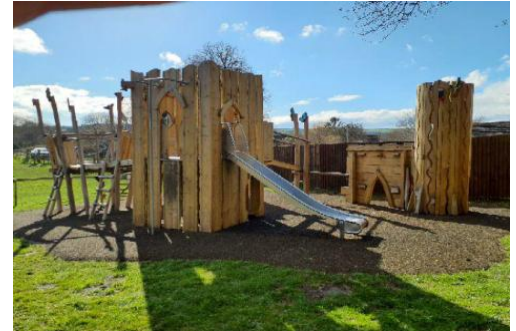
**Item:** Multi Play (Junior)  
**Manufacturer:** A Frost Design  
**Surface Type:** Bonded Rubber Mulch  
**Surface Nominal Depth:** 85mm  
**Item Quantity:** 1  
**Equipment Compliance:** No  
**Surface Area Compliance:** Yes  
**Total Findings:** 9

Parts of the timber are rough or splintered - Remove all rough or sharp edges

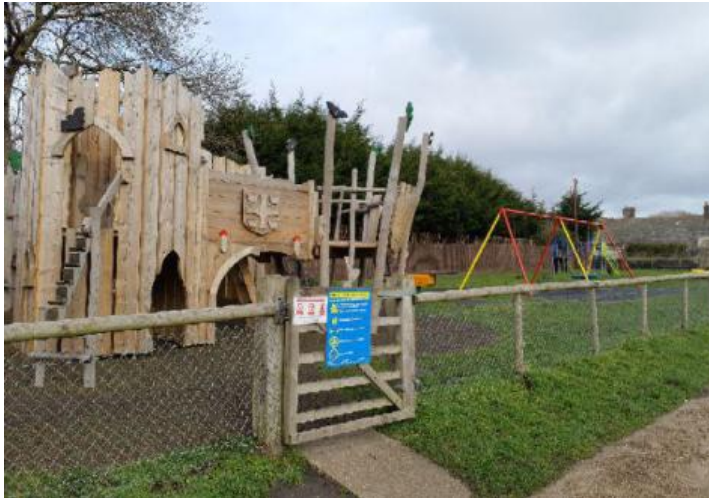
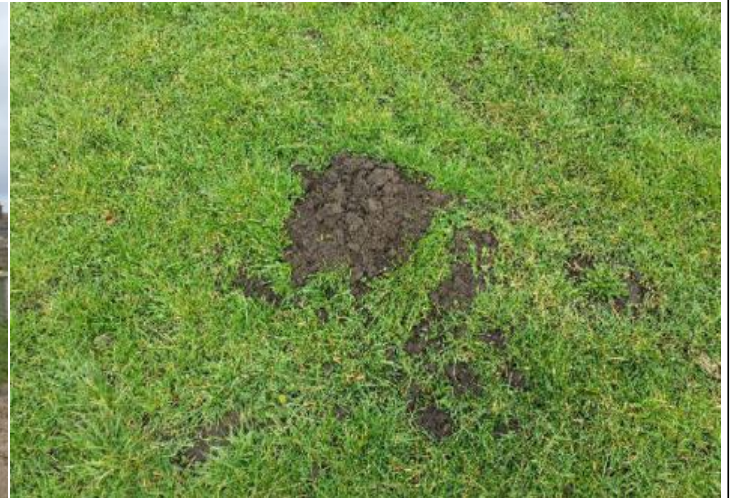
**Finding:** There are molehills in the play area

**Action:** Infill to provide a sound reasonably level surface.

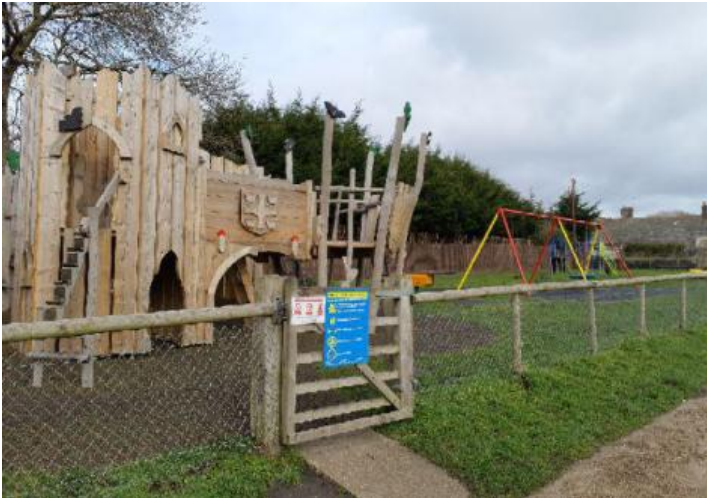
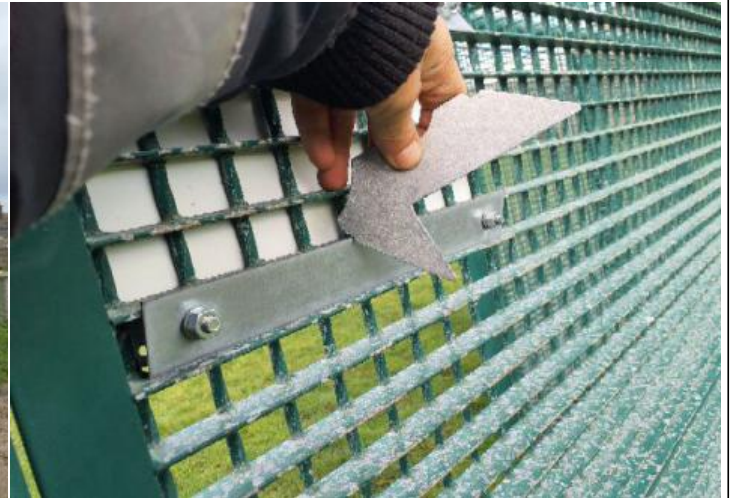
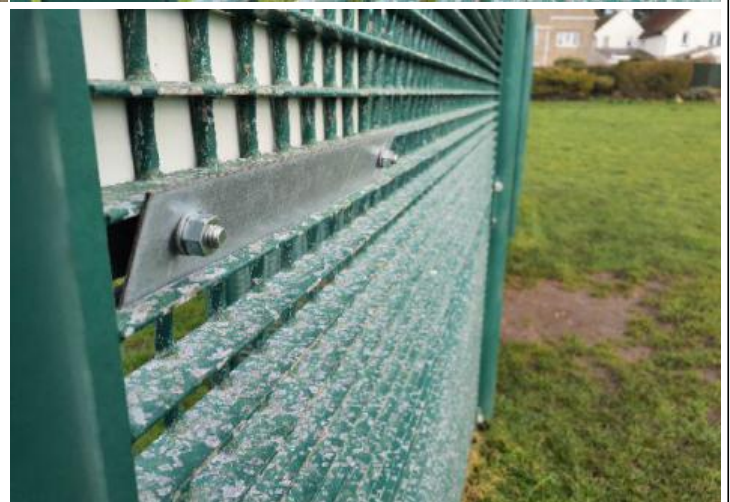
**Finding:** The sign bracket is angled away from the frame resulting in protruding sharp edges

**Action:** Adjust bracket to make flat or remove sharp edges

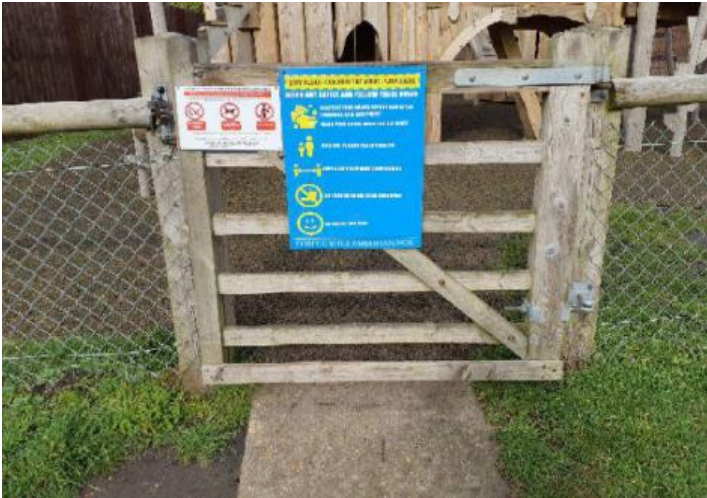
**Finding:** There are trip hazards present

**Action:** Reinstate surrounding surfaces to level to remove the trip points

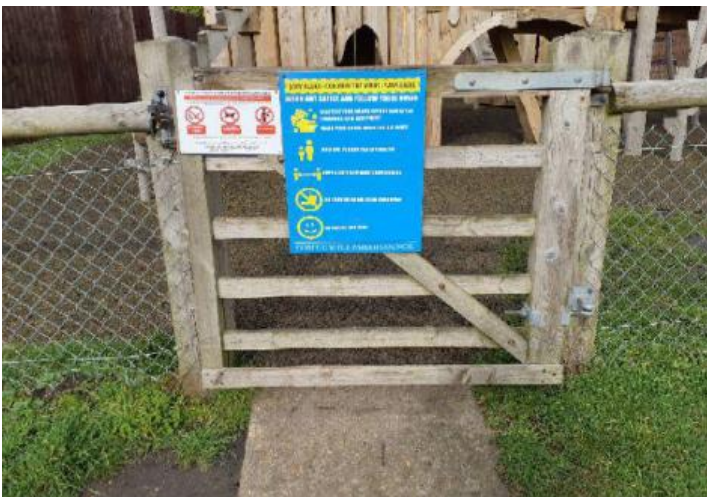
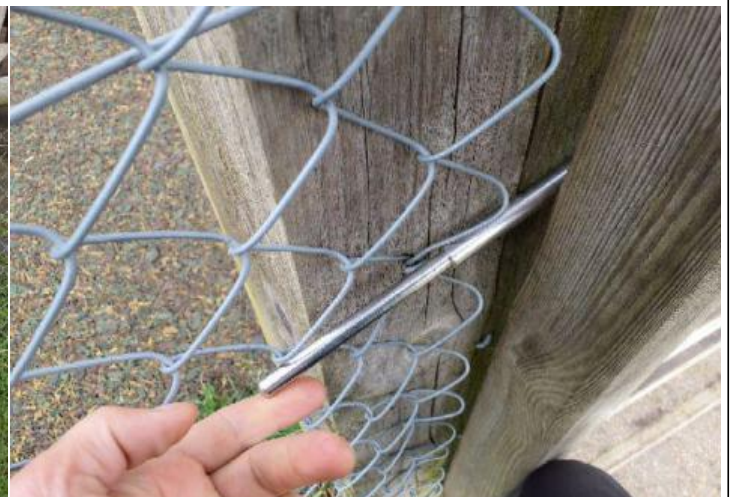
**Finding:** There are openings that are less than 12mm that could trap or crush fingers

**Action:** Provide a 12mm gap throughout full range of motion at both sides of gate

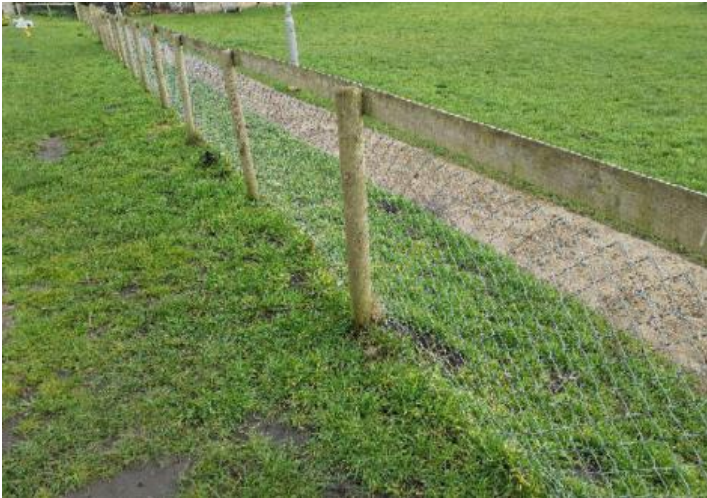
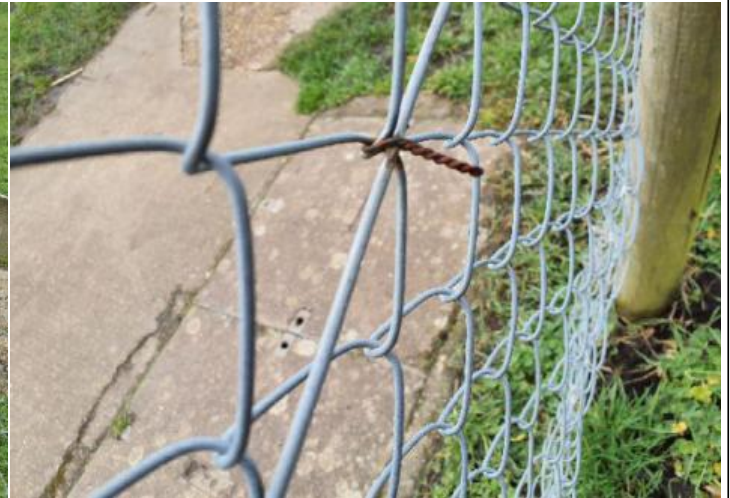
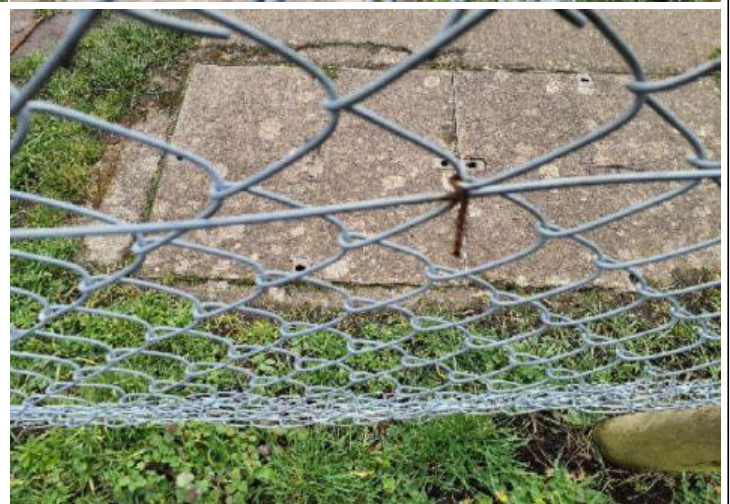
**Finding:** There are stiff twisted wires protruding into the play area **Action:** Remove sharp protrusions

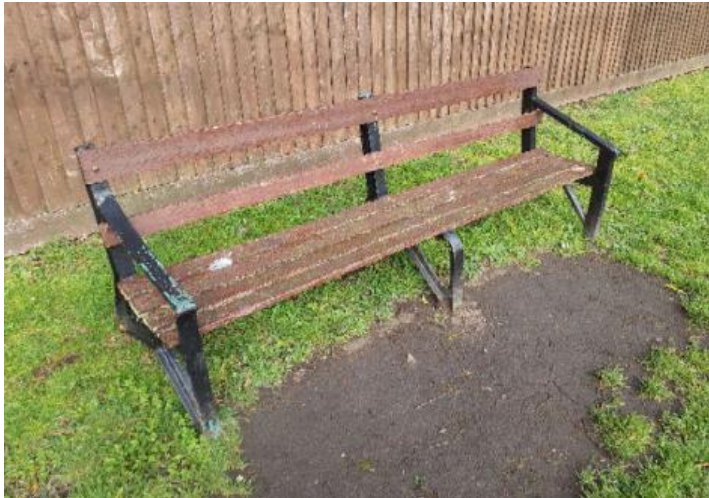
**Finding:** The surface has eroded and the foundations are exposed

**Action:** Reinstate surrounding surfaces to cover the foundations

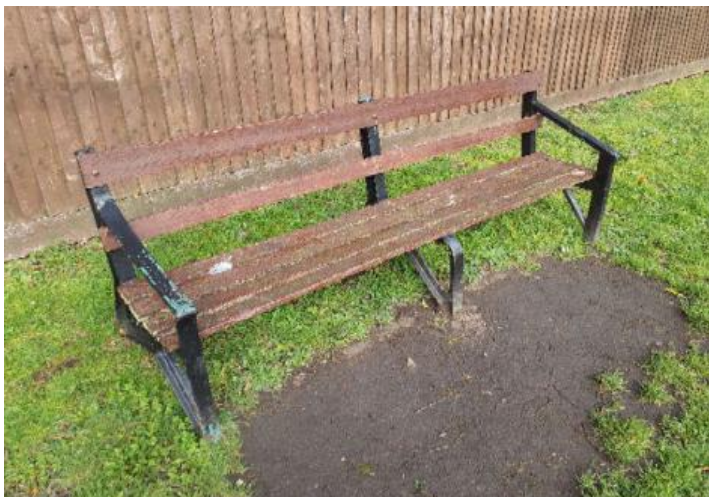
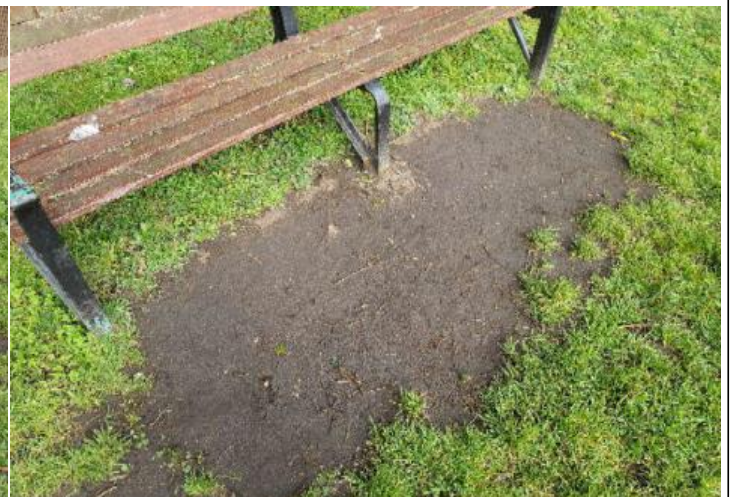
**Finding:** The area around the item has eroded and may become slippery

**Action:** Reinstate eroded area

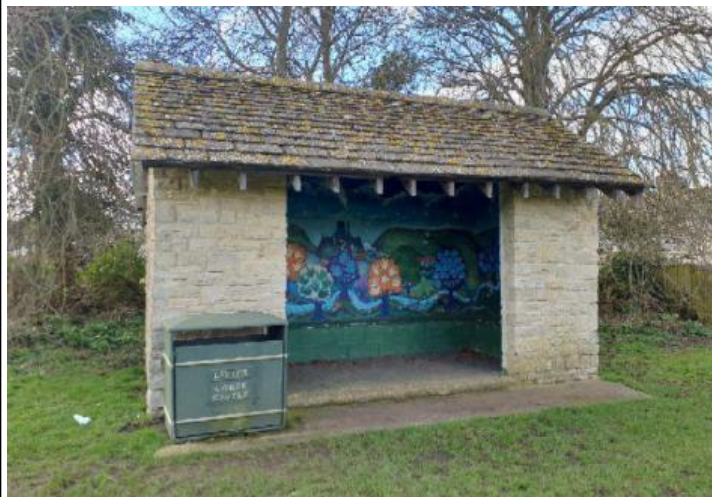
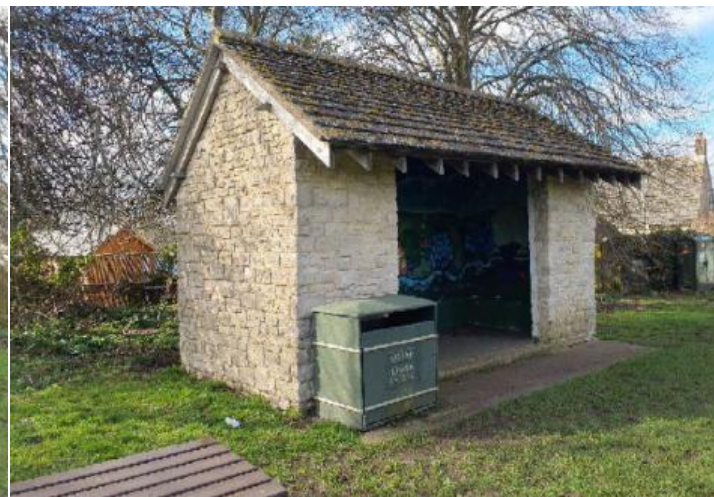
**Finding:** The structural integrity of a building such as this falls outside the scope of our expertise

**Action:** Ensure the structure is inspected regularly by a relevant professional

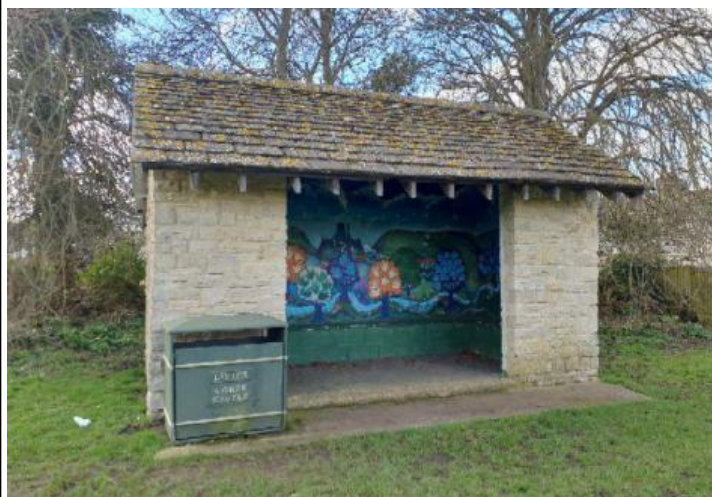
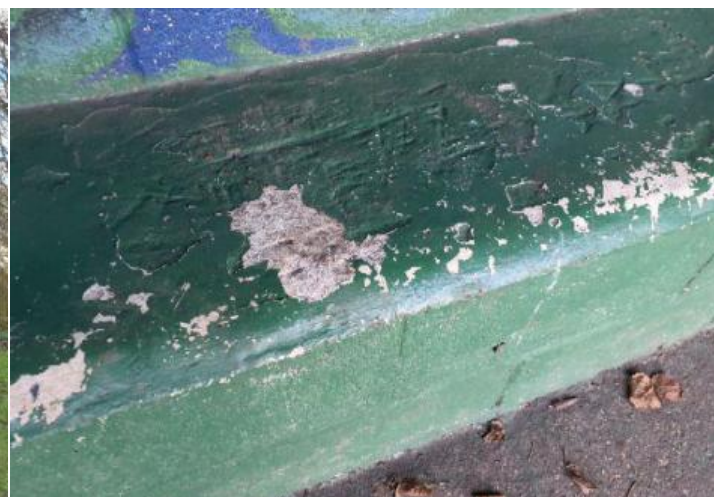
**Finding:** There is some damage to the seating

**Action:** Monitor for any further deterioration and repair as required

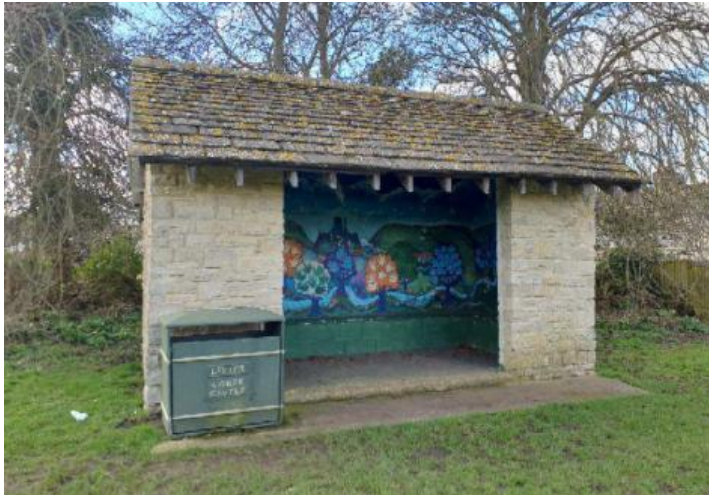
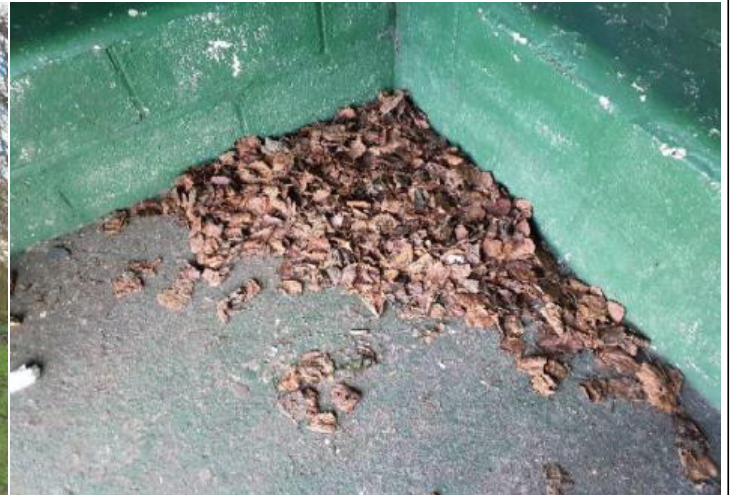
**Item:** Ancillary Items - Shelter  
**Manufacturer:** Not Identified

**Finding:** There is some tree debris on the surfacing

**Action:** Remove and maintain

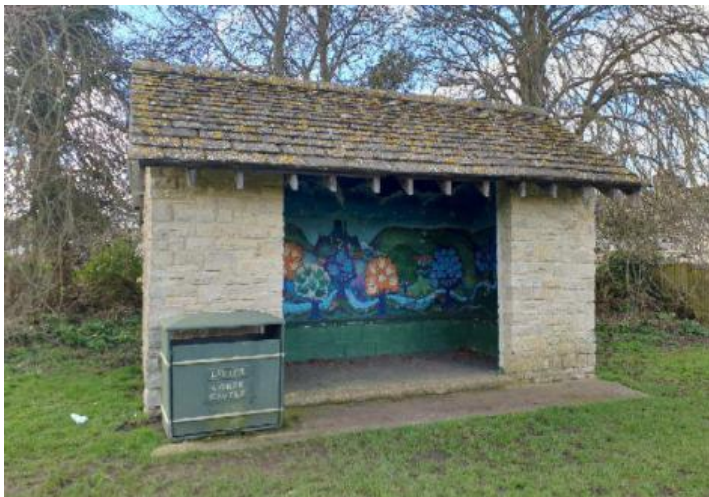
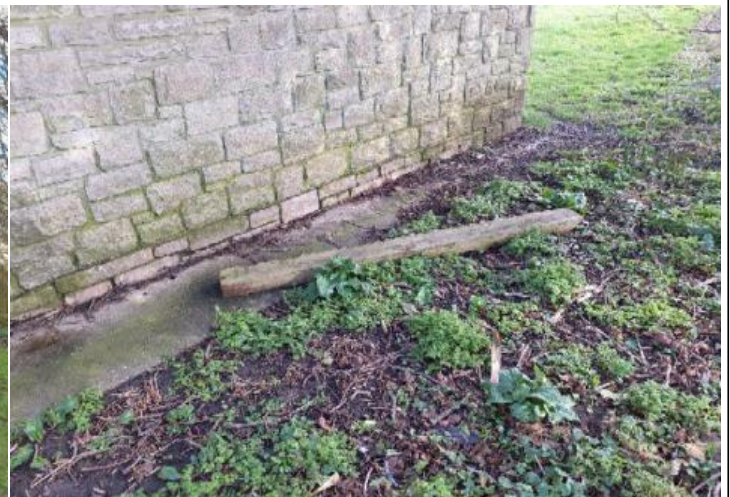
**Item:** Ancillary Items - Shelter  
**Manufacturer:** Not Identified

**Finding:** There is a large piece of timber behind the shelter

**Action:** Remove from the area

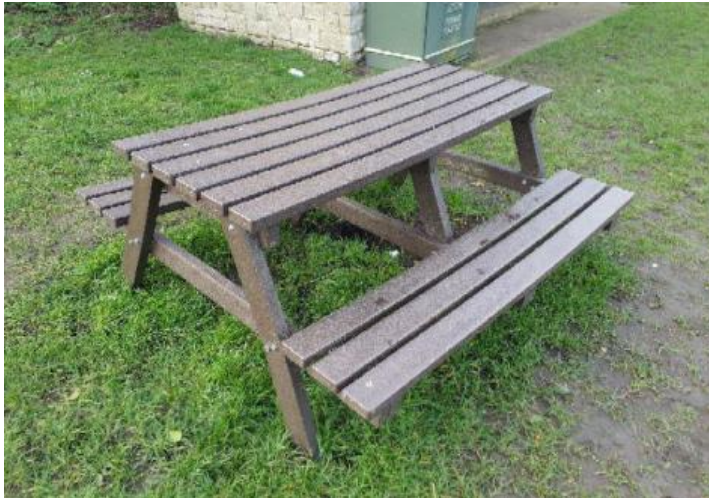
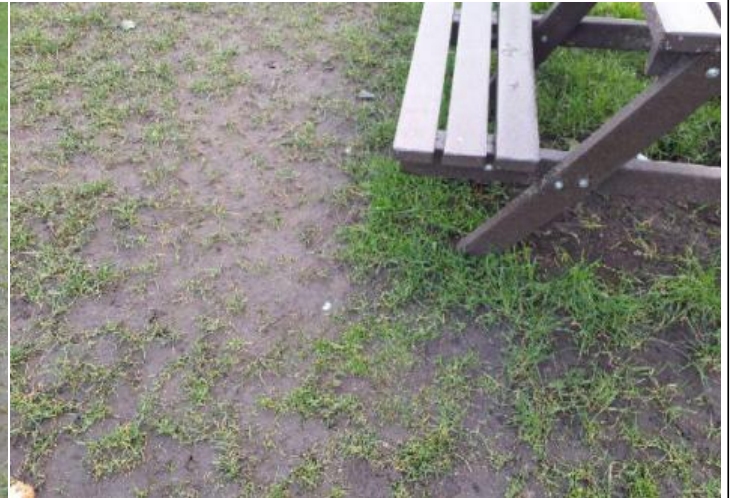
**Item:** Ancillary Items - Picnic Table  
**Manufacturer:** Not Identified

**Finding:** The area around the item has eroded and may become slippery

**Action:** Reinststate eroded area

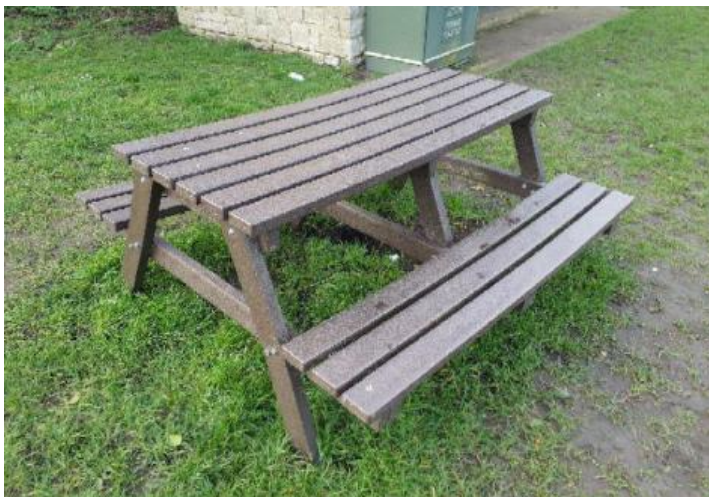
**Item:** Ancillary Items - Picnic Table  
**Manufacturer:** Not Identified

**Finding:** There is some evidence of fire damage to the item

**Action:** Monitor for any further deterioration and repair as required

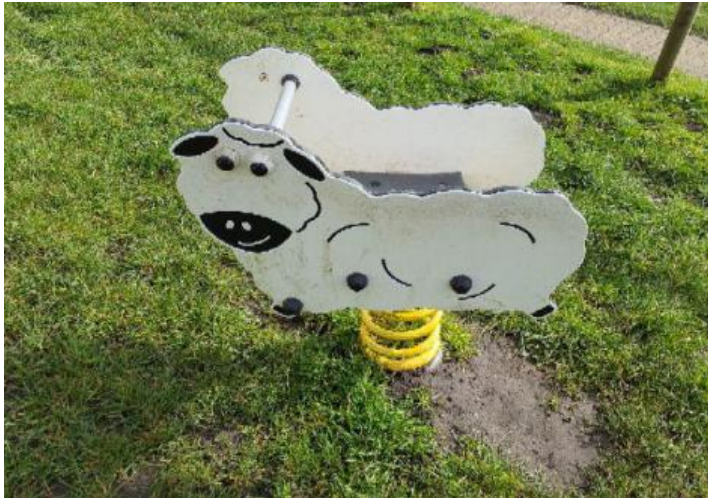
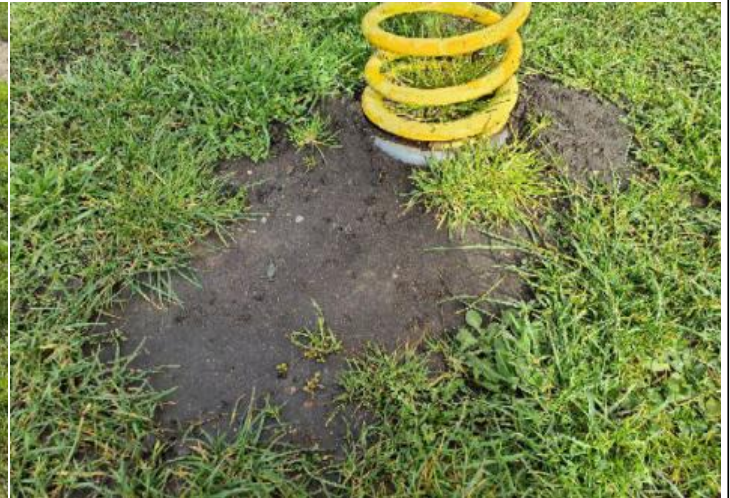
**Item:** Rocking Equipment - Spring Sheep  
**Manufacturer:** Fahr Industries

**Finding:** The area around the item has eroded and may become slippery

**Action:** Reinststate eroded area

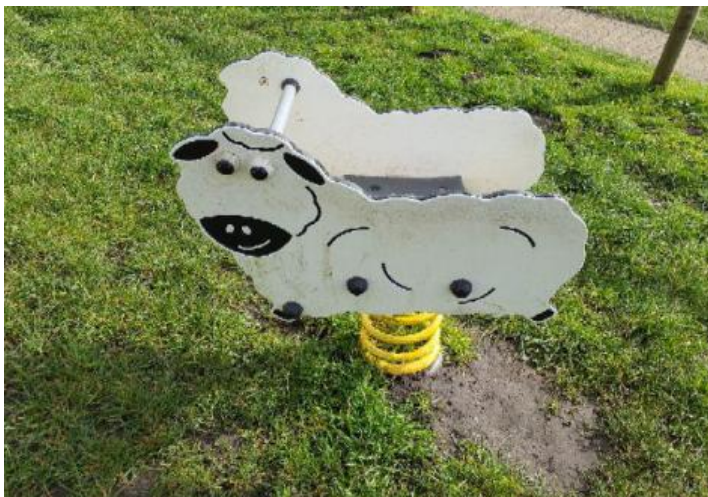
**Item:** Rocking Equipment - Spring Sheep  
**Manufacturer:** Fahr Industries

**Finding:** The paintwork on this item has been damaged or worn exposing the metal underneath which is rusting

**Action:** Treat any rusting components and repaint

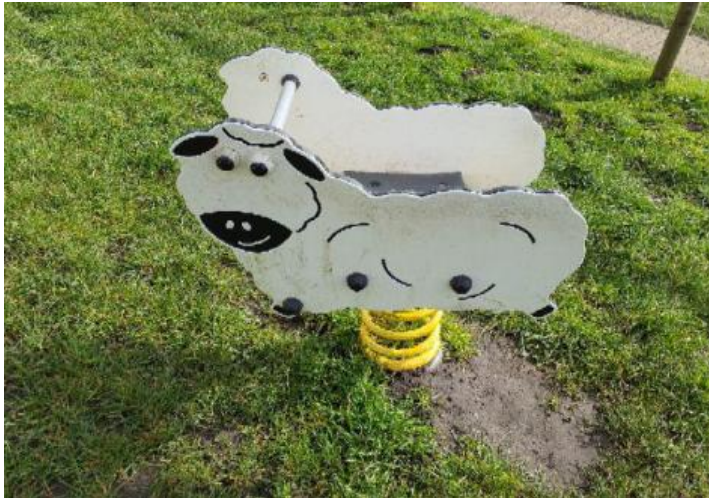
**Item:** Rocking Equipment - Spring Sheep  
**Manufacturer:** Fahr Industries

**Finding:** The fixings have corroded excessively

**Action:** Replace all corroded fixings

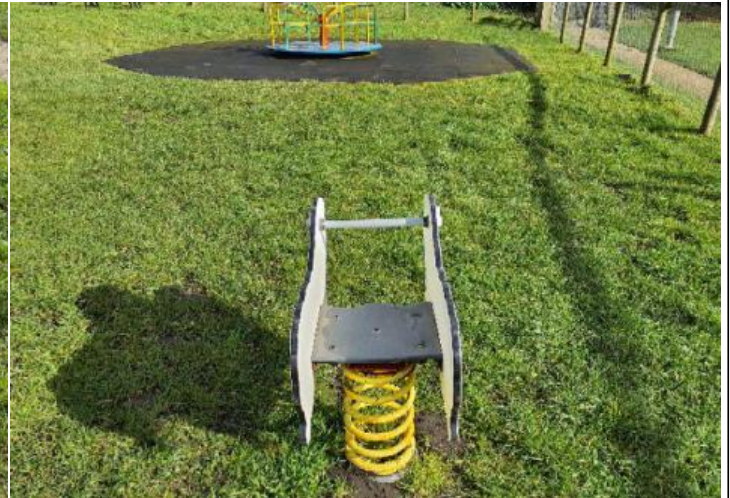
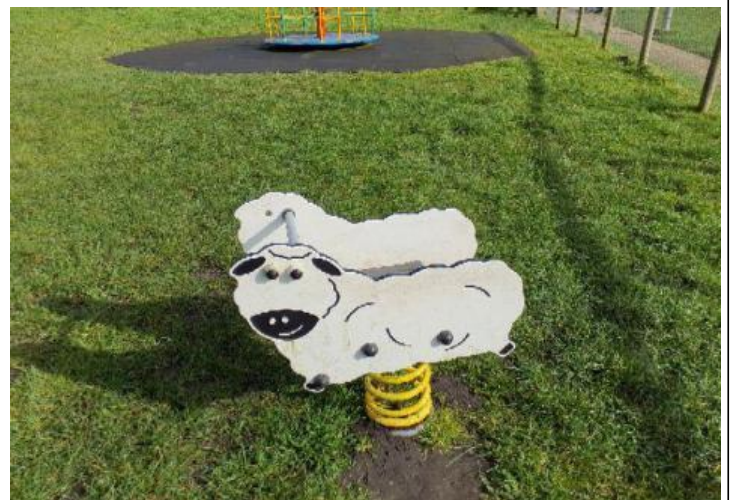
**Item:** Rocking Equipment - Spring Sheep  
**Manufacturer:** Fahr Industries

**Finding:** The spring rotates easily on the base

**Action:** Secure spring to prevent rotation

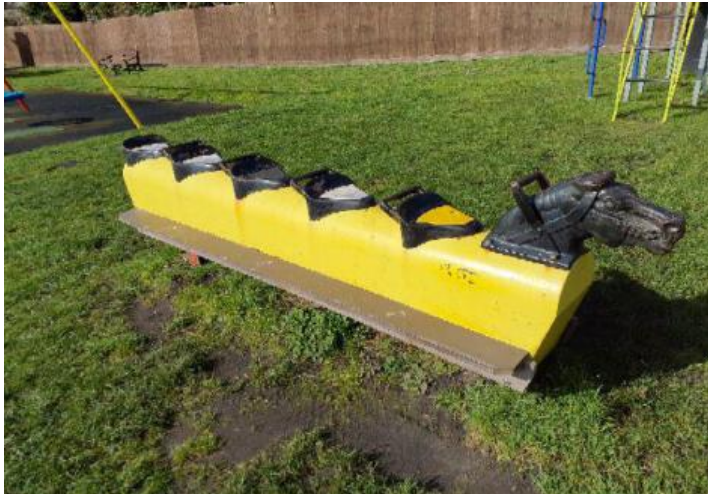
**Item:** Rocking Equipment - Rocking Horse  
**Manufacturer:** Wicksteed Playgrounds

**Finding:** The item has exposed edges and corners with a radius of less than 3mm and fails the requirements of BS EN 1176 **Action:** Provide a 3mm radius to all exposed edges and corners

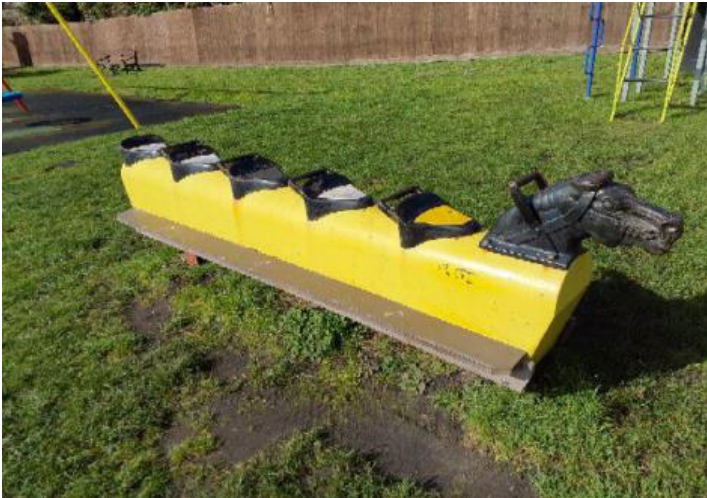
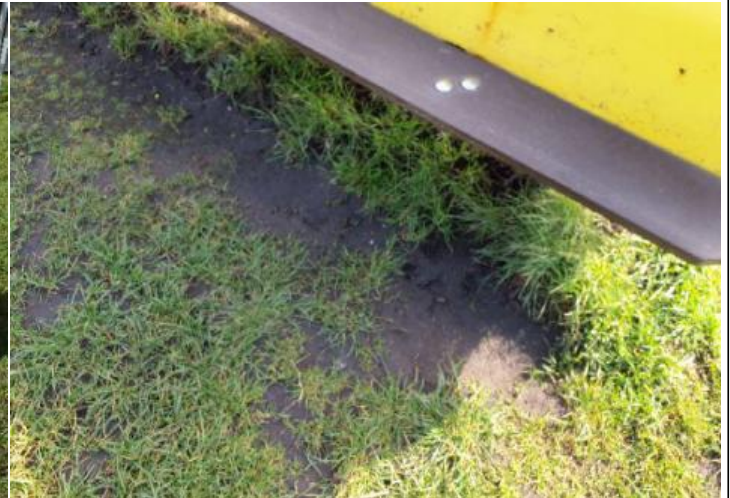
**Item:** Rocking Equipment - Rocking Horse  
**Manufacturer:** Wicksteed Playgrounds

**Finding:** The area around the item has eroded and may become slippery

**Action:** Reinststate eroded area

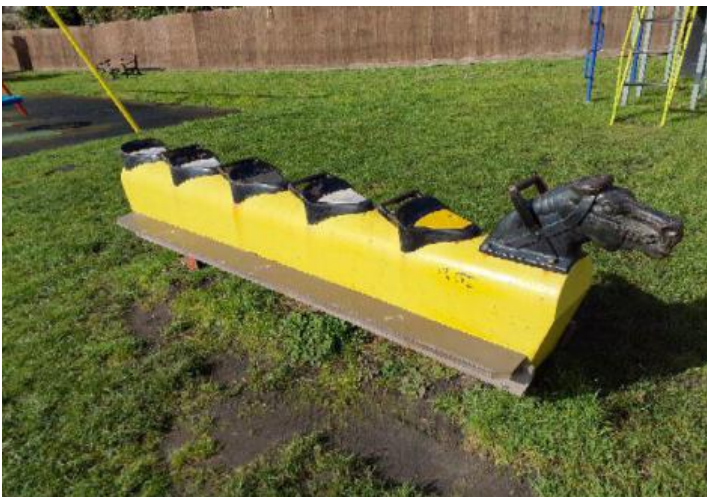
**Item:** Rocking Equipment - Rocking Horse  
**Manufacturer:** Wicksteed Playgrounds

**Finding:** The seat has minor damage or wear

**Action:** Monitor for any further deterioration and replace as required

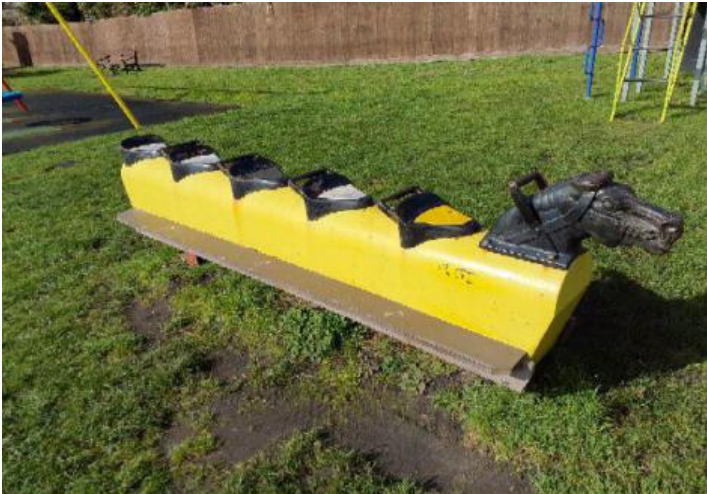
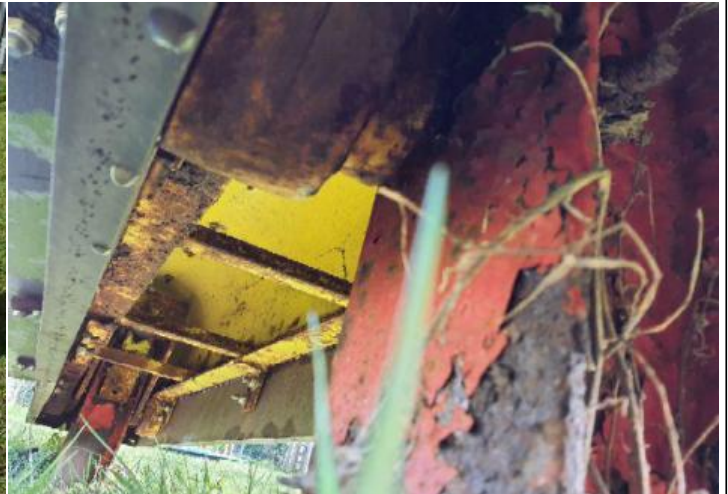
**Item:** Rocking Equipment - Rocking Horse  
**Manufacturer:** Wicksteed Playgrounds

**Finding:** There is no gaiter protection for accessible moving parts (possible shear trap) as recommended in BS EN 1176 Part 1; 4.2.6 Moving Parts

**Action:** Monitor - No remedial work recommended

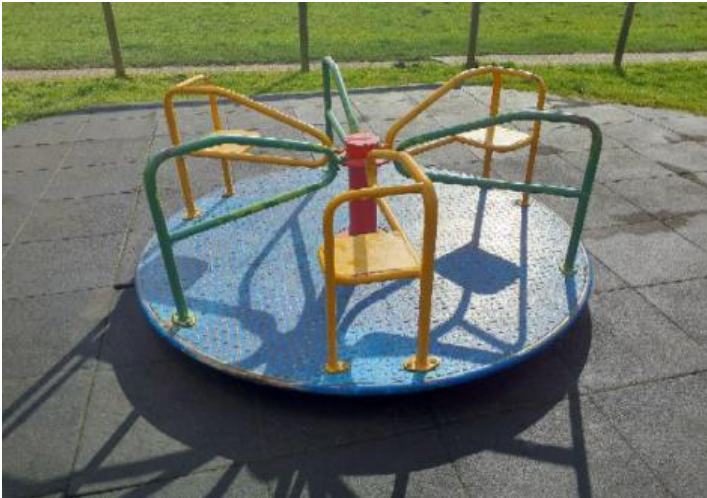
**Item:** Rotor Play - Roundabout  
**Manufacturer:** Not Identified

**Finding:** There are gaps opening in between the tiles

**Action:** Repair

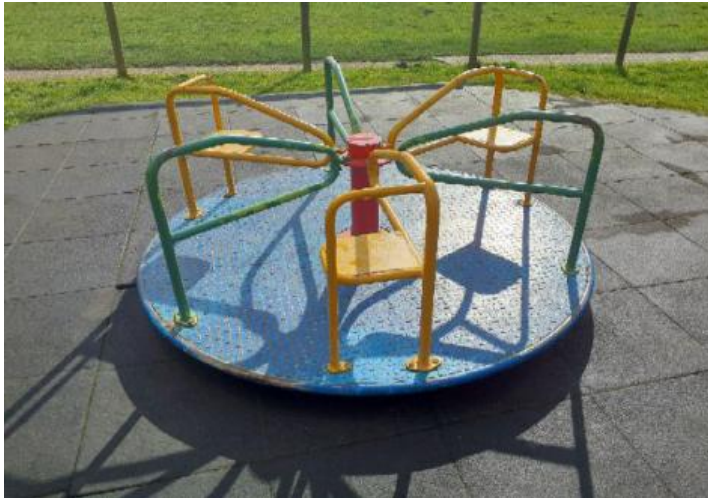
**Item:** Rotor Play - Roundabout  
**Manufacturer:** Not Identified

**Finding:** A number of fixing(s) have worked loose

**Action:** Secure all loose fixings

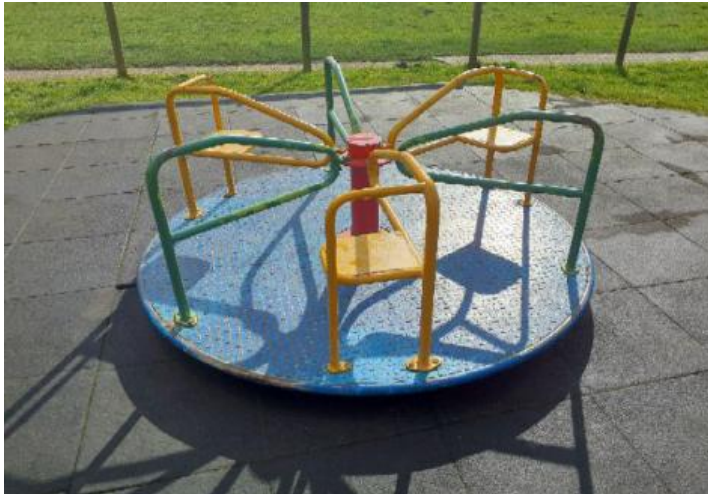
**Item:** Rotor Play - Roundabout  
**Manufacturer:** Not Identified

**Finding:** The paintwork on this item has been damaged or worn exposing the metal underneath which is rusting

**Action:** Treat any rusting components and repaint

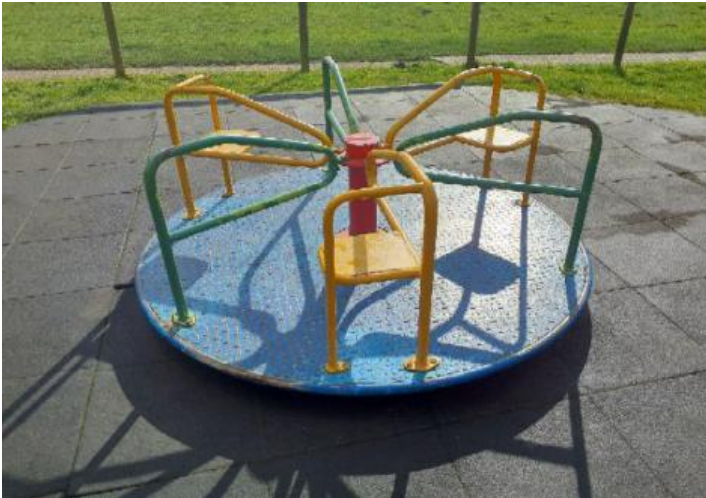
**Item:** Rotor Play - Roundabout  
**Manufacturer:** Not Identified

**Finding:** Parts of the steel on this item have corroded excessively and the metal has perforated in places

**Action:** Ensure all affected areas are treated and repaired

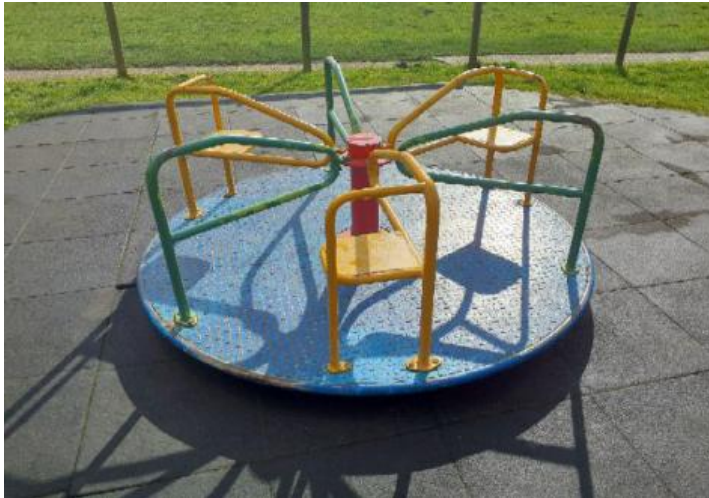
**Item:** Rotor Play - Roundabout  
**Manufacturer:** Not Identified

**Finding:** The bearing is showing signs of wear

**Action:** Monitor for any further deterioration and replace as required

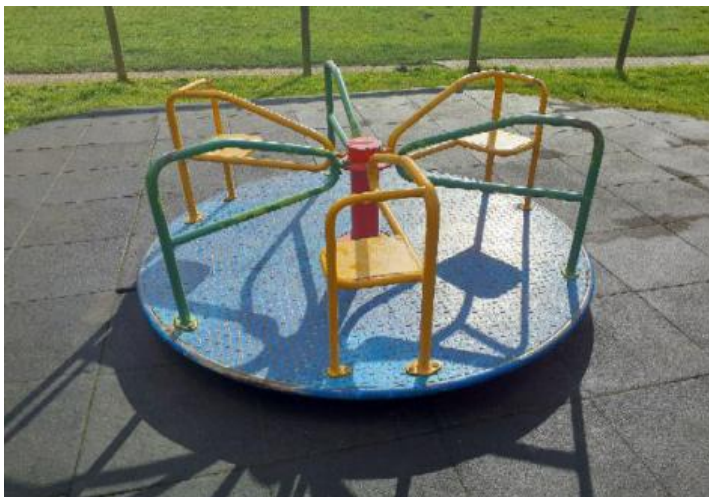
**Item:** Rotor Play - Roundabout  
**Manufacturer:** Not Identified

**Finding:** There is moderate damage to the surface

**Action:** Repair the damaged areas of surfacing

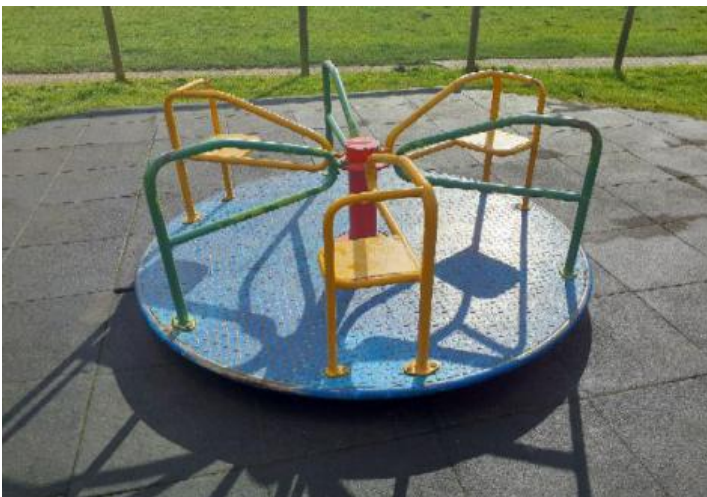
**Item:** Rotor Play - Roundabout  
**Manufacturer:** Not Identified

**Finding:** There are trip hazards at the edges of the surface **Action:** Reinstate surrounding surface levels to remove the trip points
