## Annual Inspection

Corfe Castle Parish Council

West Street Play Area

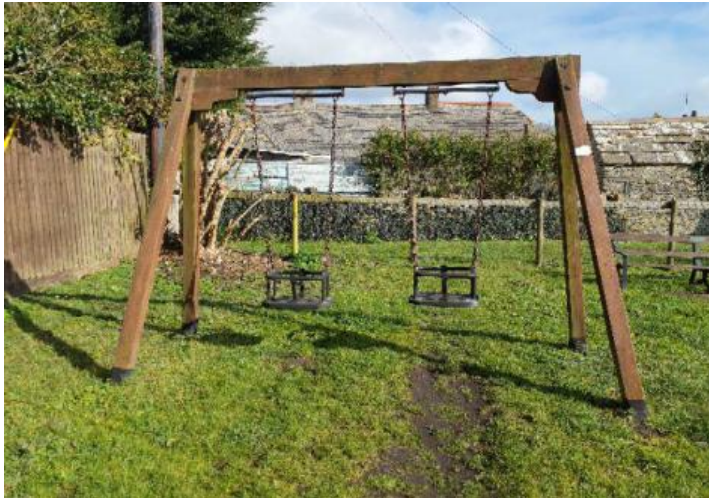
**Item:** Swings - 1 Bay 2 Seat (Cradle)  
**Manufacturer:** Taylor Made Play Equipment

**Finding:** There is some strimmer / machinery damage apparent on the posts, this can penetrate the preservative applied to the timber and accelerate the rotting process. The timber has been covered making it difficult to now test for rot without removing the plastic covering

**Action:** Remove the plastic covering to check for any deterioration (rot) and replace as required

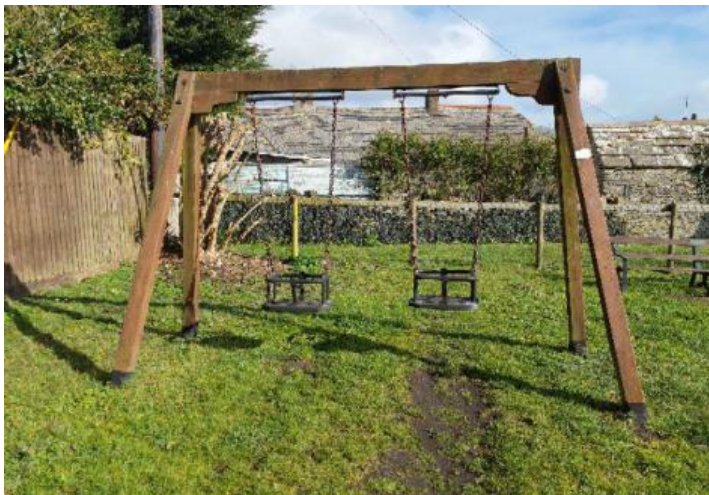
**Item:** Swings - 1 Bay 2 Seat (Cradle)  
**Manufacturer:** Taylor Made Play Equipment

**Finding:** The grass mats are silted up and the soil is compacted; this may have an effect on the impact absorbing properties of the surface

**Action:** Consider HIC testing impact absorbing properties to ensure the correct surface qualities are maintained for the equipment and replace as required

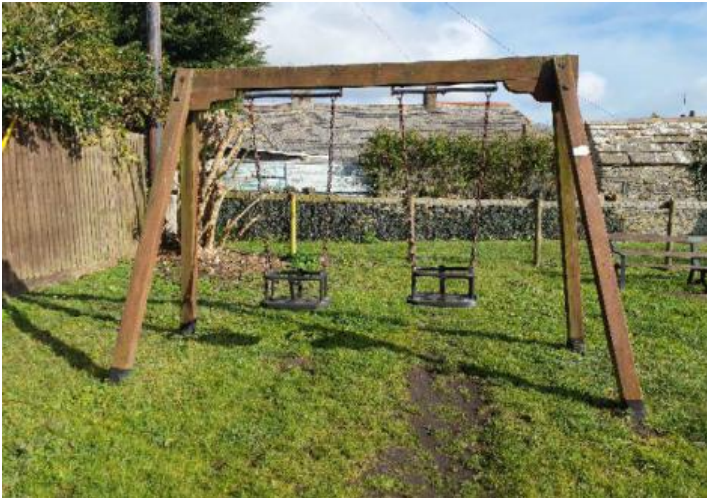
**Item:** Swings - 1 Bay 2 Seat (Cradle)  
**Manufacturer:** Taylor Made Play Equipment

**Finding:** The fixings have corroded excessively

**Action:** Replace all corroded fixings

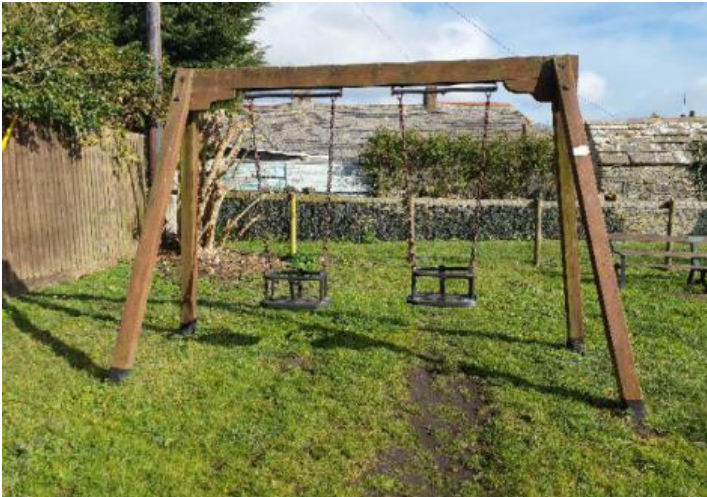
**Item:** Swings - 1 Bay 2 Seat (Cradle)  
**Manufacturer:** Taylor Made Play Equipment

**Finding:** The seat has damage or wear, possibly from internal corrosion

**Action:** Dismantle the seat for inspection and replace as required

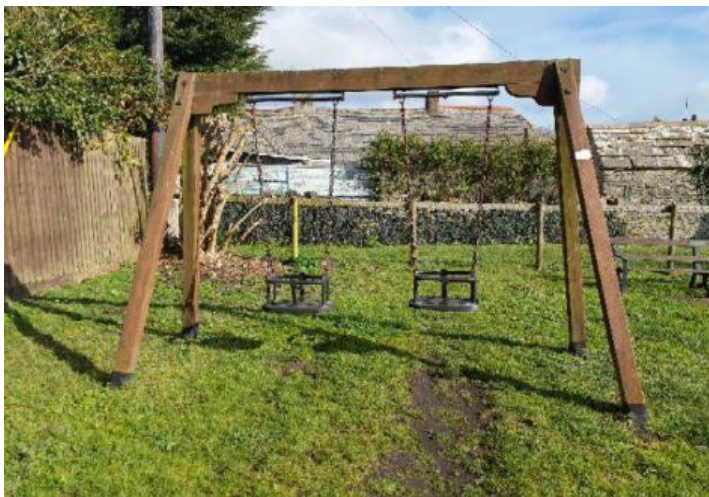
**Item:** Swings - 1 Bay 2 Seat (Cradle)  
**Manufacturer:** Taylor Made Play Equipment

**Finding:** The paintwork on this item has been damaged or worn exposing the metal underneath which is rusting

**Action:** Treat any rusting components and repaint

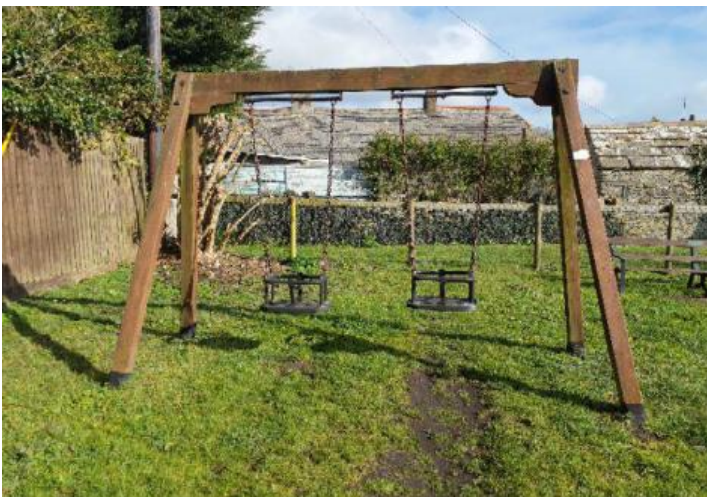
**Item:** Swings - 1 Bay 2 Seat (Cradle)  
**Manufacturer:** Taylor Made Play Equipment

**Finding:** The connecting lugs are showing signs of wear

**Action:** Monitor for any further deterioration and repair as required

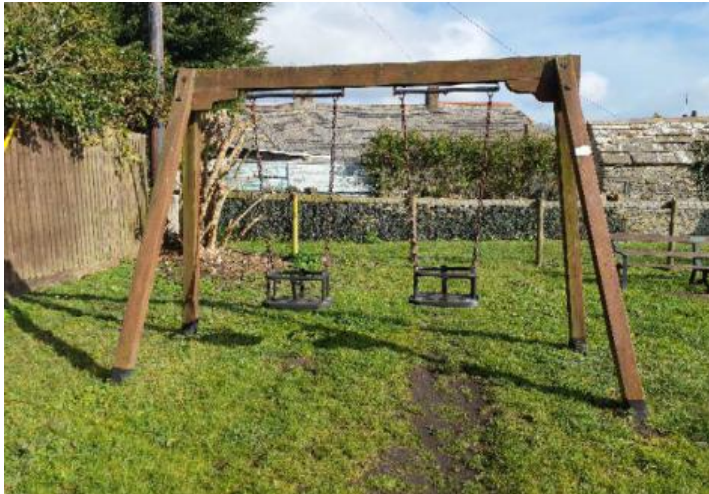
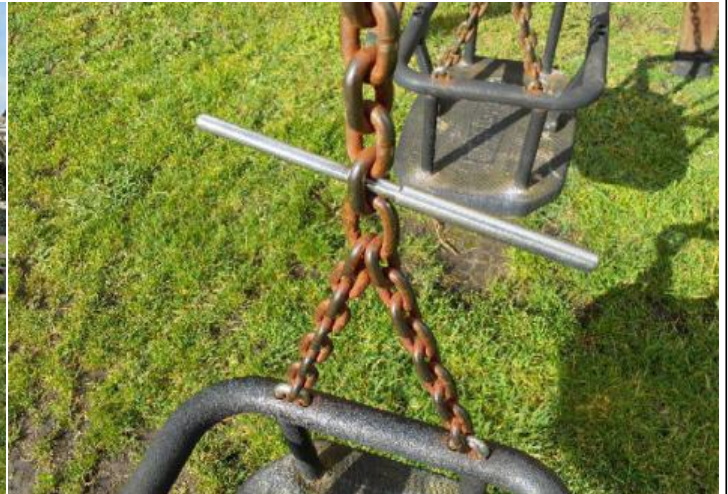
**Item:** Swings - 1 Bay 2 Seat (Cradle)  
**Manufacturer:** Taylor Made Play Equipment

**Finding:** The chain openings are in excess of the 8.6mm as recommended by BS EN 1176

**Action:** Monitor - No remedial work recommended

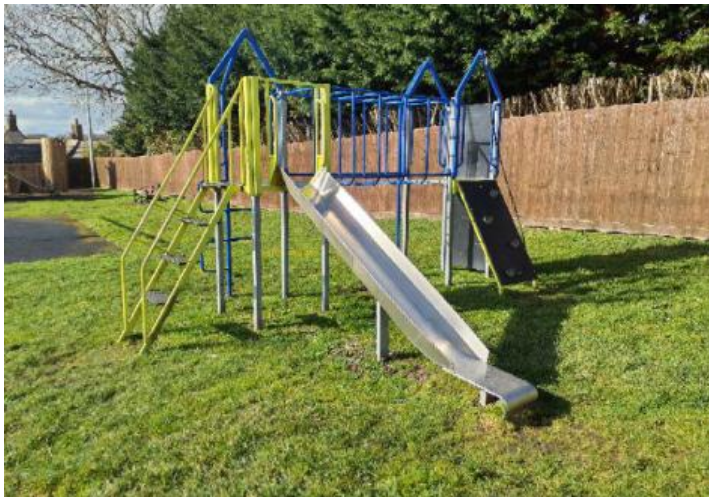
**Item:** Activity Equipment - Multi Play (Junior)  
**Manufacturer:** S M P (Playgrounds Ltd)

**Finding:** A number of fixing(s) have worked loose  
**Action:** Secure all loose fixings

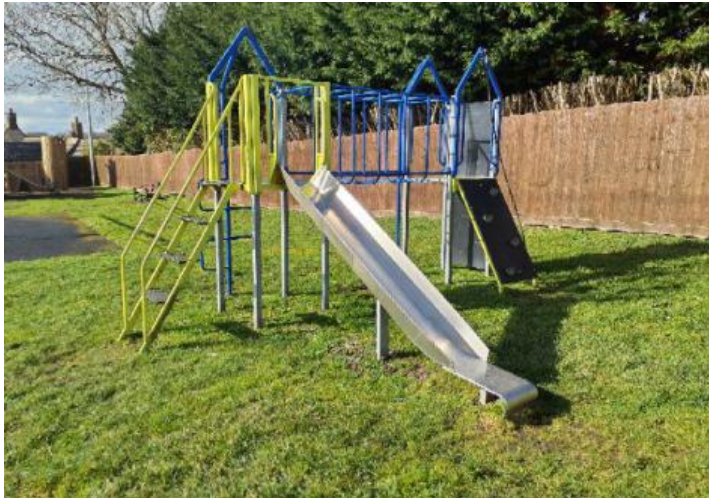
**Item:** Activity Equipment - Multi Play (Junior)  
**Manufacturer:** S M P (Playgrounds Ltd)

**Finding:** The fixings have corroded excessively

**Action:** Replace all corroded fixings

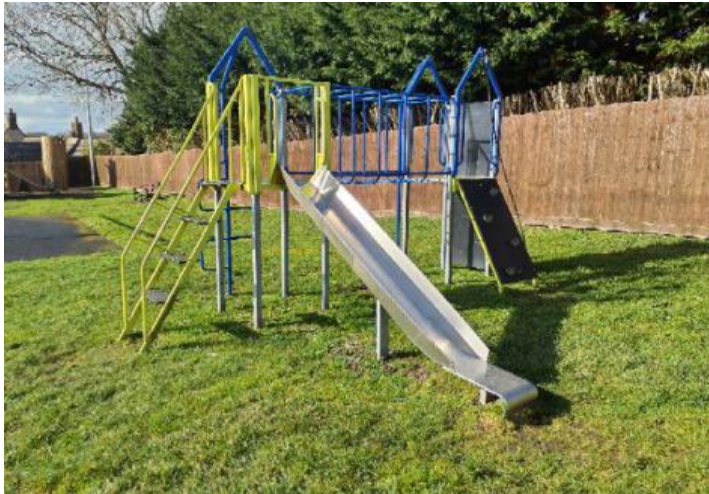
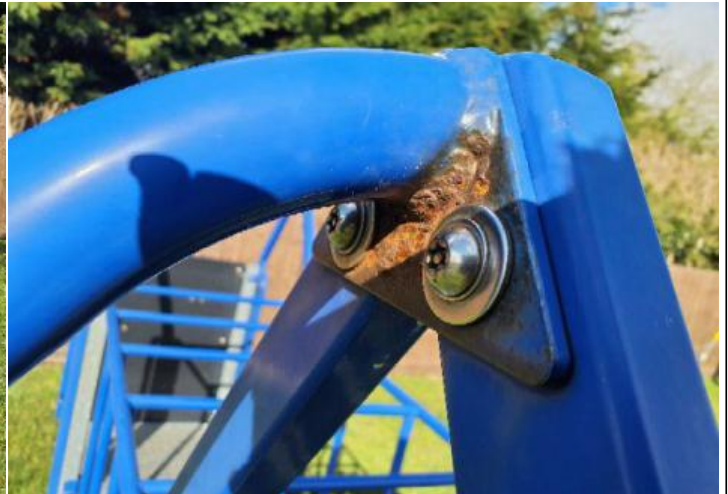
**Item:** Activity Equipment - Multi Play (Junior)  
**Manufacturer:** S M P (Playgrounds Ltd)

**Finding:** The paintwork on this item has been damaged or worn exposing the metal underneath which is rusting

**Action:** Treat any rusting components and repaint

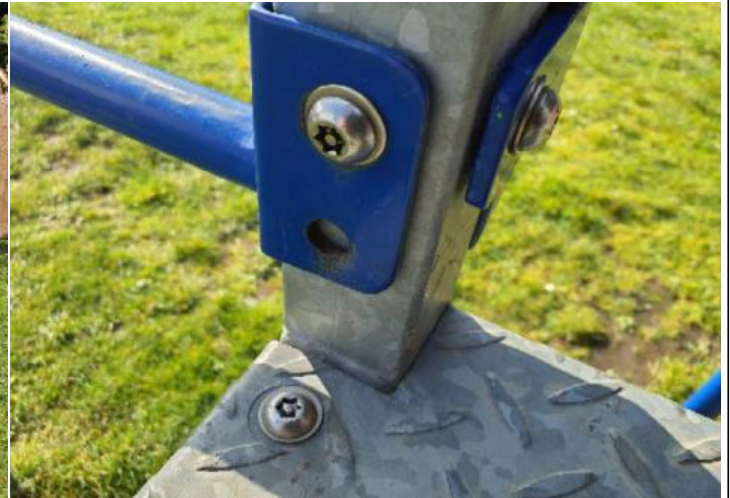
**Item:** Activity Equipment - Multi Play (Junior)  
**Manufacturer:** S M P (Playgrounds Ltd)

**Finding:** There are unused fixing holes

**Action:** Refer to manufacturer

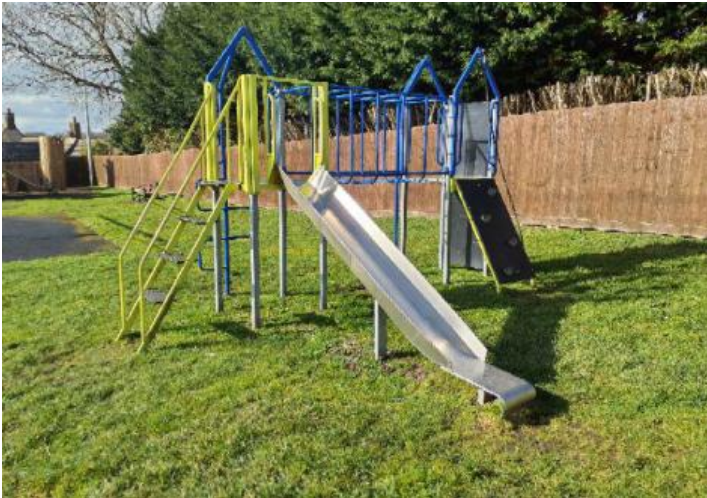
**Item:** Activity Equipment - Multi Play (Junior)  
**Manufacturer:** S M P (Playgrounds Ltd)

**Finding:** There is some wear to the shackles

**Action:** Monitor for any further deterioration and replace when 40% worn

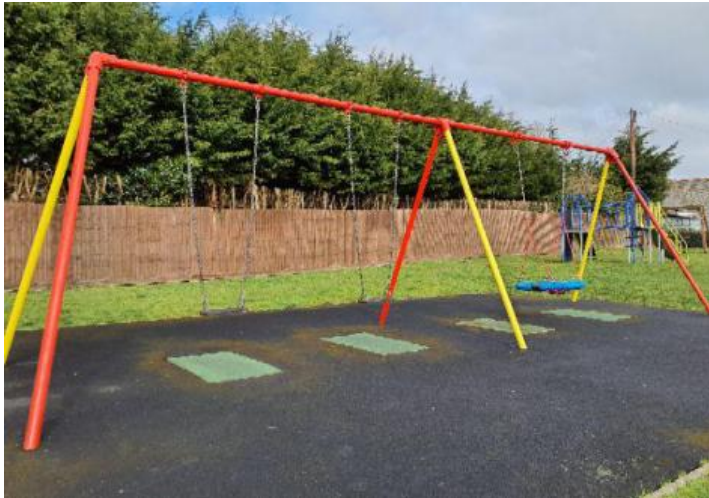
**Finding:** There are gaps opening between the surfacing and the edging surround or between the joints in the surfacing  
**Action:** Monitor for any further deterioration and repair as required

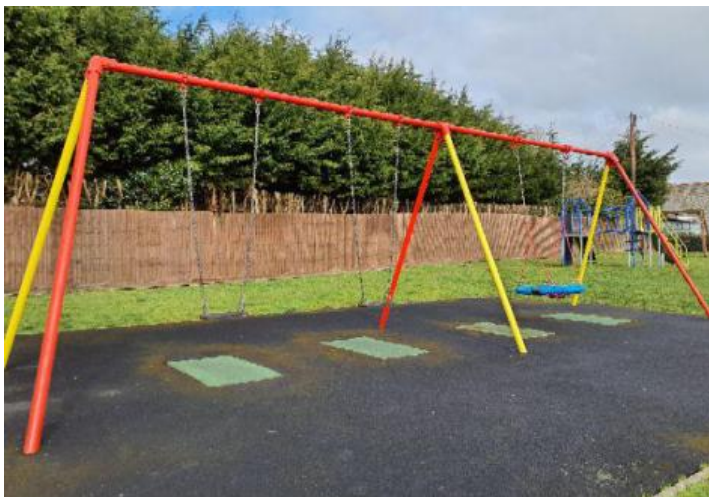
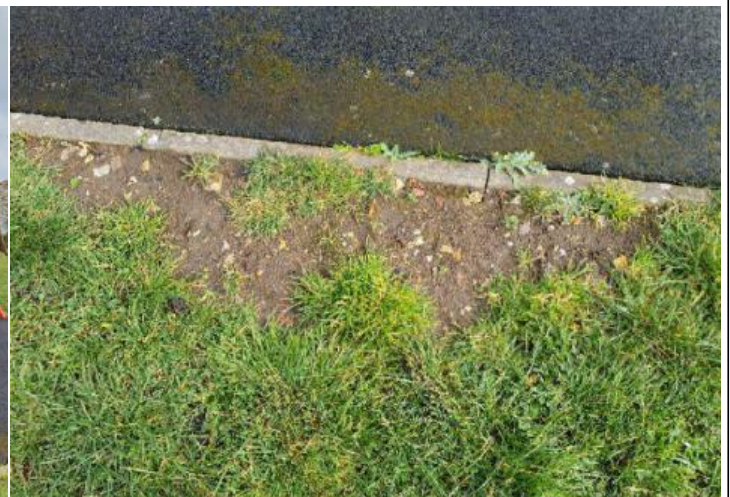
**Finding:** The area around the item has eroded and may become slippery  
**Action:** Reinstate eroded area

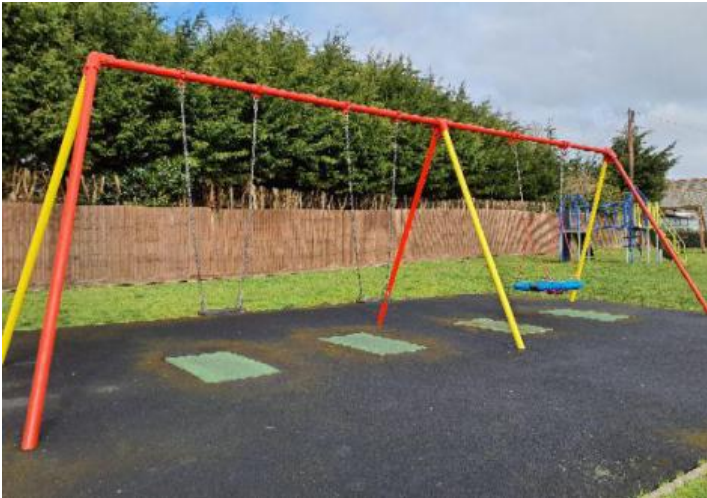
**Finding:** Crucifix or T connectors should have at least two complete chain links through the connector to meet with the manufacturers recommendations

**Action:** Rectify installation to ensure at least two complete links are through the connectors

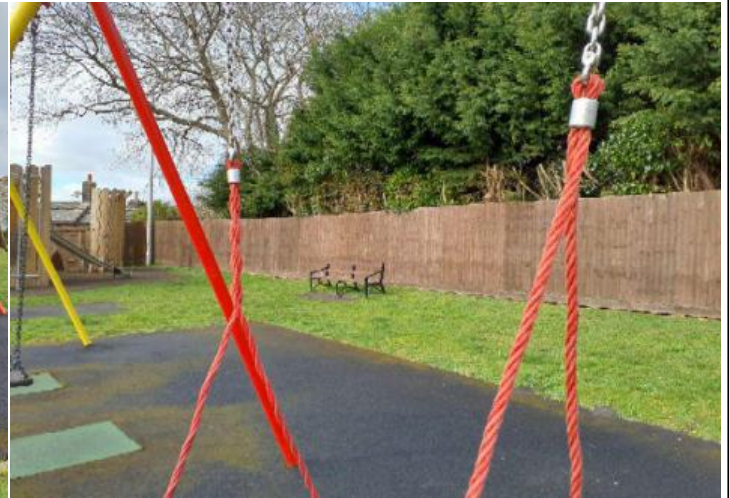
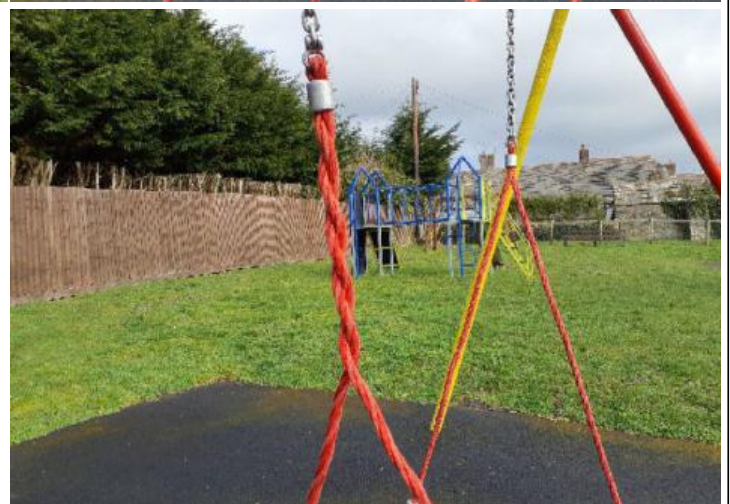
**Finding:** The ropes are twisted

**Action:** Untwist and reset

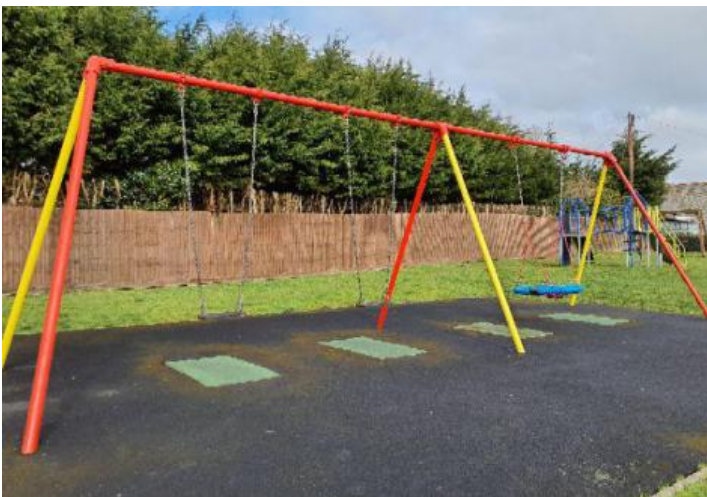
**Finding:** There is some flex in the frame when in use JD - NO

**Action:** Monitor use and repair as required

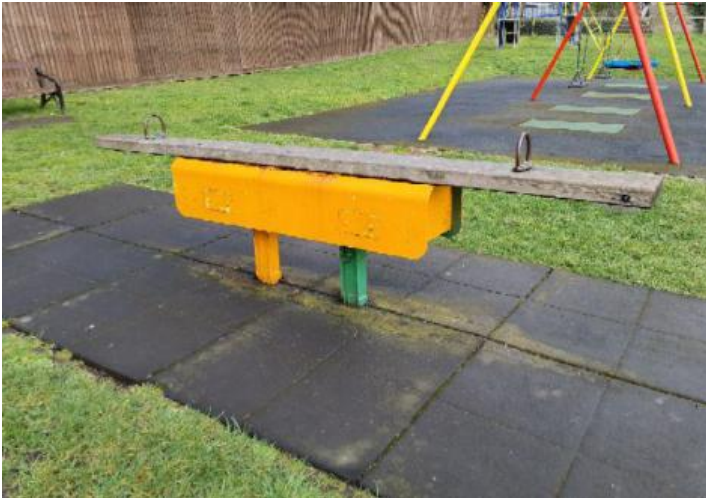
**Finding:** There are gaps opening in between the tiles

**Action:** Monitor for any further deterioration and repair as required

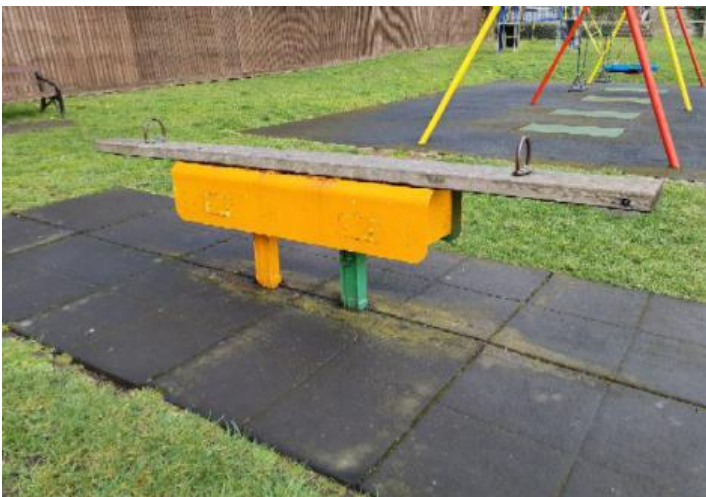
**Finding:** There is some minor damage to the surface

**Action:** Monitor for any further deterioration and repair as required

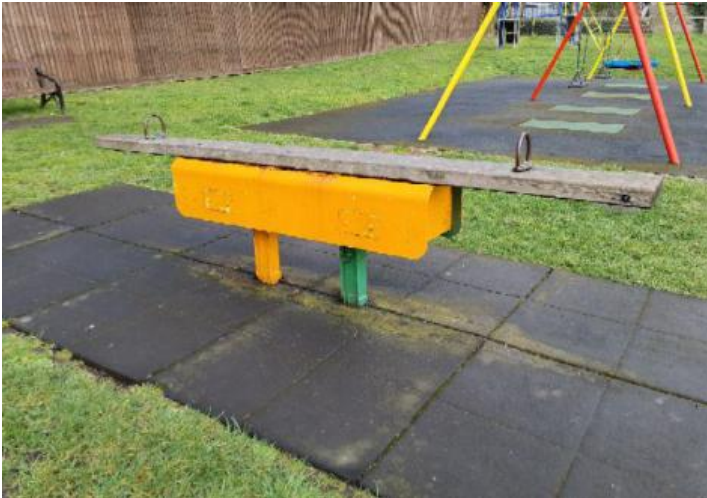
**Finding:** The paintwork on this item has been damaged or worn exposing the metal underneath which is rusting

**Action:** Treat any rusting components and repaint

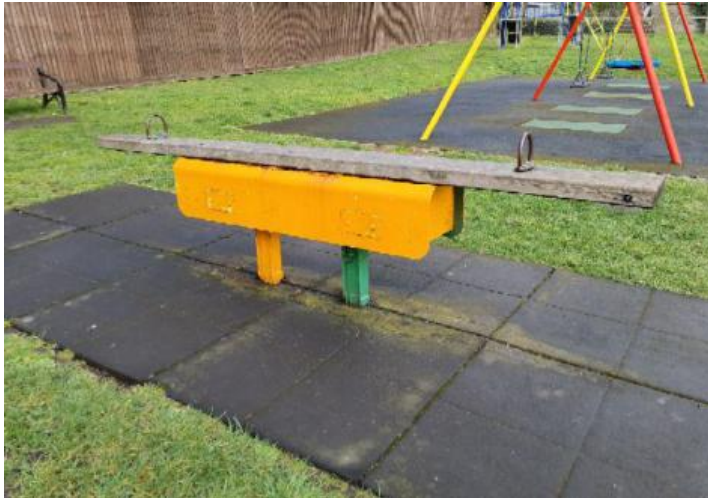
**Finding:** There is no gaiter protection for accessible moving parts (possible shear trap) as recommended in BS EN 1176 Part 1; 4.2.6 Moving Parts

**Action:** Monitor - No remedial work recommended

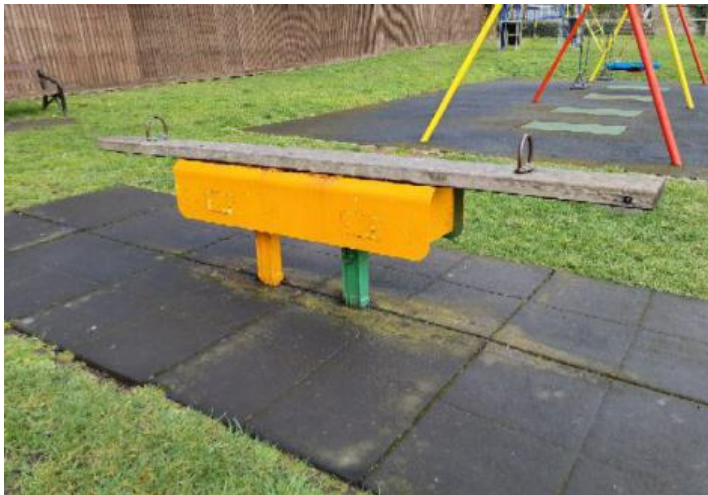
**Finding:** There are trip hazards present

**Action:** Reinstate surrounding surfaces to level to remove the trip points

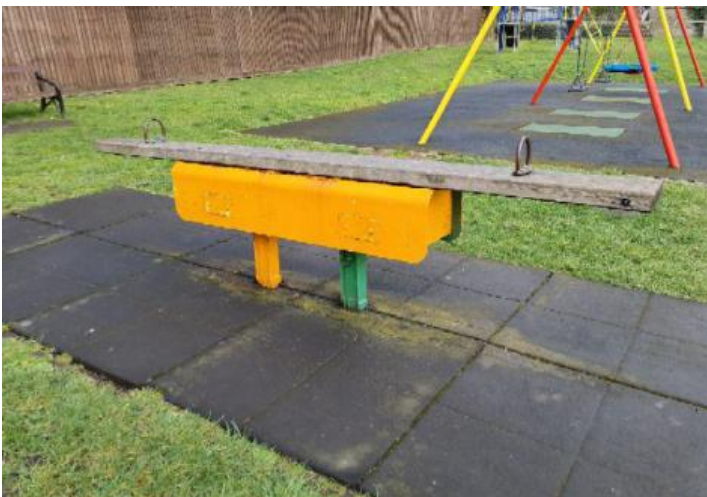
**Finding:** The mechanism is worn / damaged

**Action:** Repair / replace

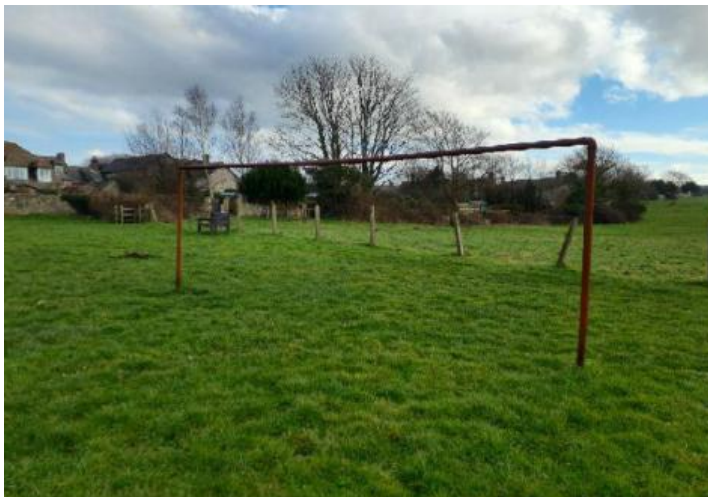
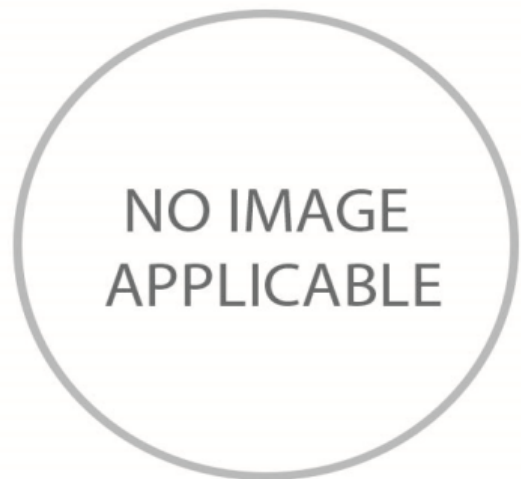
**Finding:** NB: We have undertaken a maintenance inspection only of the football goal(s); full load testing falls outside the scope of our inspection.

**Action:** Implement load testing as required

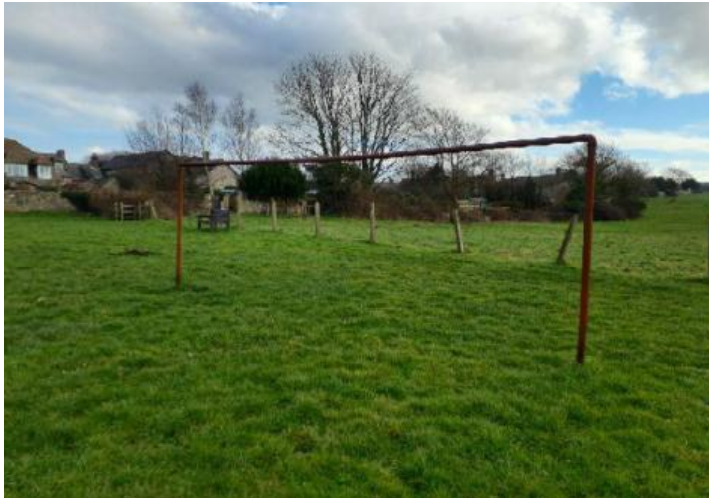
**Finding:** There is surface corrosion present on the item

**Action:** Treat the item

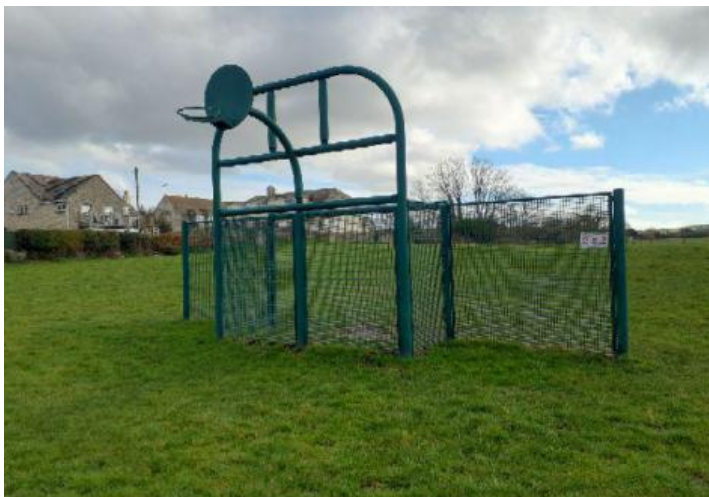
**Finding:** There is/are finger entrapments in the frame and the item fails to meet the requirements of BS EN 15312 Clause 4.4.2.2 Entrapment of fingers

**Action:** Monitor - No remedial work recommended

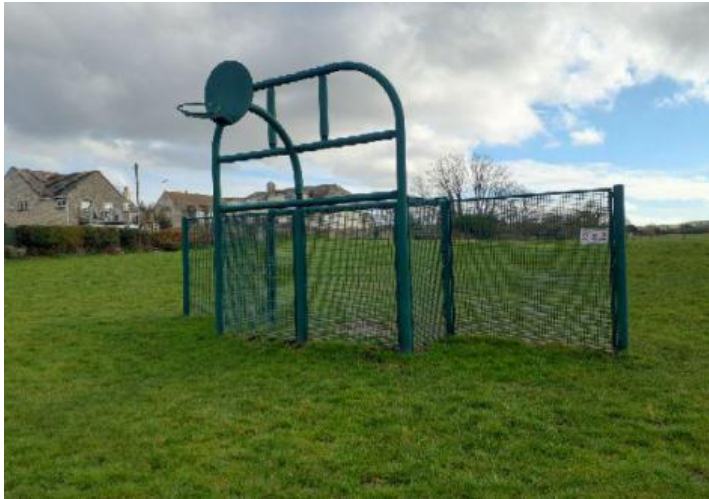
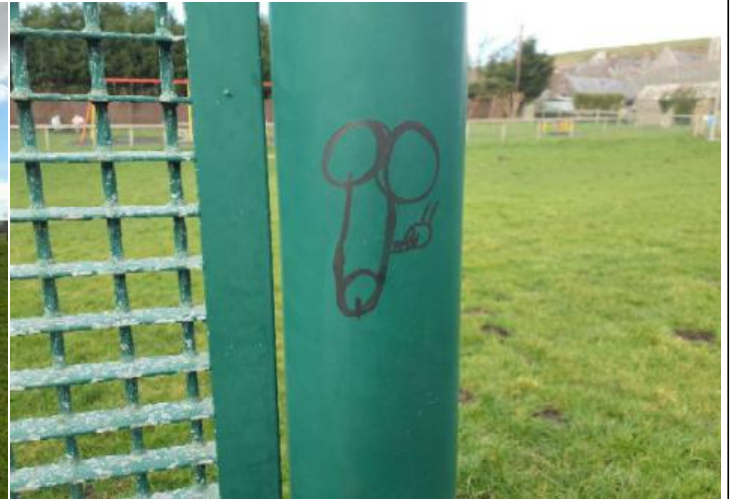
**Finding:** There is offensive graffiti present

**Action:** Remove as soon as practicable

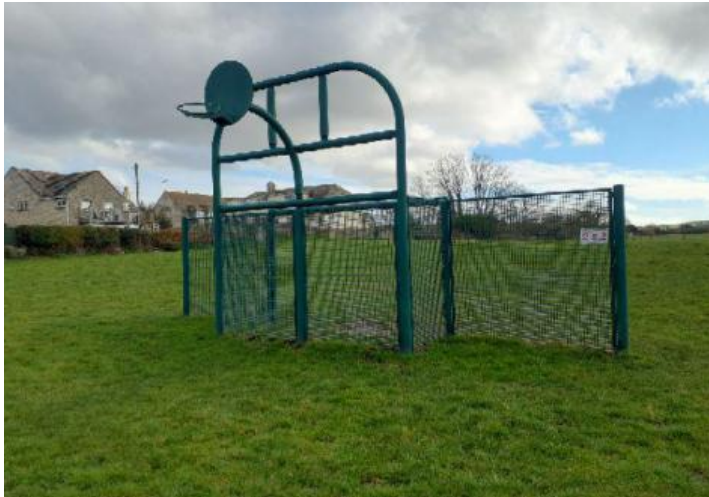
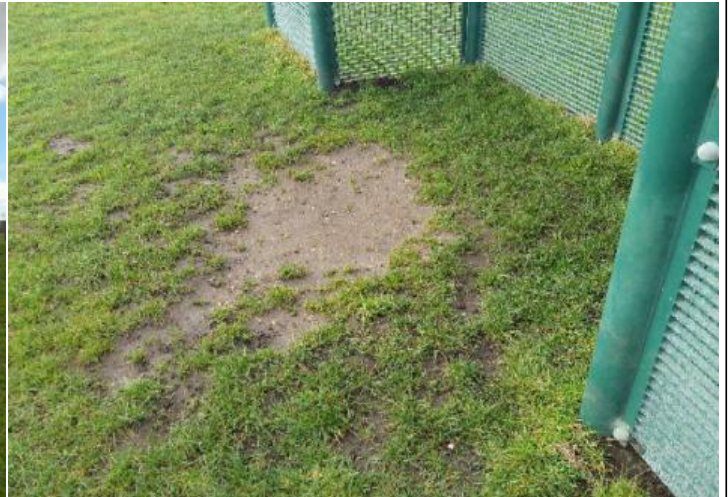
**Finding:** The area around the item has eroded and may become slippery

**Action:** Reinststate eroded area

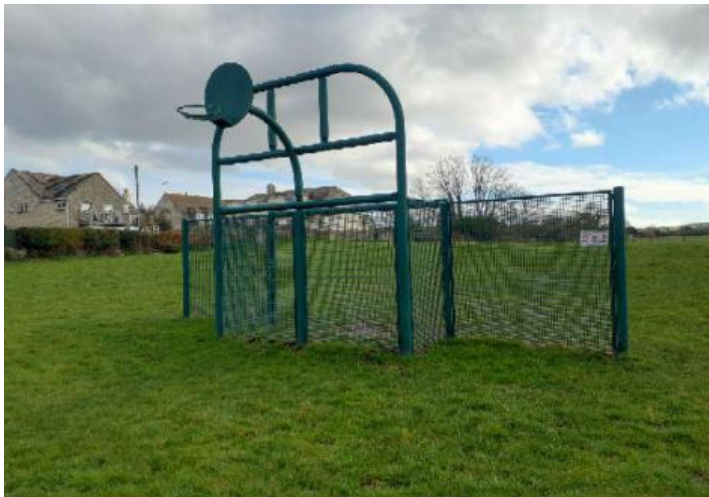
**Finding:** There is/are bolt cap covers missing or damaged on the item

**Action:** Replace missing or damaged bolt cap covers

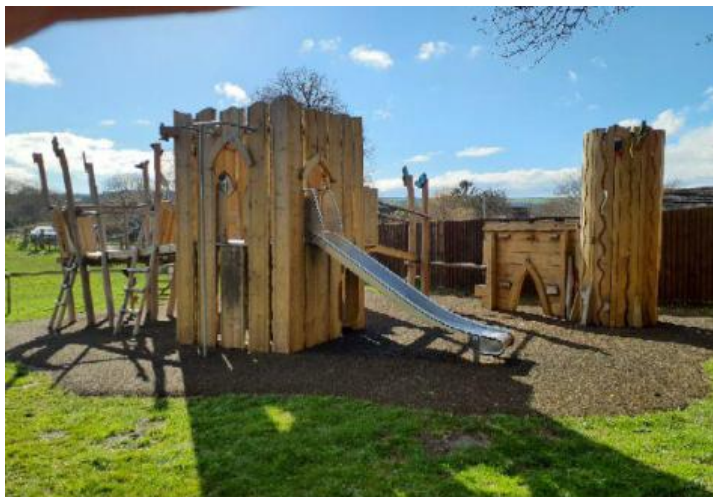
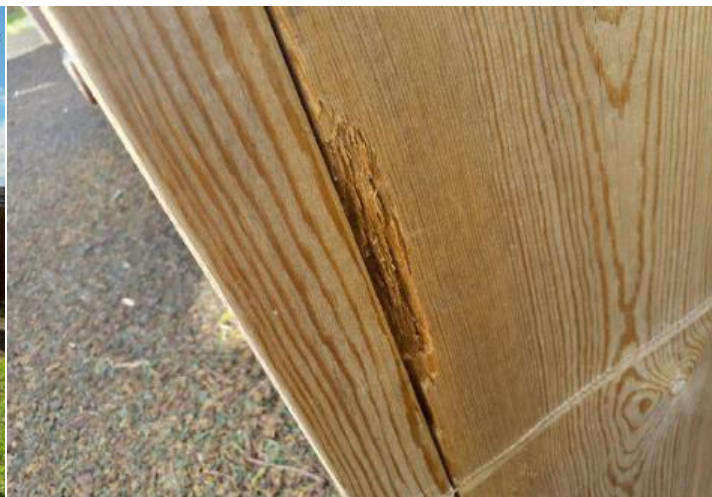
**Finding:** Parts of the timber are rough or splintered

**Action:** Remove all rough or sharp edges

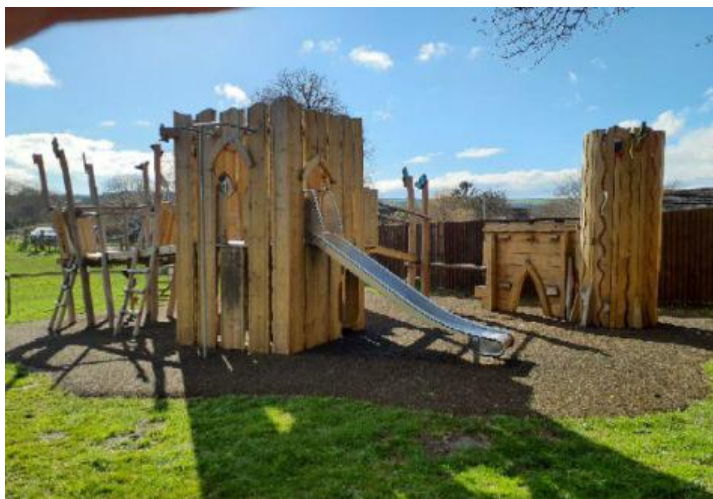
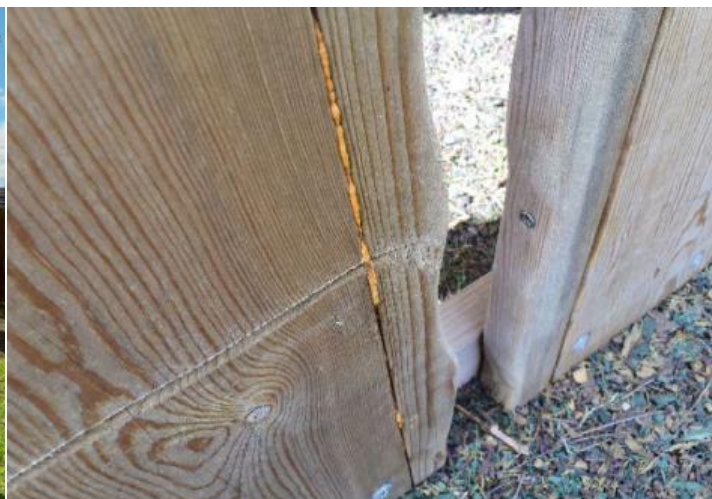
**Finding:** The use of synthetic fillers in timber is not recommended; timber being a natural material will expand and contract as the moisture content changes and the use of fillers can exacerbate the length and depth of these cracks or shakes in the timber. The only treatment that is normally required is the removal of any rough or sharp edges unless the structural integrity of the item is affected.

**Action:** Remove any rough or sharp edges and monitor timber for any further deterioration

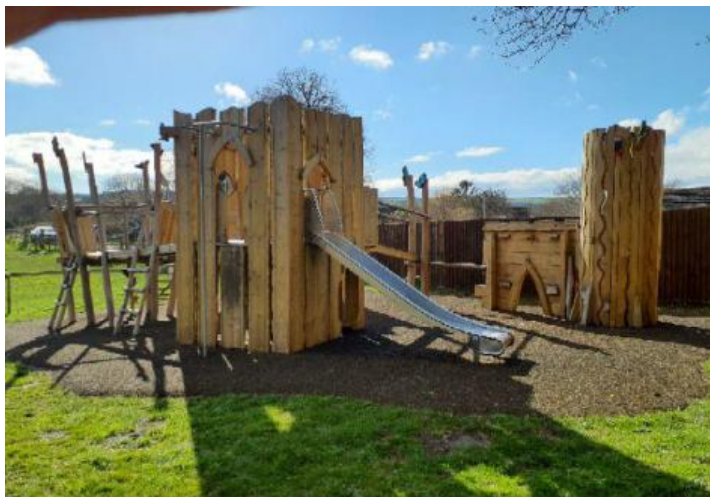
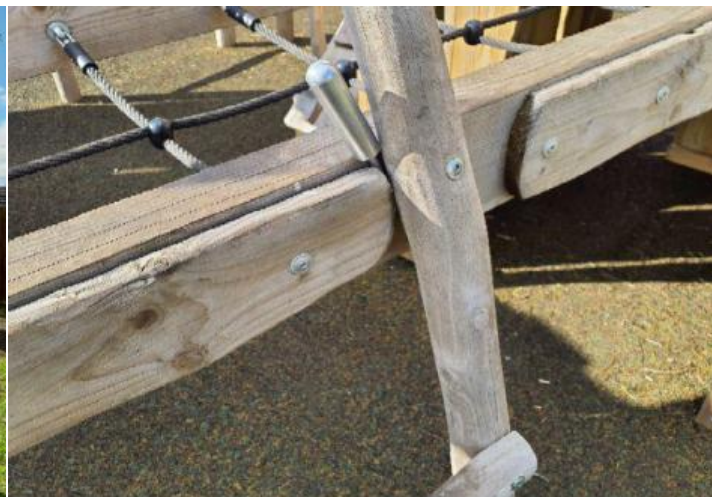
**Finding:** There is/are finger entrapment/s in the ladder and the item fails to meet the requirements of BS EN 1176 Part 1 4.2.7.6 Entrapment of fingers  
**Action:** Monitor - No remedial work recommended

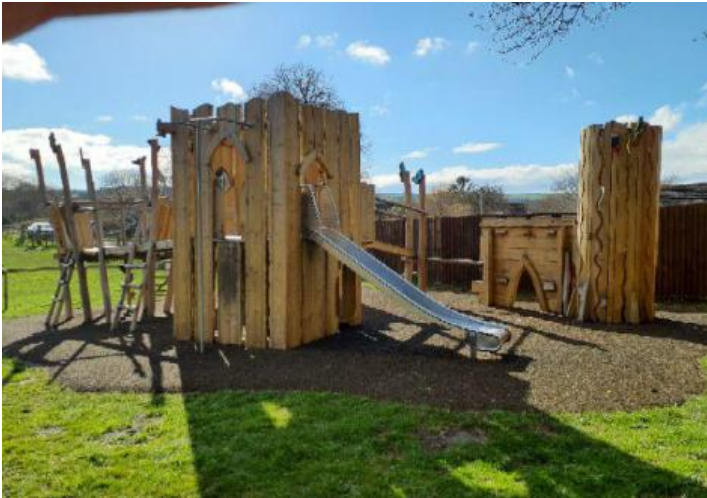
**Finding:** There are sharp edges where the barrier slats have been cut to create an entrance to below the multi-play

**Action:** Round off the sharp points

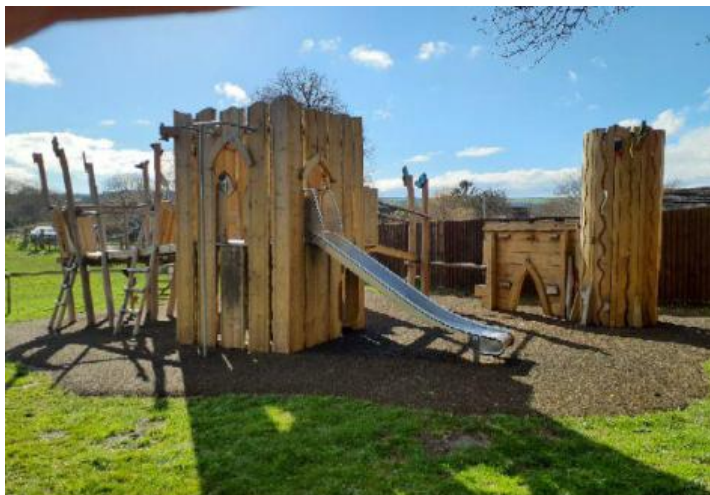
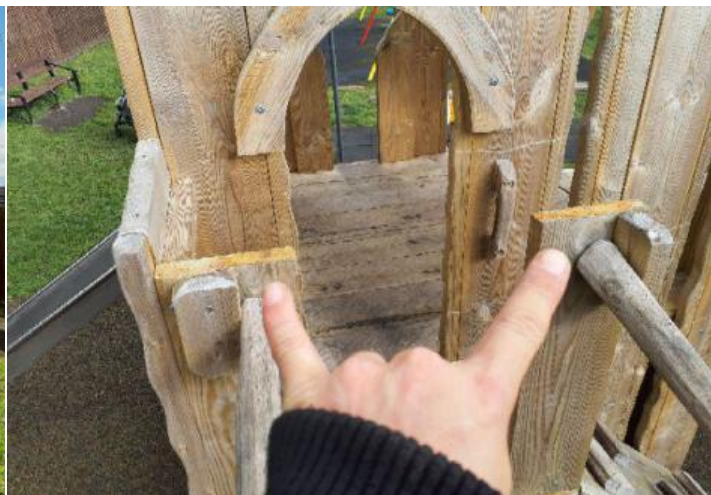
**Finding:** The item has missing component(s)

**Action:** Consider replacing missing components

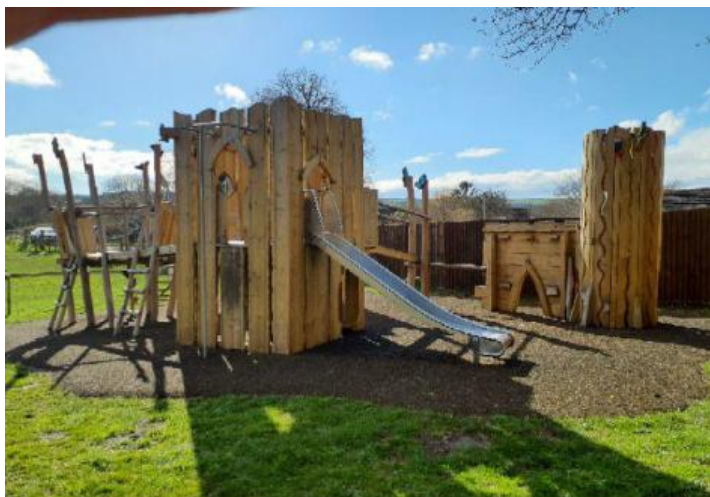
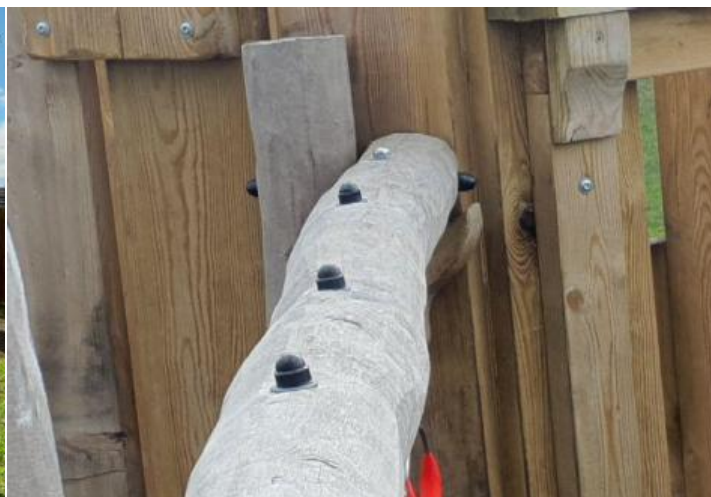
**Finding:** There is/are bolt cap covers missing or damaged on the item

**Action:** Replace missing or damaged bolt cap covers

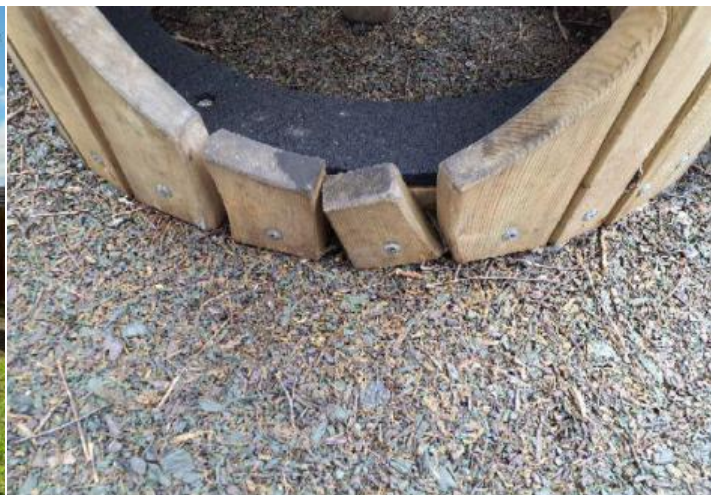
**Finding:** There is some damage to the barrier

**Action:** Repair

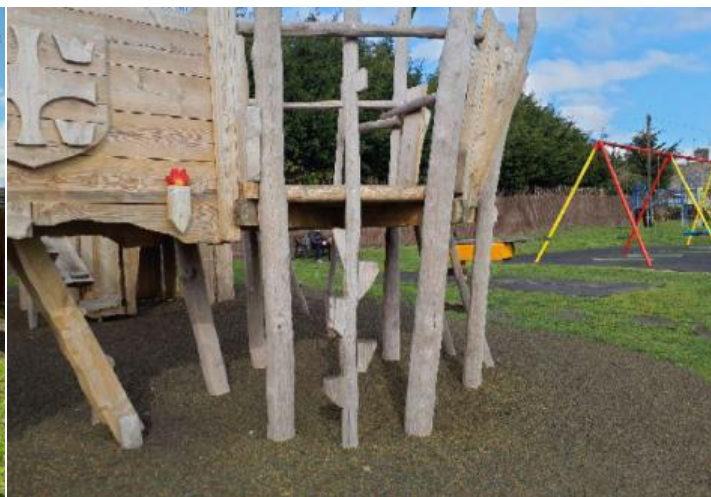
**Finding:** There are openings leading from platforms in excess of 1.0m (1.5m) in height to steep play elements and no hand supports complying with grip or grasp are provided, in contravention of BS EN 1176 Part 1: 4.2.9.4

**Action:** Monitor - No remedial work recommended
