# the play inspection company

## Post Installation Report

Corfe Castle Parish Council

West Street Play Area

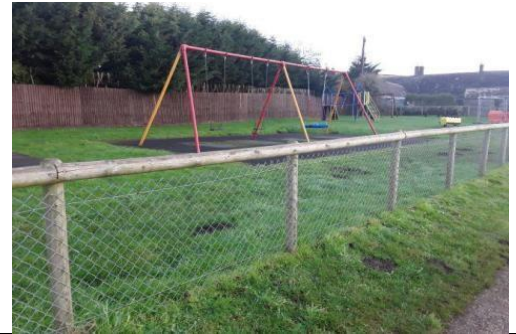
There are a number of molehills within the area and these Inspection may present unforeseen hazards for users - Remove Annual by appropriate means, reinstate surfaces to level and area

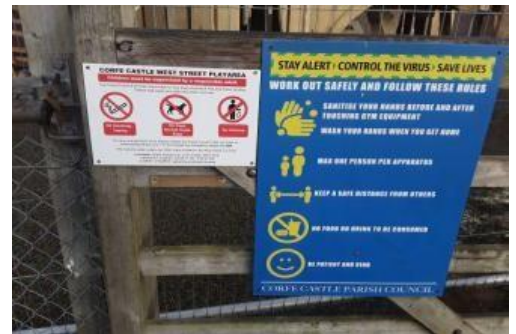
This item is satisfactory - no work required -

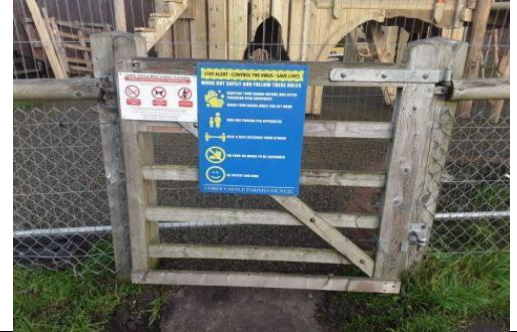
There are openings that are less than 12mm that could trap or crush fingers - Where possible a 12mm gap should be gate leafs

The timber has a number of splits/shakes or air cracks and for any this may affect the stability or allow water ingress which will accelerate the rotting process - Monitor to ensure the splits do not cross through fixing points of the structure and/or cause any instability

There is some evidence of rot in the timber - Monitor further deterioration and replace as required

There is some strimmer / machinery damage apparent on the posts, this can penetrate the preservative applied to the timber and accelerate the rotting process - Monitor for any deterioration (rot) and replace as required

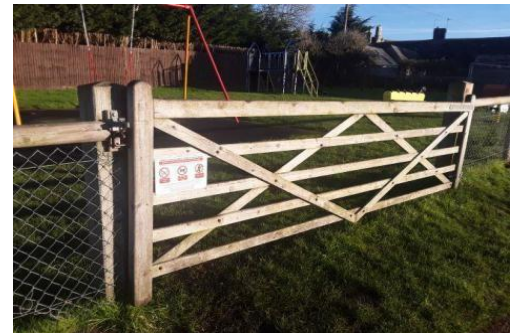
There is some evidence of rot in the timber - Monitor for any further deterioration and replace as required

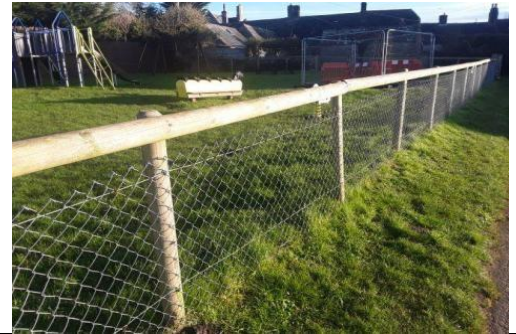
There are a number of loose posts around the fence - Monitor for any further deterioration and reset as required

There are areas or parts of the timber on the structure that have rotted - Replace all affected timbers

There is some strimmer / machinery damage apparent on Monitor for the posts, this can penetrate the preservative applied to the any further deterioration and repair as required timber and accelerate the rotting process - Monitor for any deterioration (rot) and replace as required

There is some damage to the fence sections -

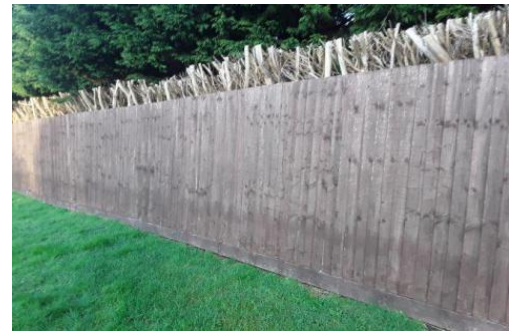
There is some damage to the fence sections - Monitor for fencing any further deterioration and repair as required

A number of fixings have worked loose around the Secure all loose fixings

There are a number of fixings missing from the fence - Replace missing fixings

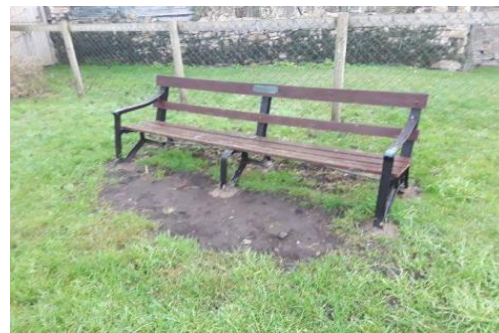
The surface has eroded and the foundations are exposed - Reinstate surrounding surfaces to cover the foundations rough or sharp edges

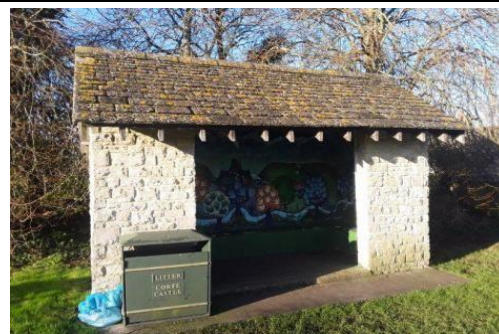
There is some damage to the seating area - Monitor for any further deterioration and remove any rough or sharp edges

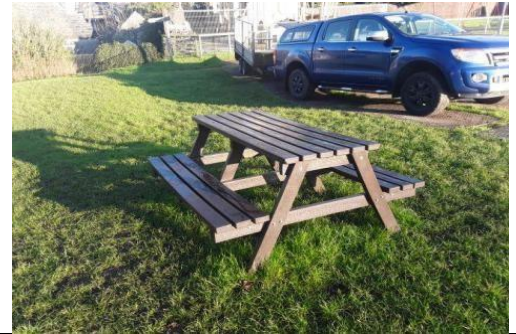
There is some evidence of fire damage to the item - Monitor for any further deterioration and repair as required

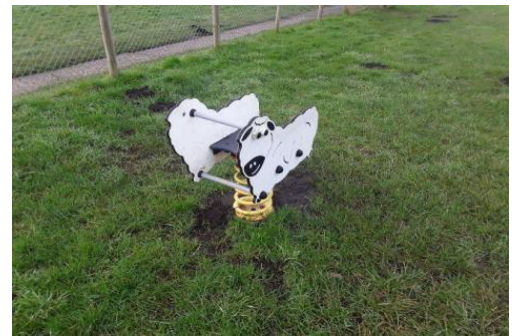
The paintwork on the spring has been damaged or worn exposing the metal underneath which is rusting - Treat any rusting components and repaint

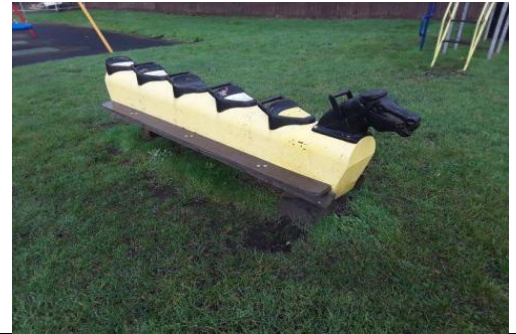
There is no gaiter protection for accessible moving parts (possible shear trap) as recommended in BS EN 1176 Part 1; 4.2.6 Moving Parts - Monitor - No remedial work recommended

There is surface corrosion present on the item - Consider treating the item

There is some lateral movement during operation - Monitor for any instability and repair as required

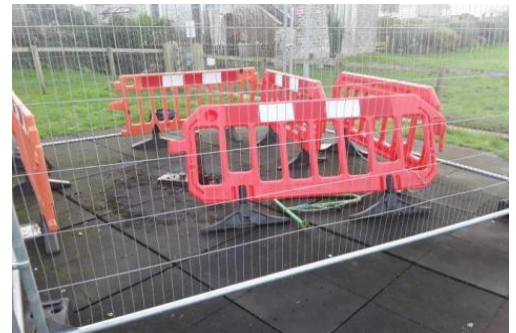
The item has been removed and access has been restricted by the owner / operator - Complete repairs or removal of item

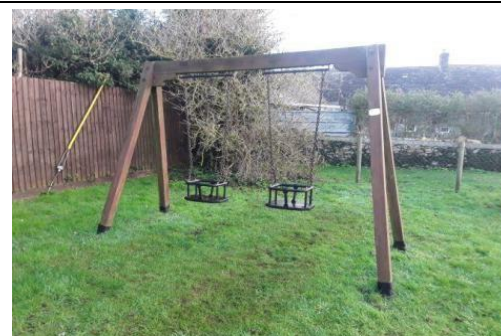
There is some strimmer / machinery damage apparent on Monitor the posts, this can penetrate the preservative applied to the for any further deterioration and replace as required timber and accelerate the rotting process - Monitor for any deterioration (rot) and replace as required

There is some evidence of rot in the crossbeam - Monitor for any further deterioration and replace as required

There is some evidence of rot in the posts - Monitor for any Monitor for further deterioration and replace as required any

There is some notable evidence of chain wear - Monitor for any further deterioration and replace when 40% worn

There is some wear to the shackles. - Monitor for any deterioration and replace when 40% worn

The shackles have corroded excessively - Replace all further corroded fixings

The paintwork on the swing hangers has been damaged or worn exposing the metal underneath which is rusting - Treat any rusting components and repaint

The seat has minor damage or wear - Monitor for any further deterioration and replace as required

The seats are too close to each other as defined in BS EN 1176 Part 2; this is a low risk failure and no remedial action work is required - Monitor - No remedial work recommended

The chain openings are in excess of the 8.6mm as recommended by BS EN 1176 - Monitor - No remedial recommended

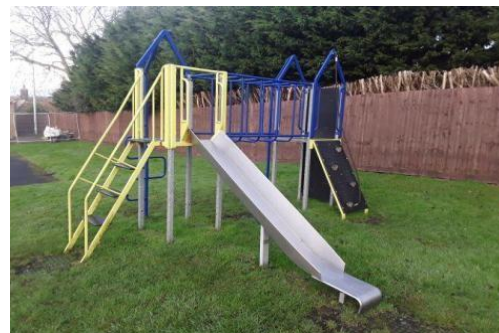
There is surface corrosion present on the item - Consider treating the item

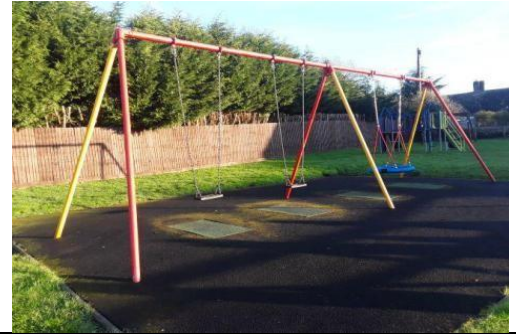
There are gaps opening between the surfacing and the edging surround or between the joints in the surfacing - for any further deterioration and repair as required

There is algae or moss growth on the surface resulting in slippery conditions - Clean and treat appropriately Monitor

There are trip hazards at the edges of the surface - Reinstate surrounding surface levels to remove the trip points

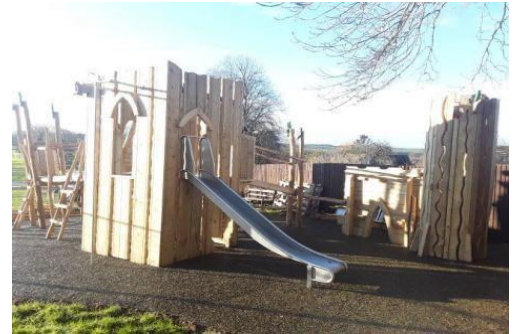
There is/are finger entrapment/s in the platforms and the fails to meet the requirements of BS EN 1176 Part 1 4.2.7.6 Entrapment of fingers - Refer to contractor

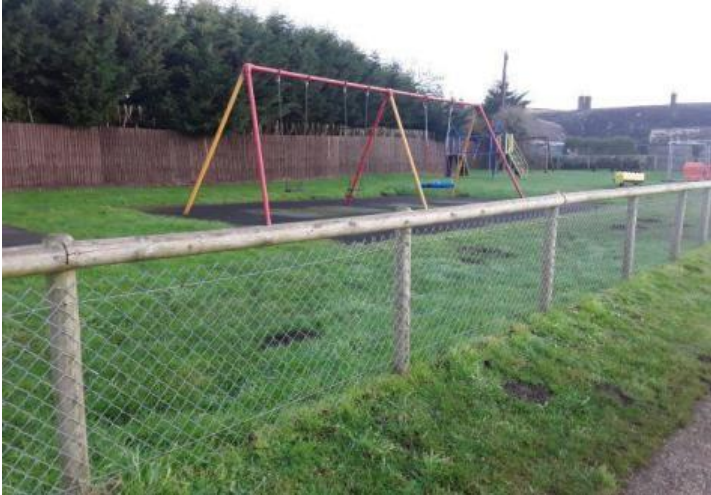
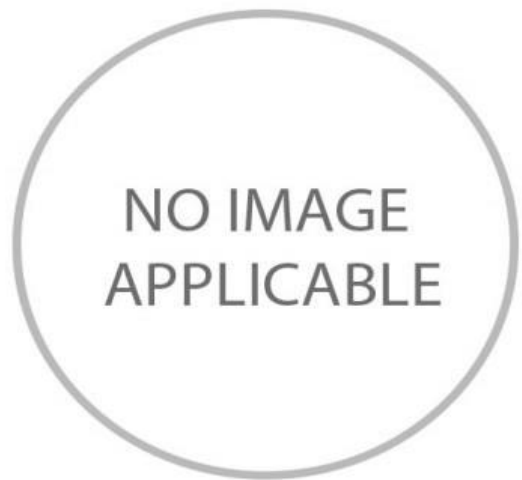
**Finding:** NOTE - This report consists of a Post Installation Inspection of the newly installed Multiplay unit and an Annual Inspection of the pre-existing equipment **Action:**

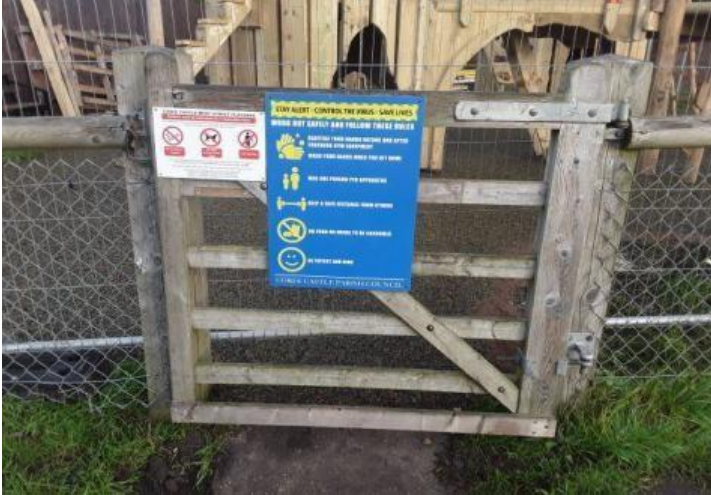
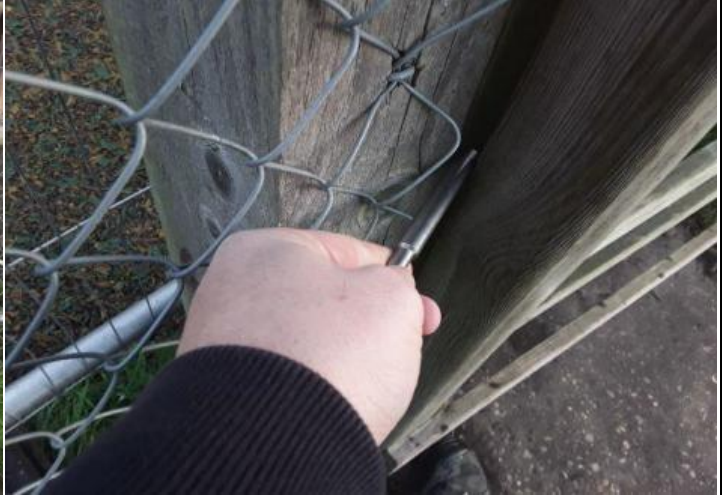
**Finding:** There are openings that are less than 12mm that maintained could trap or crush fingers on both sides or between the gate leaves  
**Action:** Where possible a 12mm gap should be

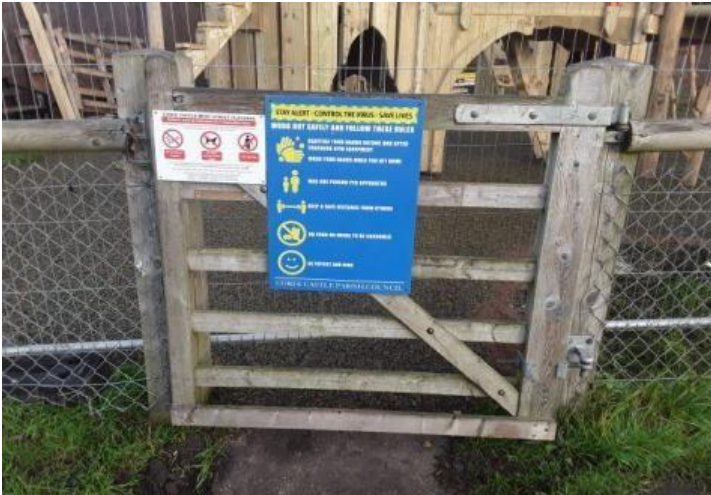
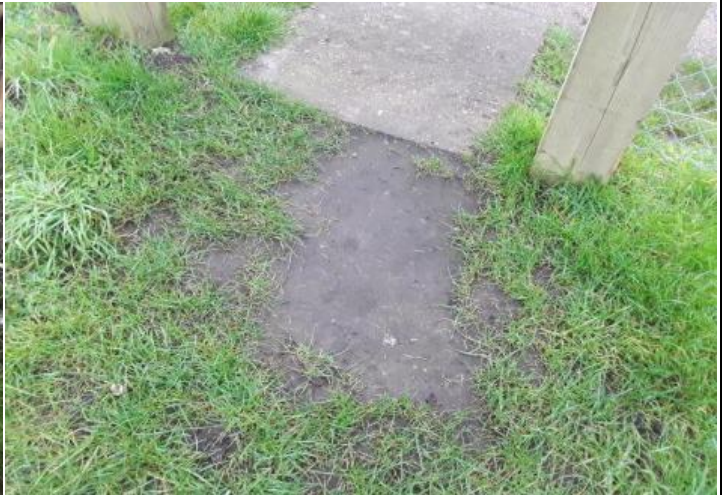
**Finding:** The surface has eroded beneath the gate  
**Action:** Reinstate the surface

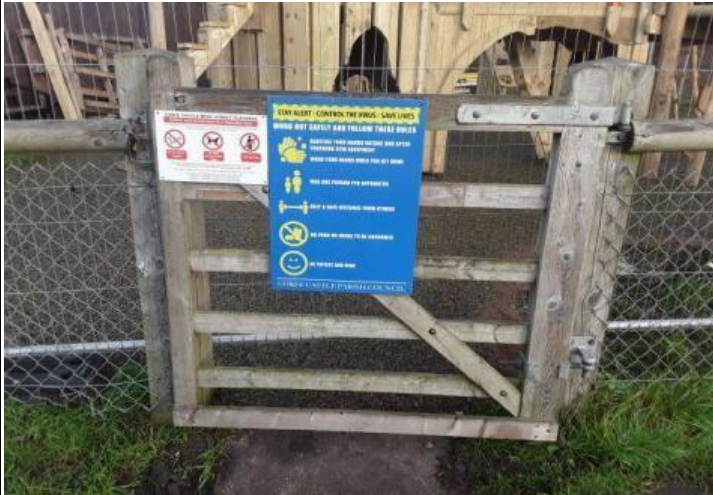
**Finding:** There is some evidence of rot in the timber

**Action:** Monitor for any further deterioration and replace as required

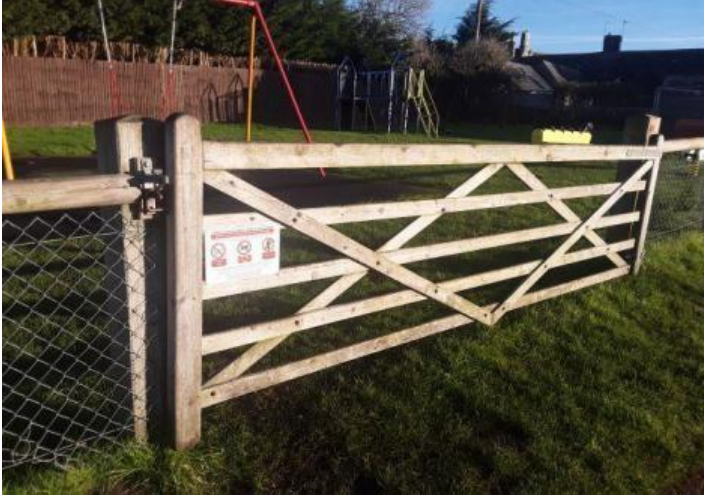
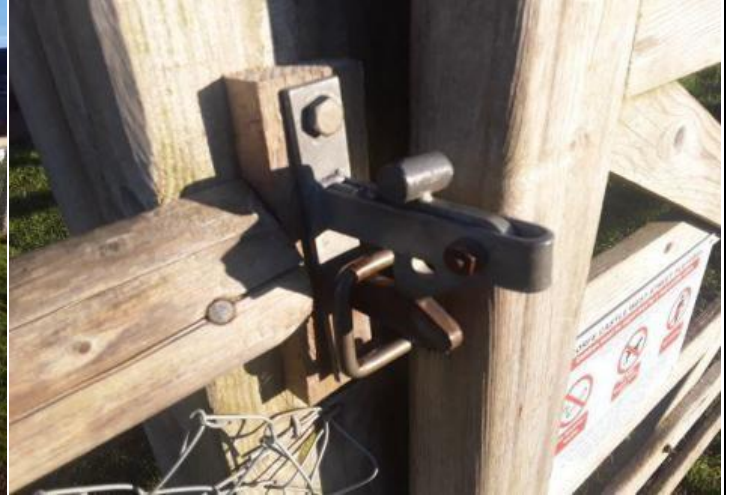
**Finding:** There is no padlock on the maintenance gate

**Action:** Provide a padlock to secure the gate

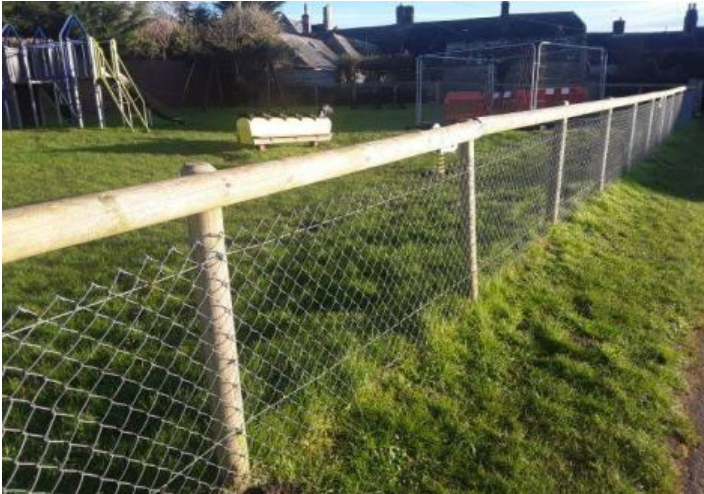
**Finding:** There are a number of loose posts around the required

**Action:** Monitor for any further deterioration and reset as fence

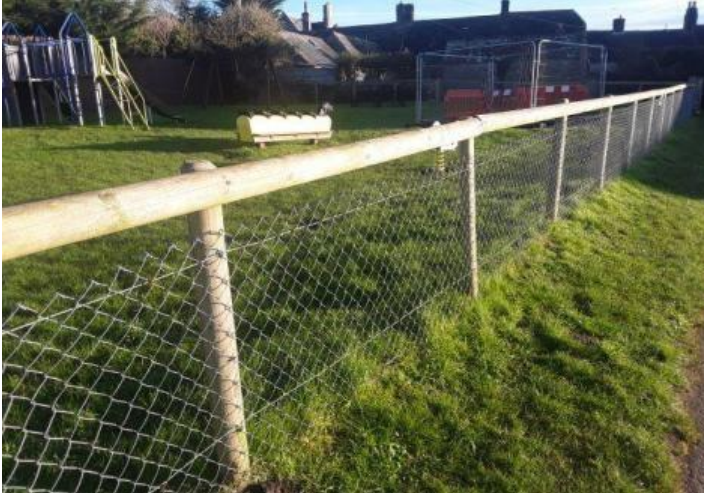
**Finding:** There are areas or parts of the timber on the that have rotted  
**Action:** Replace all affected timbers structure

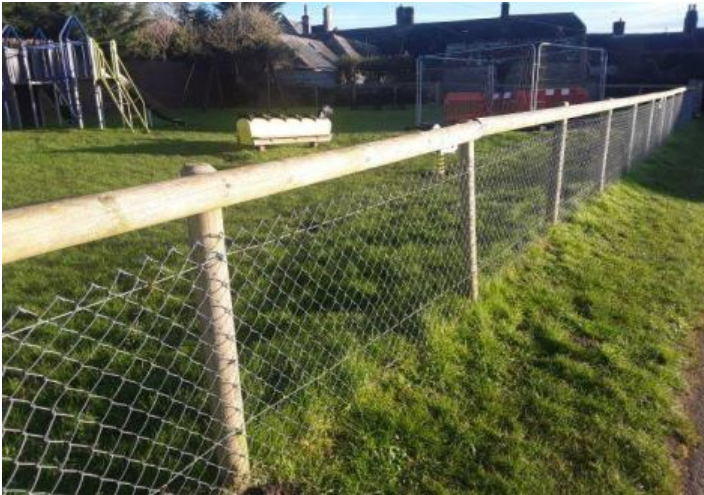
**Finding:** There is some strimmer / machinery damage apparent on the posts, this can penetrate the preservative applied to the timber and accelerate the rotting process  
**Action:** Monitor for any deterioration (rot) and replace as required

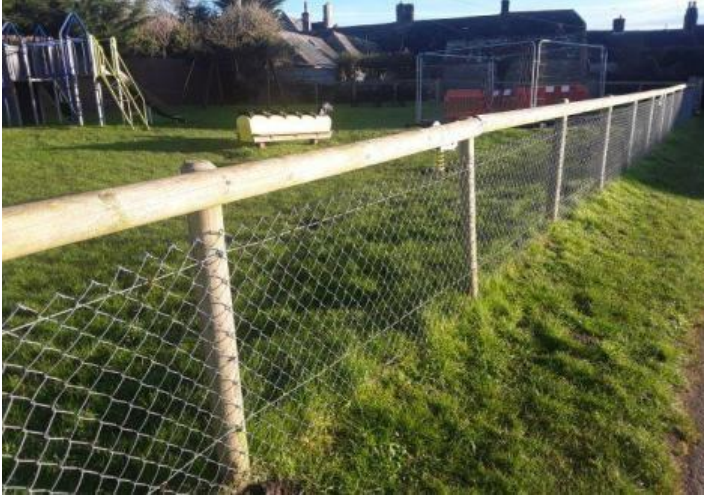
**Finding:** There is some damage to the fence sections

**Action:** Monitor for any further deterioration and repair as required

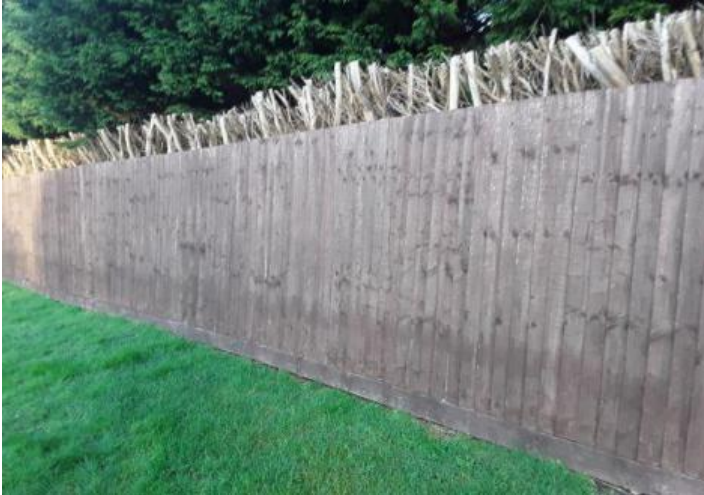
**Finding:** There is some damage to the fence sections

**Action:** Monitor for any further deterioration and repair as required

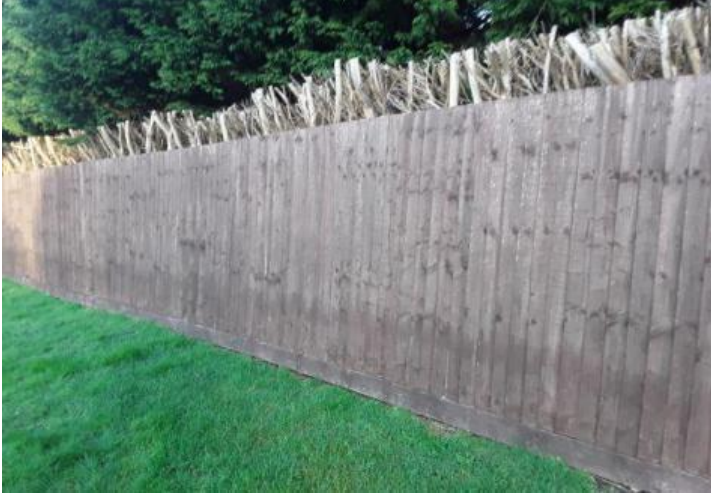
**Finding:** A number of fixings have worked loose around the fencing  
**Action:** Secure all loose fixings

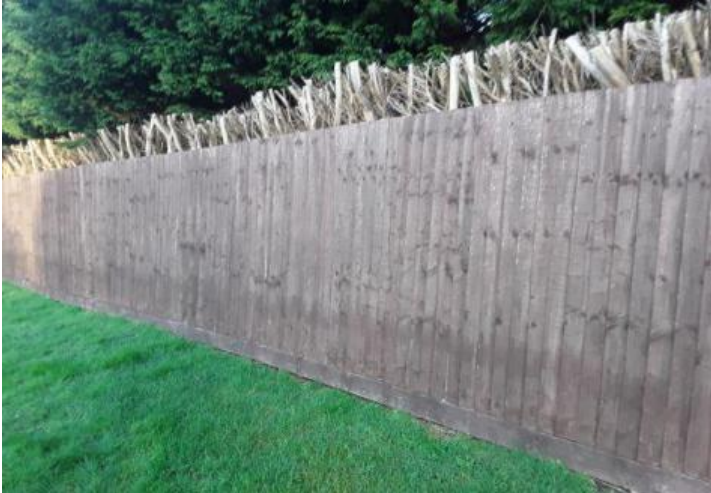
**Finding:** There are a number of fixings missing from the fence  
**Action:** Replace missing fixings fence

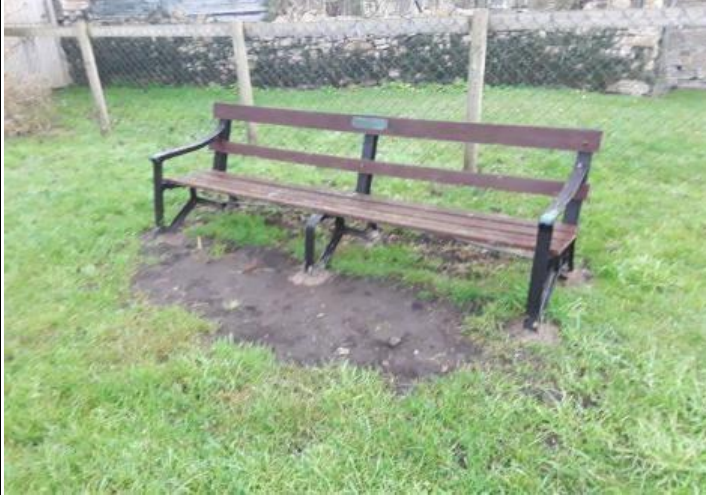
**Finding:** The surface has eroded and the foundations are exposed

**Action:** Reinststate surrounding surfaces to cover the foundations

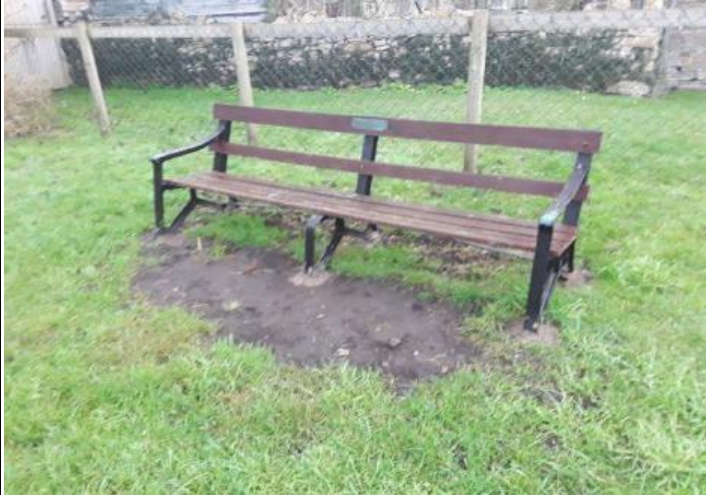
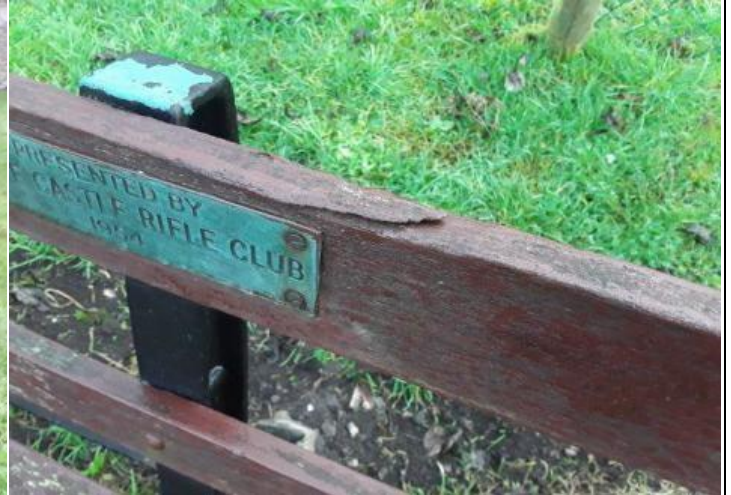
**Item:** Ancillary Items - Bench  
**Manufacturer:** Not Identified

**Finding:** Parts of the timber are rough or splintered

**Action:** Remove all rough or sharp edges

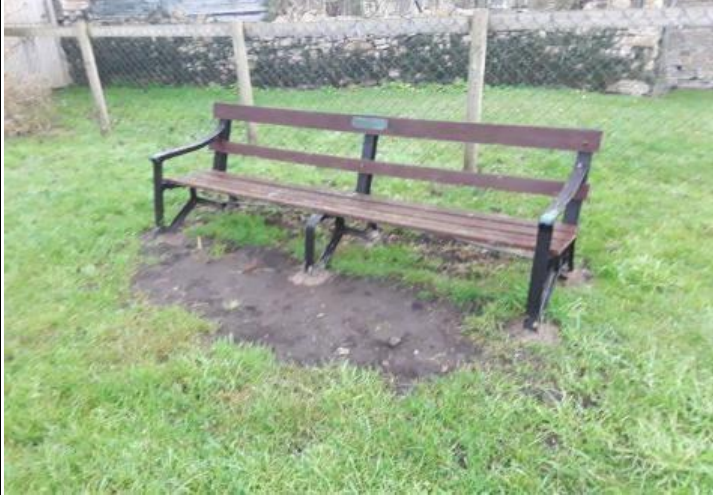
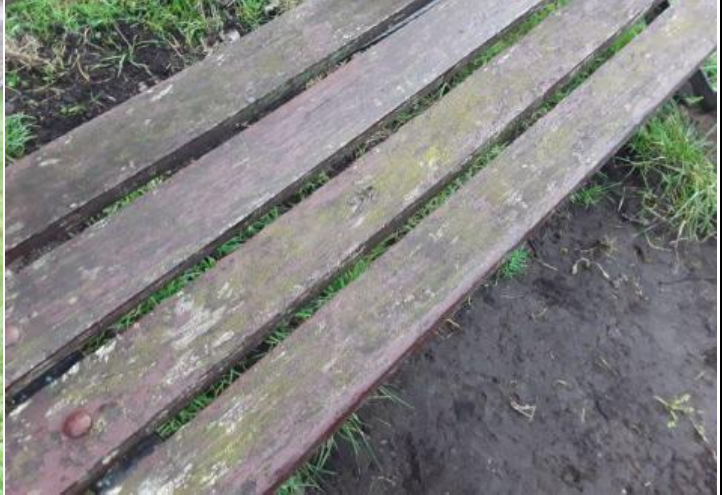
**Item:** Ancillary Items - Bench  
**Manufacturer:** Not Identified

**Finding:** There is algae or moss on the surface of the **Action:** Clean and treat appropriately equipment

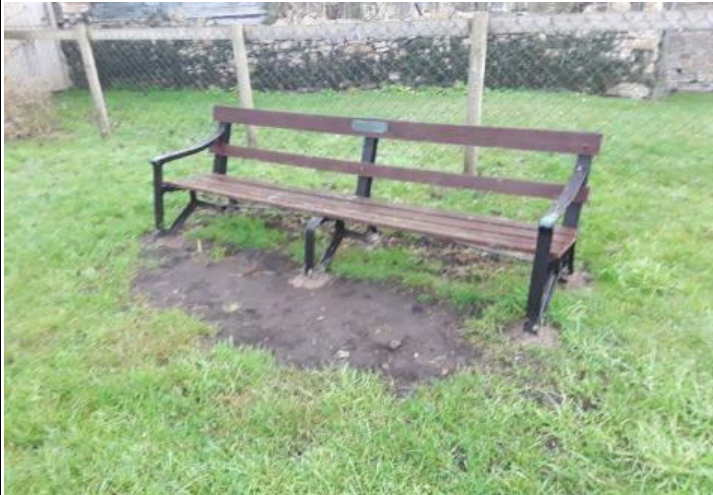
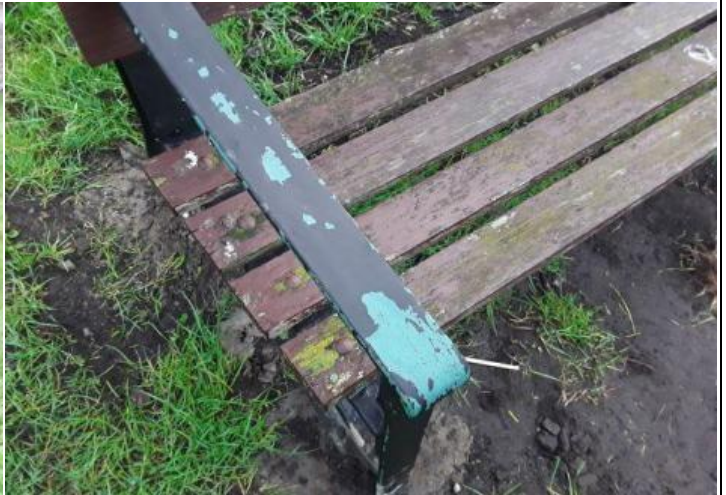
**Item:** Ancillary Items - Bench  
**Manufacturer:** Not Identified

**Finding:** The paint is flaking off the metalwork **Action:** Rub down and re-paint

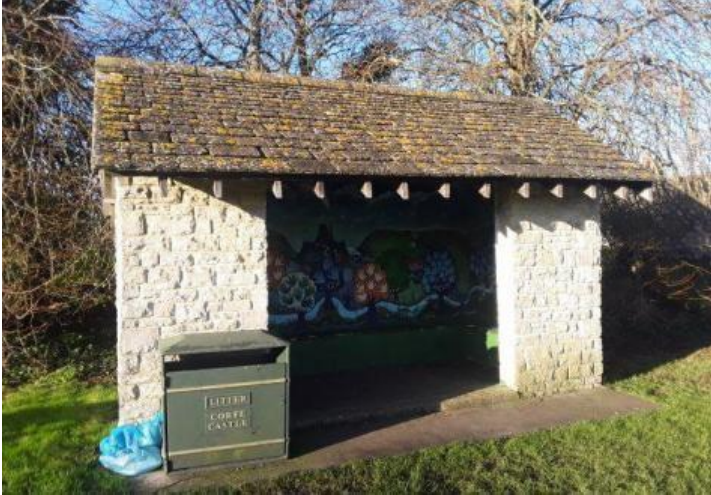
**Item:** Ancillary Items - Shelter  
**Manufacturer:** Owner/Operator

**Finding:** There is some damage to the seating area

**Action:** Monitor for any further deterioration and remove any rough or sharp edges

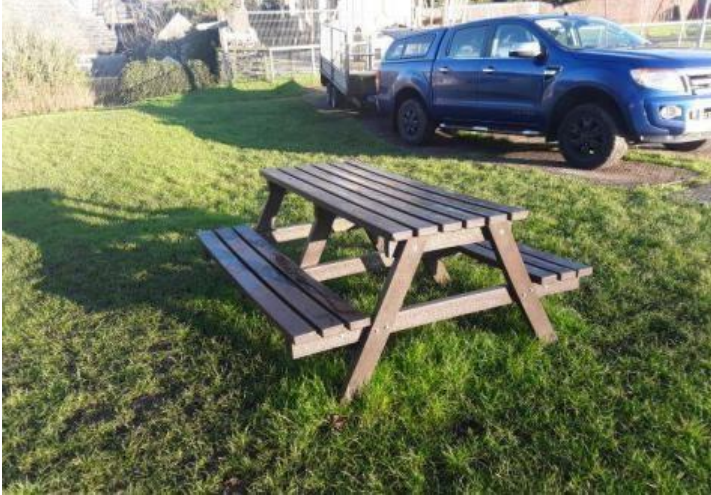
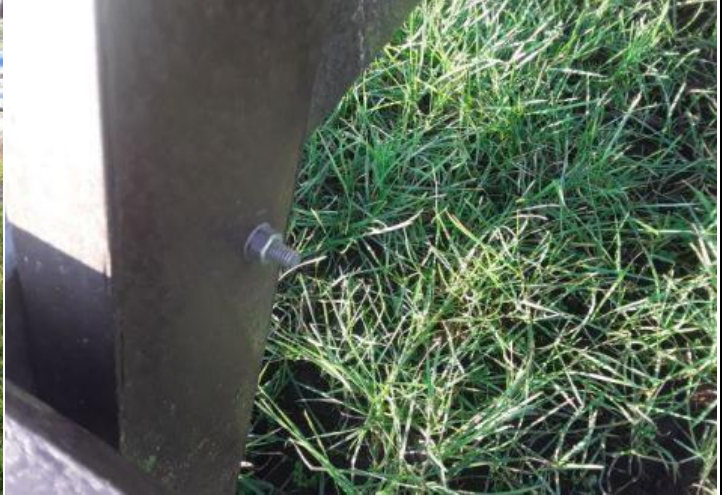
**Item:** Ancillary Items - Picnic Table  
**Manufacturer:** Not Identified

**Finding:** There are projecting bolt thread(s) present

**Action:** Remove excess thread length and deburr or provide cap

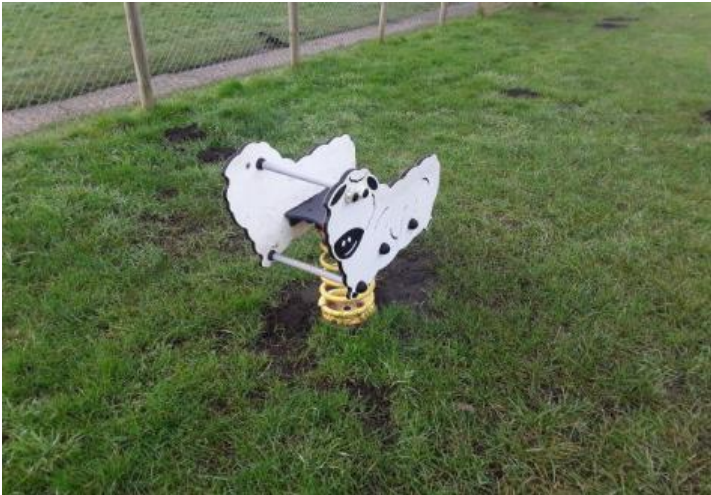
**Item:** Rocking Equipment - Spring Sheep  
**Manufacturer:** Fahr Industries

**Finding:** The paintwork on the spring has been damaged or worn exposing the metal underneath which is rusting

**Action:** Treat any rusting components and repaint

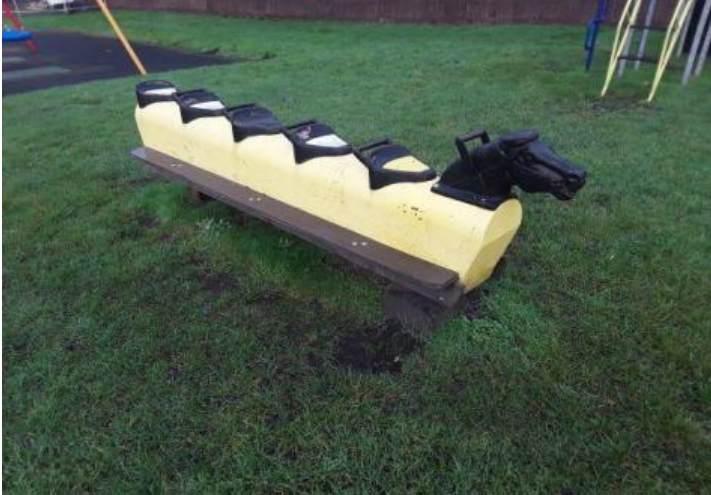
**Item:** Rocking Equipment - Rocking Horse  
**Manufacturer:** Wicksteed Playgrounds

**Finding:** There is no gaiter protection for accessible moving **Action:** Monitor - No remedial work recommended parts (possible shear trap) as recommended in BS EN 1176 Part 1; 4.2.6 Moving Parts

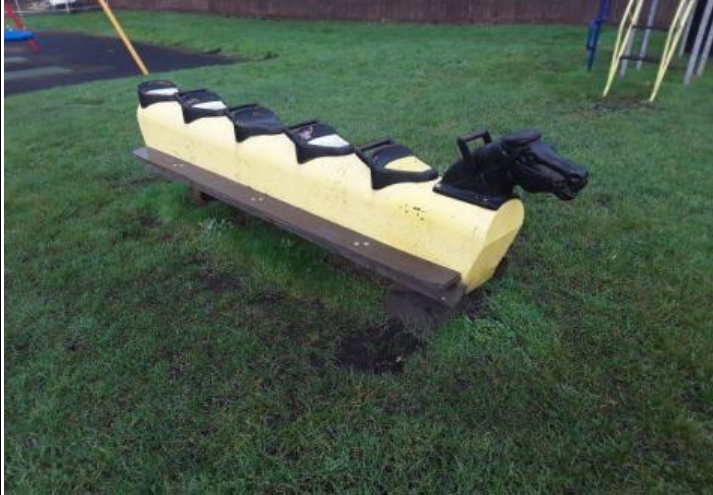
**Item:** Rocking Equipment - Rocking Horse  
**Manufacturer:** Wicksteed Playgrounds

**Finding:** There is some lateral movement during operation **Action:** Monitor for any instability and repair as required

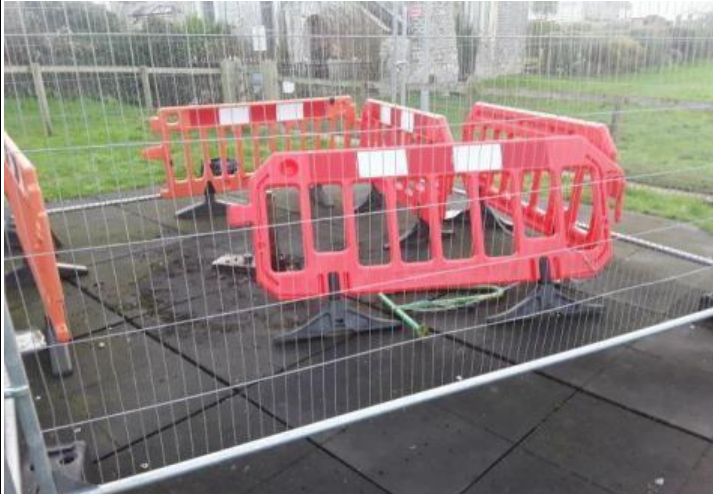
**Item:** Rotor Play - Roundabout  
**Manufacturer:** Not Identified

**Finding:** The item has been removed and access has been restricted by the owner / operator **Action:** Complete repairs or removal of item

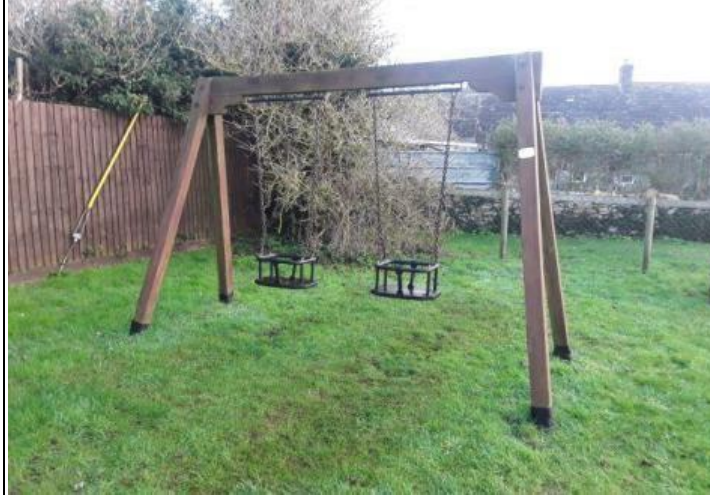
#### 6 - Low Risk (Finding 1)

**Item:** Swings - 1 Bay 2 Seat (Cradle)  
**Manufacturer:** Taylor Made Play Equipment

**Finding:** There is some strimmer / machinery damage apparent on the posts, this can penetrate the preservative applied to the timber and accelerate the rotting process  
**Action:** Monitor for any deterioration (rot) and replace as required

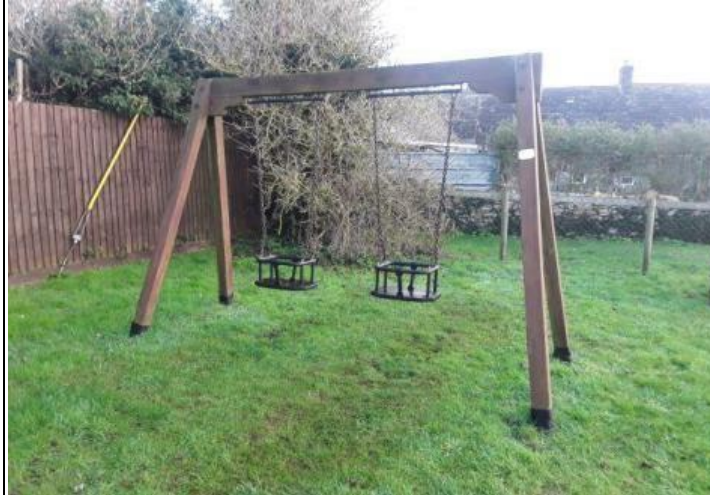
8 - Low Risk (Finding 2)

**Item:** Swings - 1 Bay 2 Seat (Cradle)  
**Manufacturer:** Taylor Made Play Equipment

**Finding:** There is some evidence of rot in the crossbeam  
**Action:** Monitor for any further deterioration and replace as required

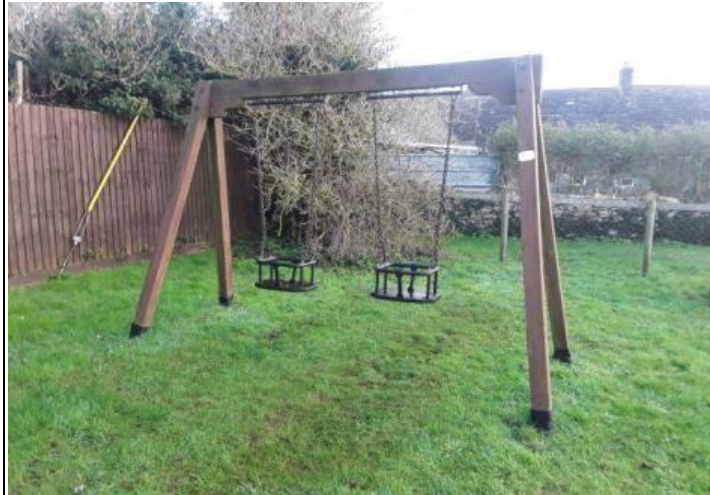
6 - Low Risk (Finding 4)

**Item:** Swings - 1 Bay 2 Seat (Cradle)  
**Manufacturer:** Taylor Made Play Equipment

**Finding:** There is some notable evidence of chain wear

**Action:** Monitor for any further deterioration and replace when 40% worn

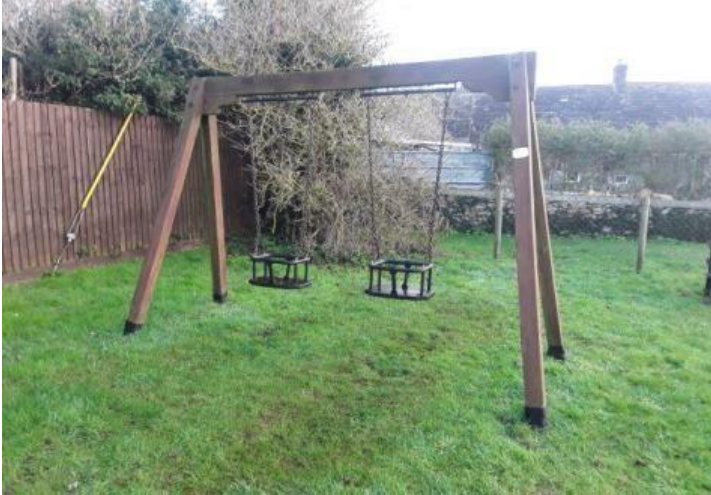
**Item:** Swings - 1 Bay 2 Seat (Cradle)  
**Manufacturer:** Taylor Made Play Equipment

**Finding:** There is some wear to the shackles.

**Action:** Monitor for any further deterioration and replace when 40% worn

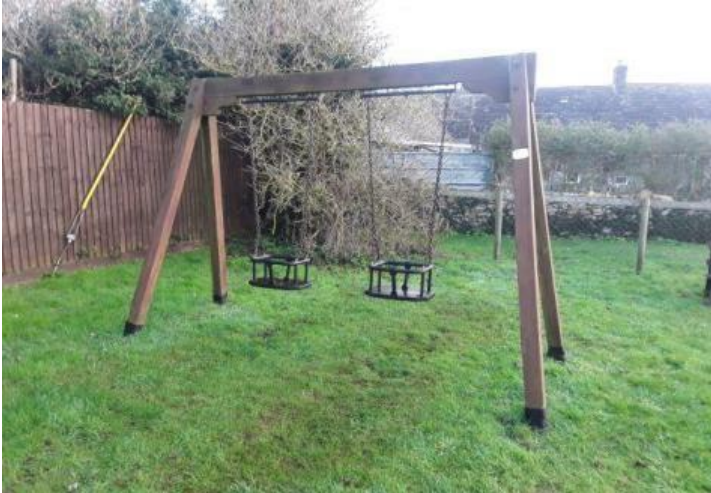
**Item:** Swings - 1 Bay 2 Seat (Cradle)  
**Manufacturer:** Taylor Made Play Equipment

**Finding:** The shackles have corroded excessively

**Action:** Replace all corroded fixings

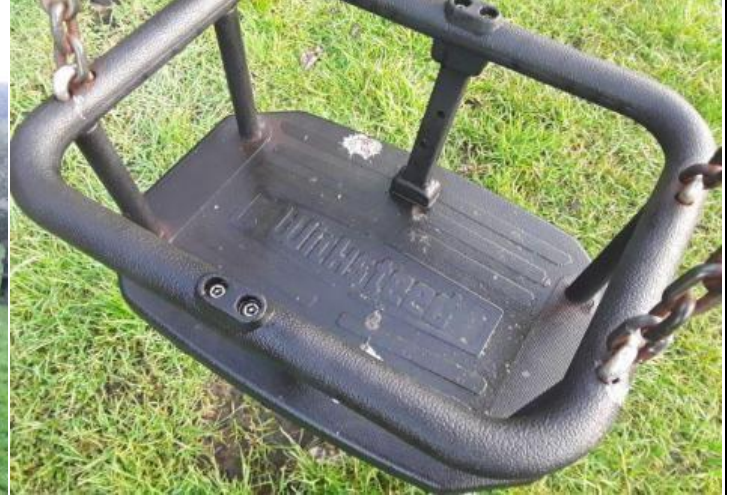
**Finding:** There is bird excrement on the seats

**Action:** Clean and maintain

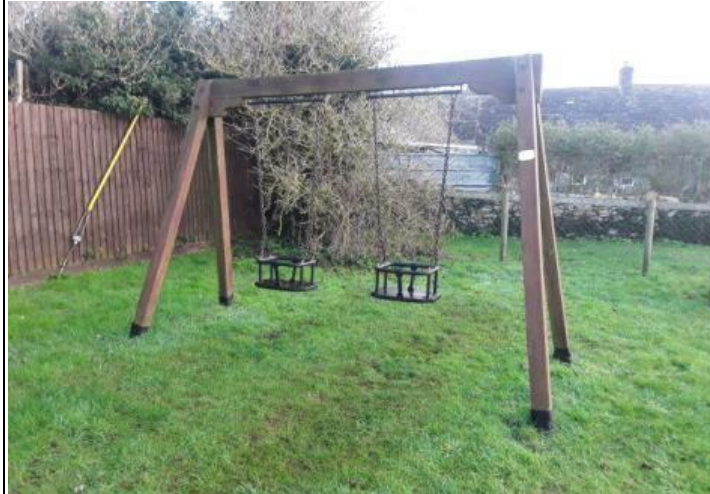
6 - Low Risk (Finding 8)

**Item:** Swings - 1 Bay 2 Seat (Cradle)  
**Manufacturer:** Taylor Made Play Equipment

**Finding:** The paintwork on the swing hangers has been damaged or worn exposing the metal underneath which is rusting

**Action:** Treat any rusting components and repaint

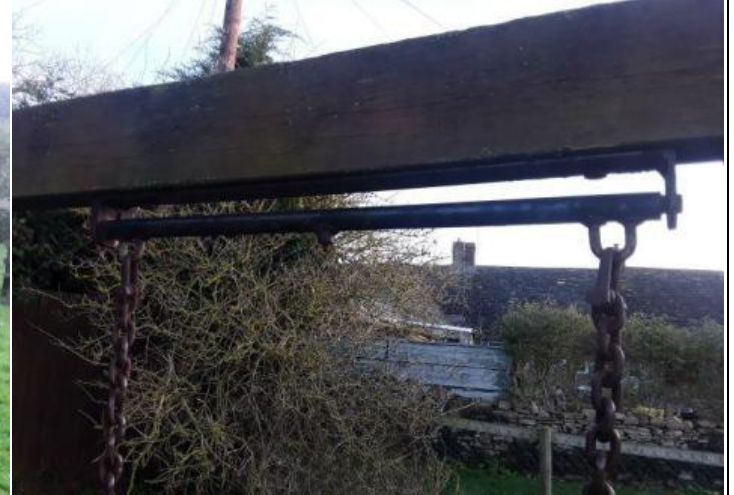
**Finding:** The swings are noisy during operation

**Action:** Service and lubricate as required

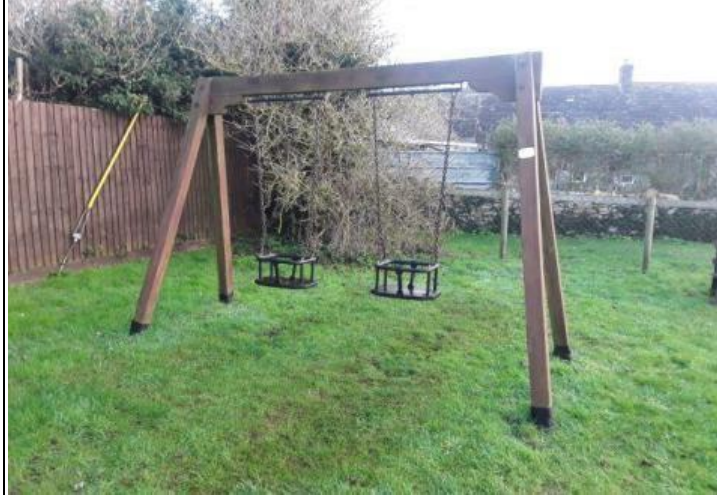
4 - Very Low Risk (Finding 11)

**Item:** Swings - 1 Bay 2 Seat (Cradle)  
**Manufacturer:** Taylor Made Play Equipment

**Finding:** The seats are too close to each other as defined in BS EN 1176 Part 2; this is a low risk failure and no remedial action is required  
**Action:** Monitor - No remedial work recommended

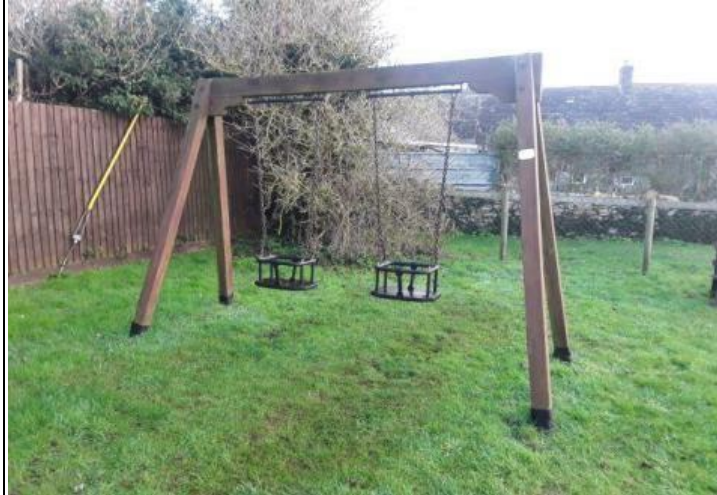
#### 5 - Very Low Risk (Finding 12)

**Item:** Swings - 1 Bay 2 Seat (Cradle)  
**Manufacturer:** Taylor Made Play Equipment

**Finding:** The chain openings are in excess of the 8.6mm as recommended by BS EN 1176  
**Action:** Monitor - No remedial work recommended

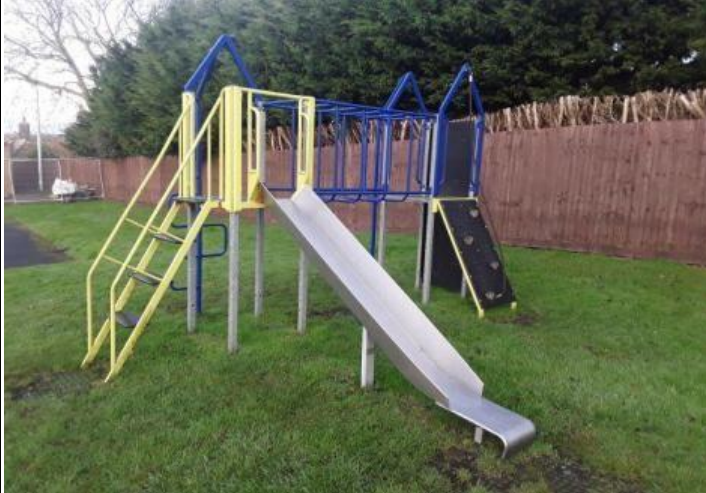
**Item:** Activity Equipment - Multi Play (Junior)  
**Manufacturer:** S M P (Playgrounds Ltd)

**Finding:** There is surface corrosion present on the item

**Action:** Consider treating the item

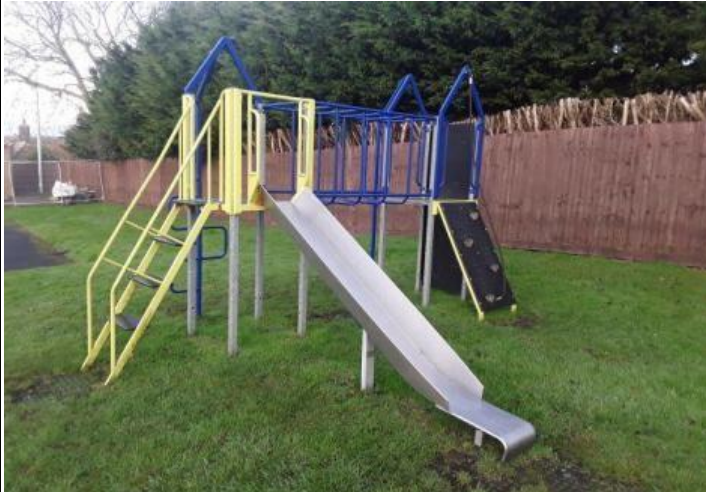
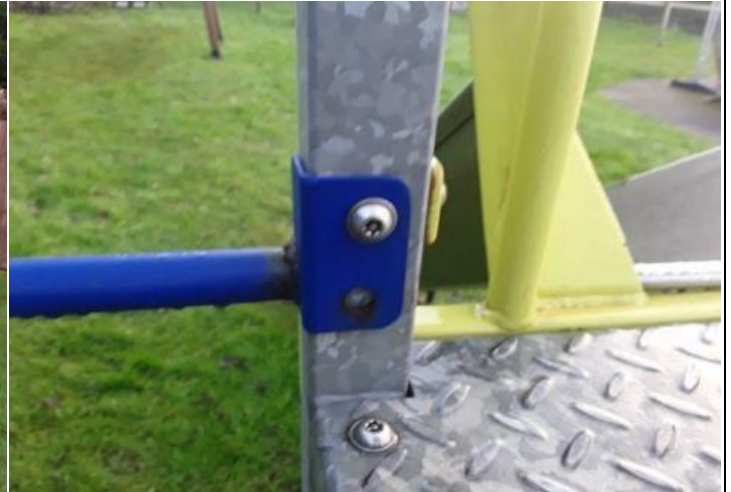
**Item:** Activity Equipment - Multi Play (Junior)  
**Manufacturer:** S M P (Playgrounds Ltd)

**Finding:** There are redundant fixing holes in the framework

**Action:** Refer to manufacturer for installation instruction

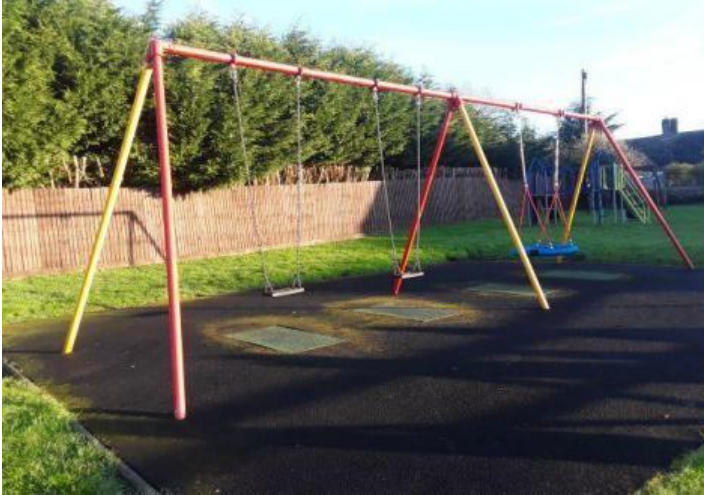
**Item:** Swings - 2 Bay 2 Flat 1 Basket Seat  
**Manufacturer:** Not Identified

**Finding:** There are gaps opening between the surfacing and the edging surround or between the joints in the surfacing  
**Action:** Monitor for any further deterioration and repair as required

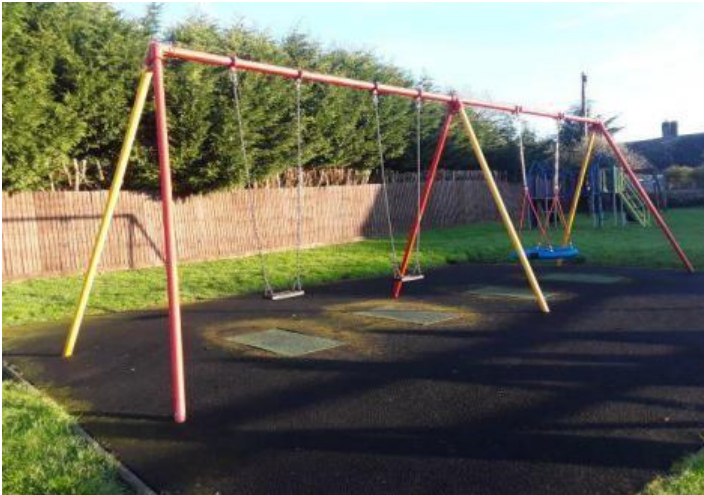
**Item:** Swings - 2 Bay 2 Flat 1 Basket Seat  
**Manufacturer:** Not Identified

**Finding:** There is algae or moss growth on the surface  
**Action:** Clean and treat appropriately resulting in slippery conditions

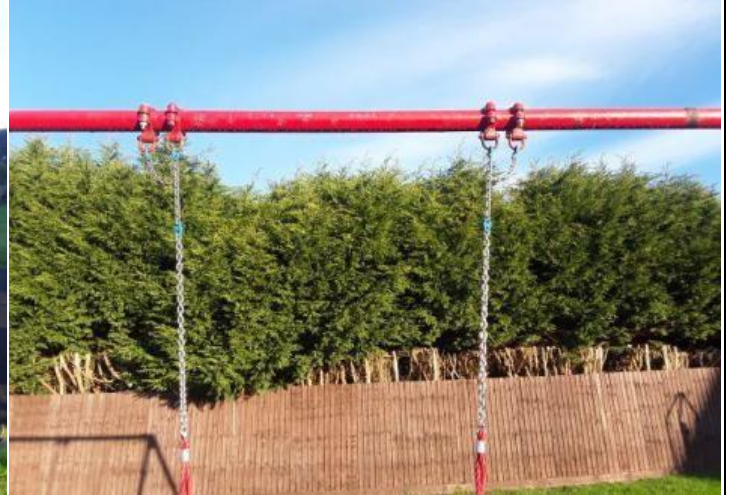
**Item:** Swings - 2 Bay 2 Flat 1 Basket Seat  
**Manufacturer:** Not Identified

**Finding:** The lateral stability of the basket swing seat does not meet with the requirements of BS EN 1176 Part 2; the minimum distance between the suspension members should be the distance between the swing seat connections plus 30% of the suspension length

**Action:** Monitor - no remedial work

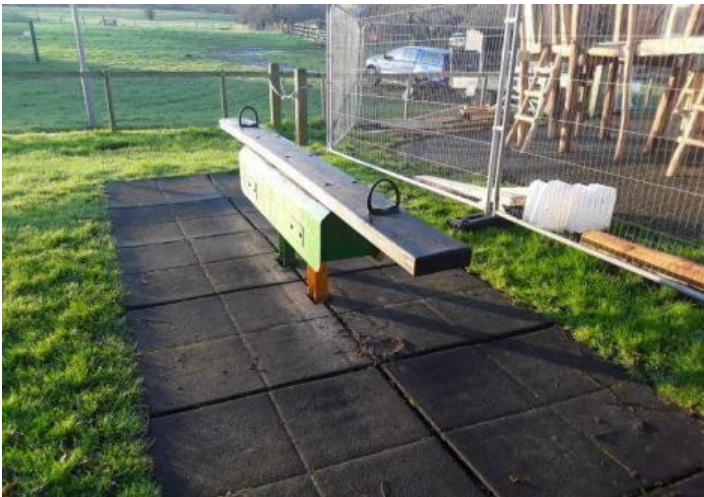
**Item:** Rocking Equipment - See Saw  
**Manufacturer:** Not Identified

**Finding:** There are gaps opening in between the tiles

**Action:** Monitor for any further deterioration and repair as required
