# the play inspection company

## Post Installation Report

Corfe Castle Parish Council

West Street Play Area

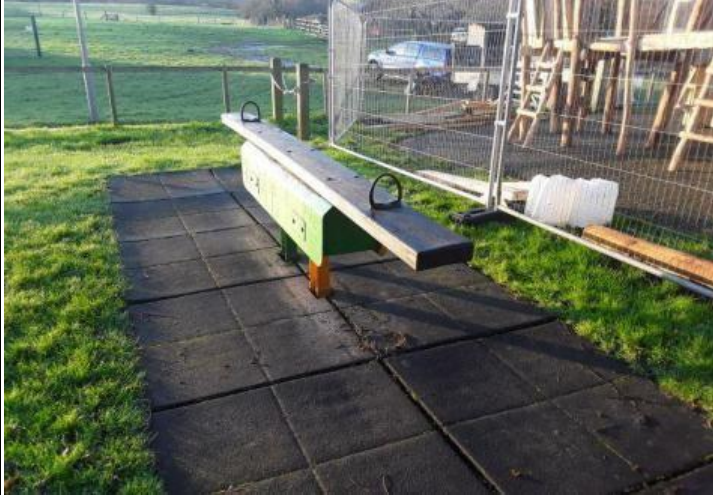
**Item:** Rocking Equipment - See Saw  
**Manufacturer:** Not Identified

**Finding:** There is algae or moss growth on the surface **Action:** Clean and treat appropriately resulting in slippery conditions

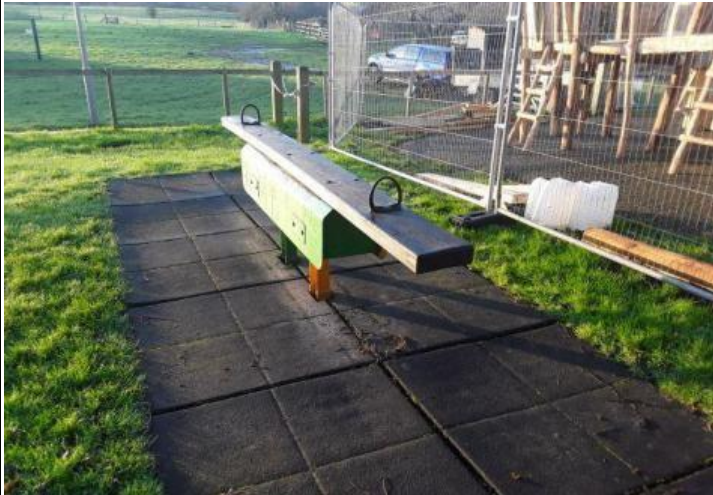
**Item:** Rocking Equipment - See Saw  
**Manufacturer:** Not Identified

**Finding:** There is some minor damage to the surface

**Action:** Monitor for any further deterioration and repair as required

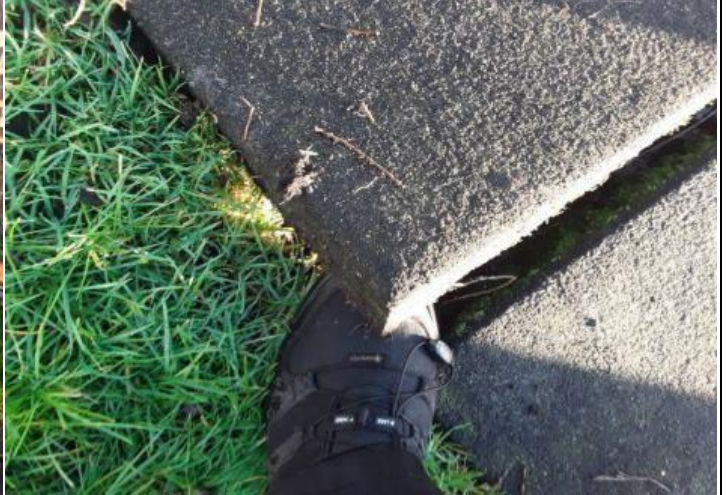
**Item:** Rocking Equipment - See Saw  
**Manufacturer:** Not Identified

**Finding:** The tiles can easily be lifted or are lifting along the edges of the area  
**Action:** Lift and re-glue tiles to secure

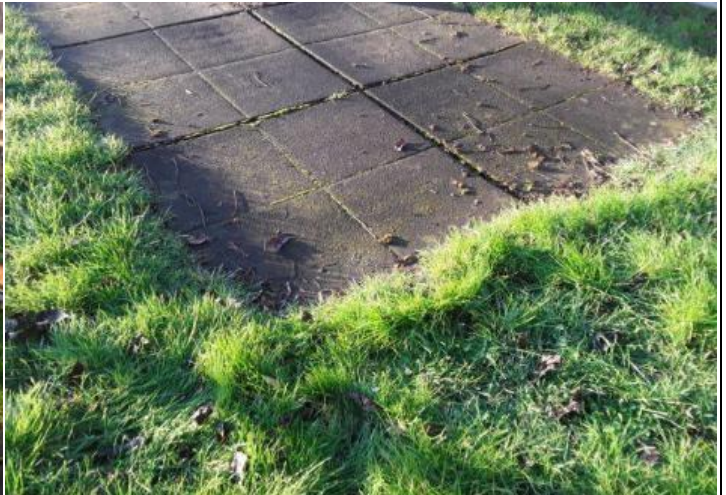
**Item:** Rocking Equipment - See Saw  
**Manufacturer:** Not Identified

**Finding:** There are weeds/vegetation growth between or around the edges of the surfacing  
**Action:** Remove weeds/vegetation growth around

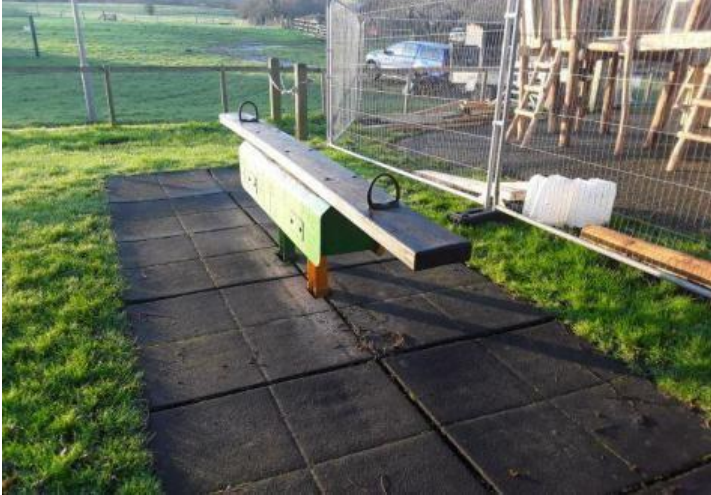
**Item:** Rocking Equipment - See Saw  
**Manufacturer:** Not Identified

**Finding:** There is no gaiter protection for accessible moving **Action:** Monitor - No remedial work recommended parts (possible shear trap) as recommended in BS EN 1176 Part 1; 4.2.6 Moving Parts

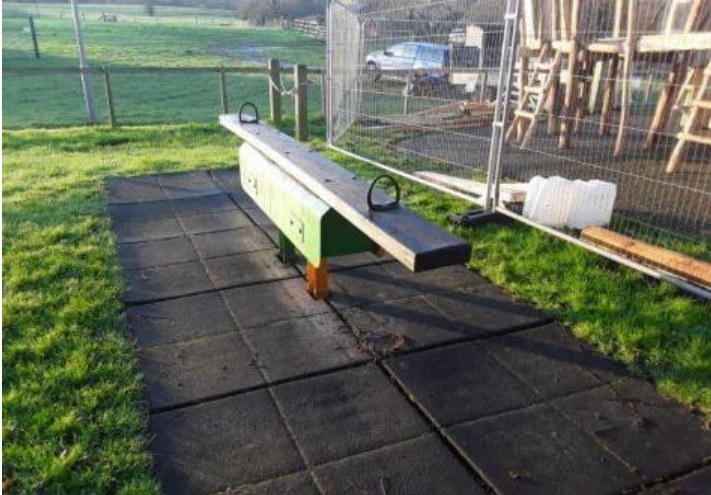
**Item:** Rocking Equipment - See Saw  
**Manufacturer:** Not Identified

**Finding:** The paintwork on this item has been damaged or repainted worn exposing the metal underneath which is rusting

**Action:** Treat any rusting components and

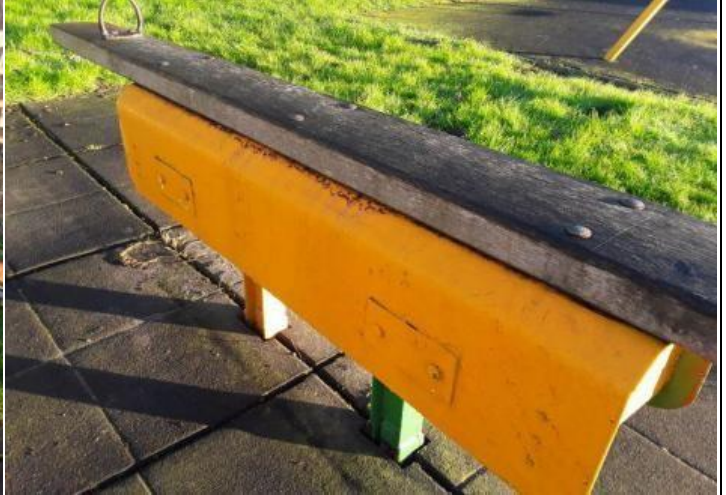
**Item:** Rocking Equipment - See Saw  
**Manufacturer:** Not Identified

**Finding:** The item is noisy during operation

**Action:** Service and lubricate as required

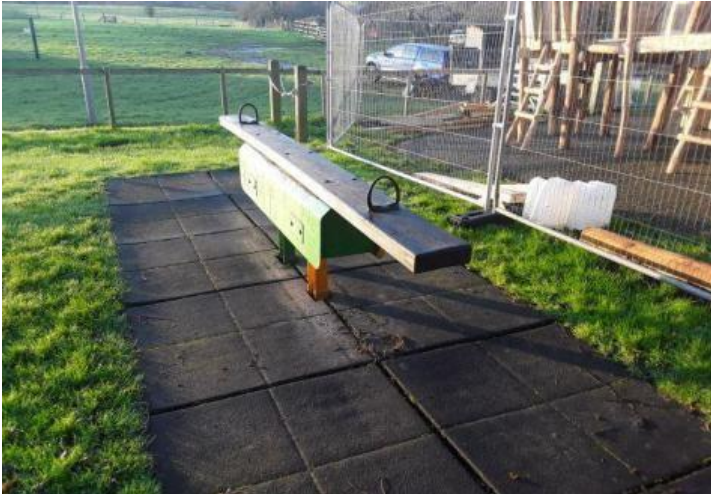
**Item:** Rocking Equipment - See Saw  
**Manufacturer:** Not Identified

**Finding:** The use of synthetic fillers in timber is not recommended; timber being a natural material will expand and contract as the moisture content changes and the use of fillers can exacerbate the length and depth of these cracks or shakes in the timber. The only treatment that is normally required is the removal of any rough or sharp edges unless the structural integrity of the item is affected.

**Action:** Remove any rough or sharp edges and monitor timber for any further deterioration and contract as

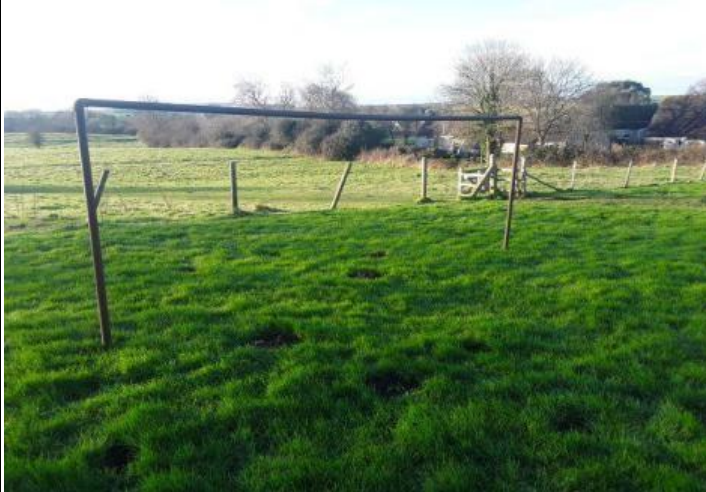
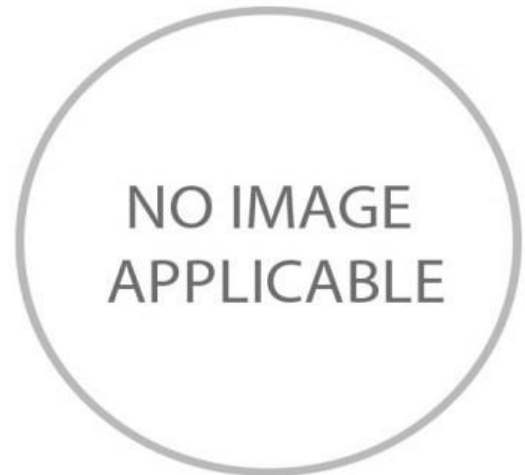
**Item:** Multi Use Games Area - Football Goal  
**Manufacturer:** Not Identified

**Finding:** NB: We have undertaken a maintenance inspection only of the football goal(s); full load testing falls outside the scope of our inspection. **Action:** Implement load testing as required

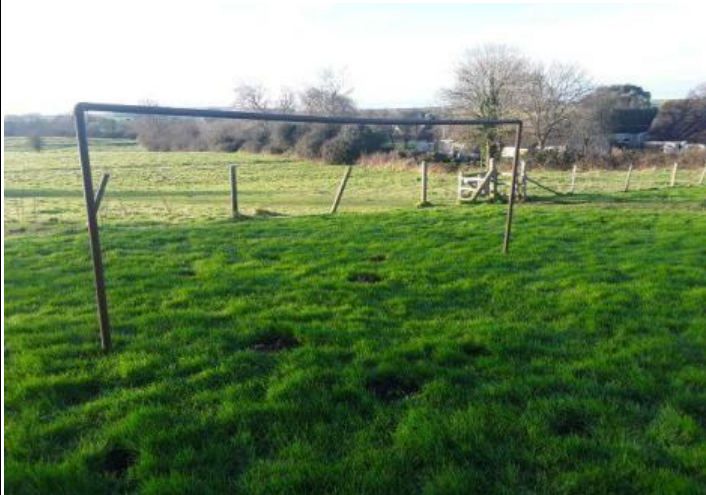
**Item:** Multi Use Games Area - Football Goal  
**Manufacturer:** Not Identified

**Finding:** The paintwork on this item has been damaged or repainted worn exposing the metal underneath which is rusting

**Action:** Treat any rusting components and

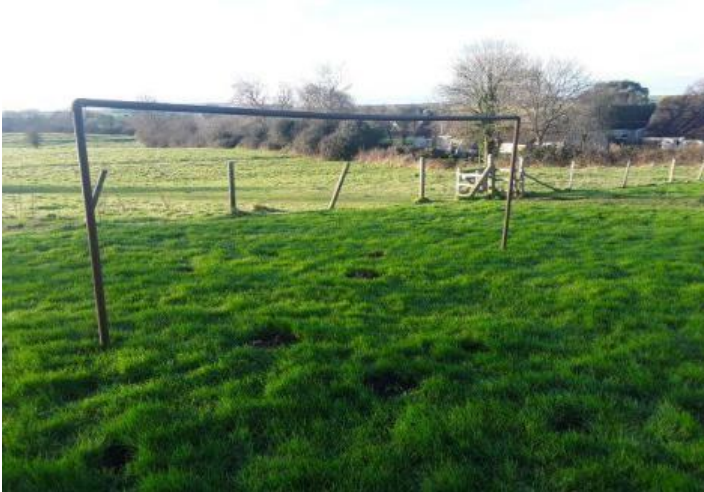
**Item:** Multi Use Games Area - Football Goal  
**Manufacturer:** Not Identified

**Finding:** The item is slightly loose in its foundations

**Action:** Monitor for any further deterioration and repair as required

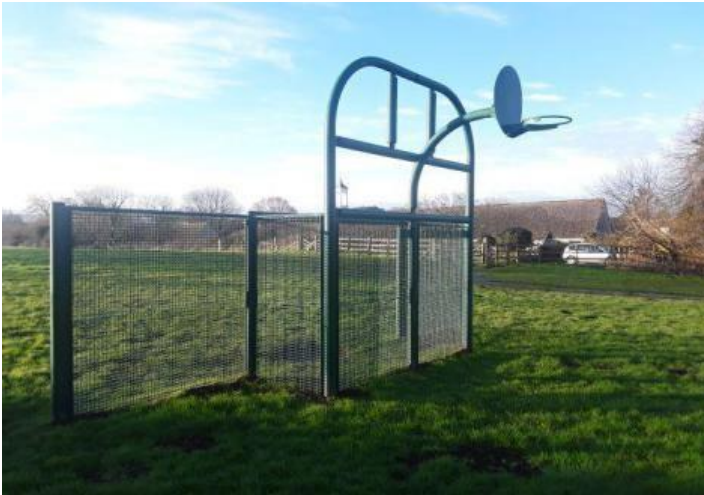
**Item:** Multi Use Games Area - Goalmouth and Basketball Post  
**Manufacturer:** Not Identified

**Finding:** There is/are finger entrapments in the framework recommended and the item fails to meet the requirements of BS EN 15312 Clause 4.4.2.2 Entrapment of fingers

**Action:** Monitor - No remedial work

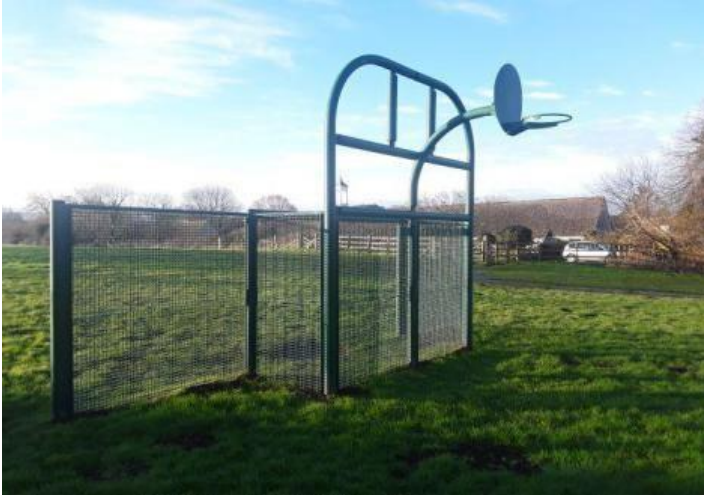
**Finding:** There is/are bolt cap covers missing or damaged covers on the item

**Action:** Replace missing or damaged bolt cap

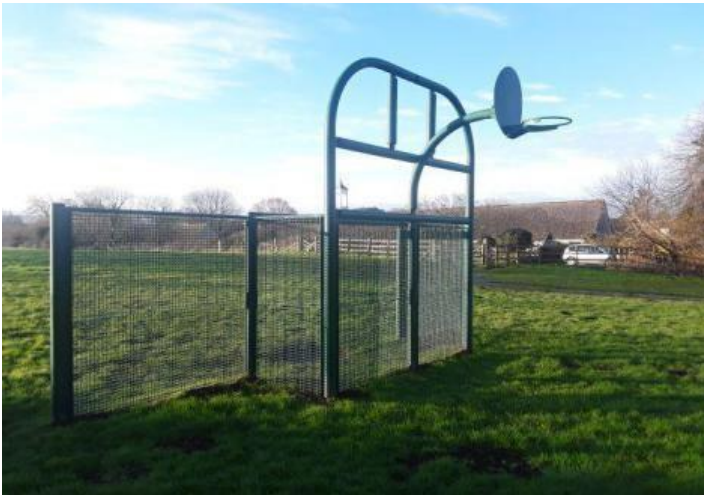
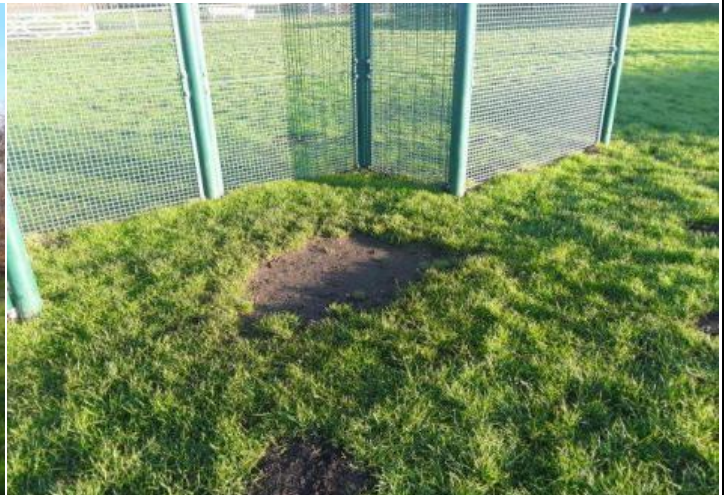
**Finding:** The surface has eroded in some areas

**Action:** Reinststate the surface

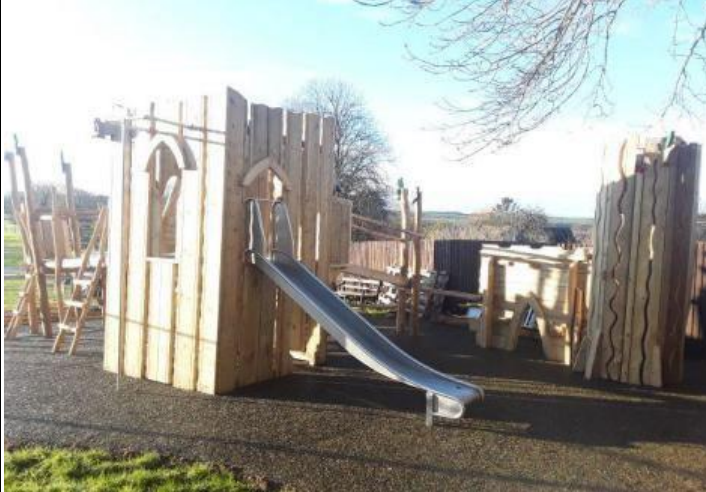
**Item:** Activity Equipment - Multi Play (Junior)  
**Manufacturer:** A Frost Design

**Finding:** There is/are finger entrapment/s in the platforms  
contractor and the item fails to meet the requirements of BS EN 1176  
Part 1 4.2.7.6 Entrapment of fingers

**Action:** Refer to

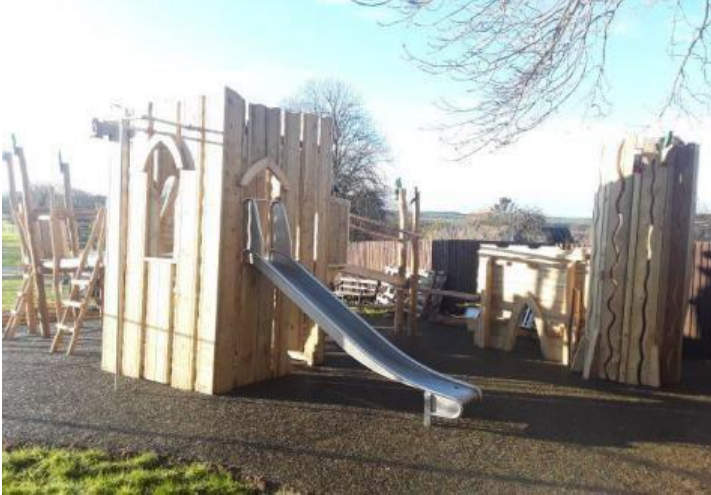
**Item:** Activity Equipment - Multi Play (Junior)  
**Manufacturer:** A Frost Design

**Finding:** There is/are finger entrapment/s between the rope **Action:** Refer to contractor bridge and framework and the item fails to meet the requirements of BS EN 1176 Part 1 4.2.7.6 Entrapment of fingers

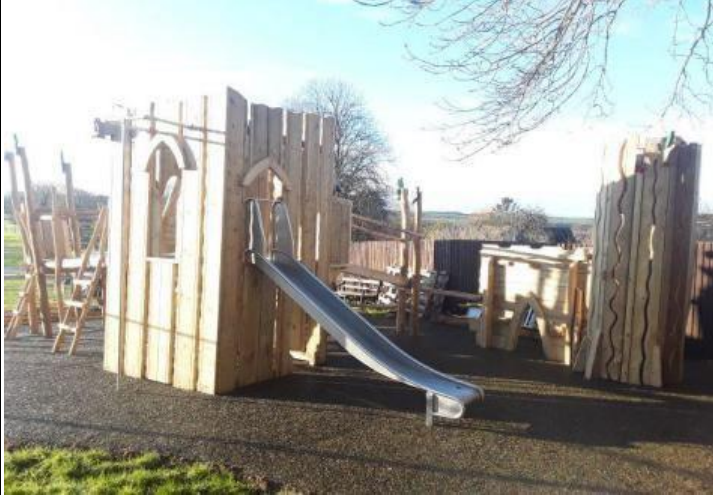
**Item:** Activity Equipment - Multi Play (Junior)  
**Manufacturer:** A Frost Design

**Finding:** There are falls in excess of 600mm (920mm) **Action:** Refer to contractor between adjacent components on the structure, in contravention of the recommendations set out in BS EN 1176 Part 1; 4.2.8.4

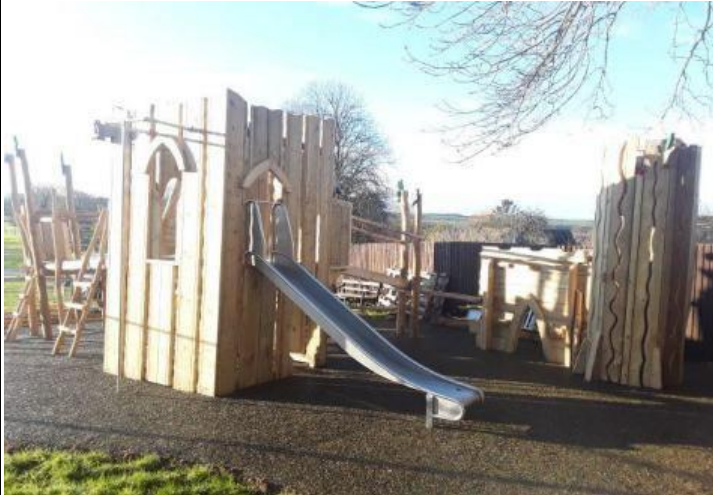
**Item:** Activity Equipment - Multi Play (Junior)  
**Manufacturer:** A Frost Design

**Finding:** There are openings leading from platforms in excess of 1.0m (1.4m) in height to steep play elements and no hand supports complying with grip or grasp are provided, in contravention of BS EN 1176 Part 1: 4.2.9.4

**Action:** Refer to contractor

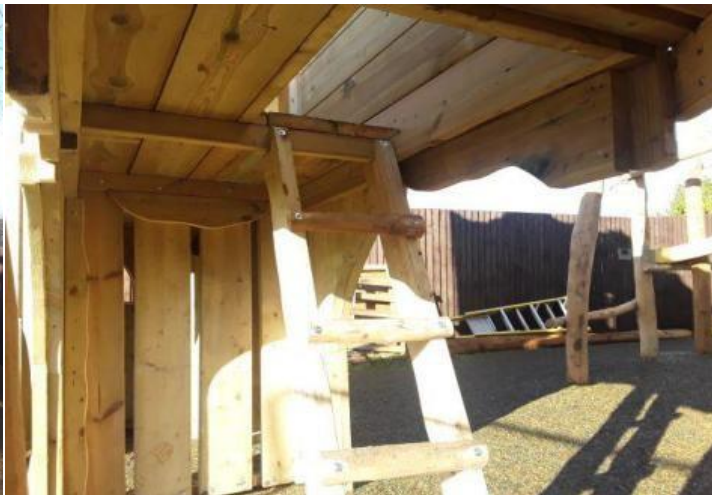
**Item:** Activity Equipment - Multi Play (Junior)  
**Manufacturer:** A Frost Design

**Finding:** There are openings leading from platforms in excess of 1.0m (1.4m) in height to steep play elements and no hand supports complying with grip or grasp are provided, in contravention of BS EN 1176 Part 1: 4.2.9.4

**Action:** Refer to contractor
